## HAILSTORM INVESTIGATION

DALLAS / FORT WORTH, TX

MAY 24, 2011

## **HAILSTORM INVESTIGATION REPORT**

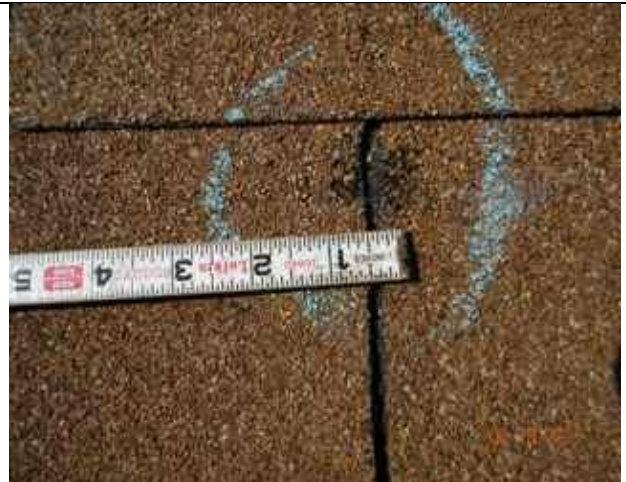
1.14-2. Overview of 1-inch impact mark on damaged 3-tab shingle.

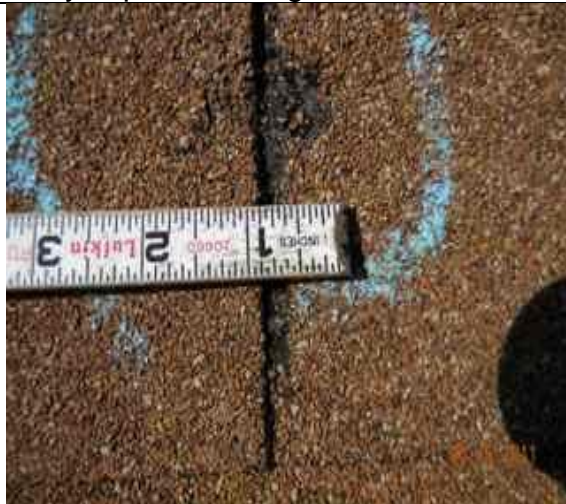
1.14-3. Overview of 1-inch to 1-1/4-inch impact mark on damaged 3-tab shingle.

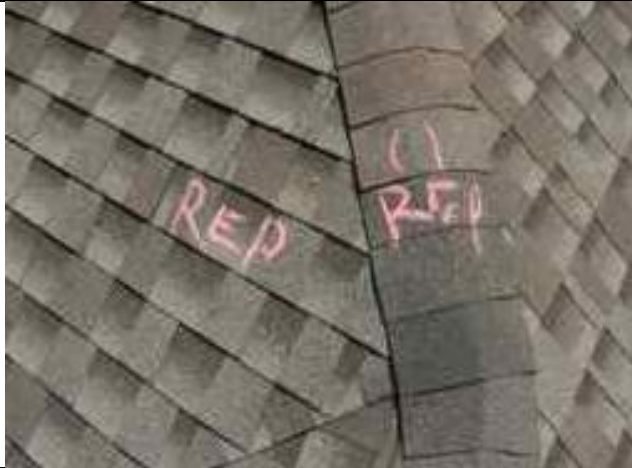
2.06-1. Repair at northwest-facing valley.

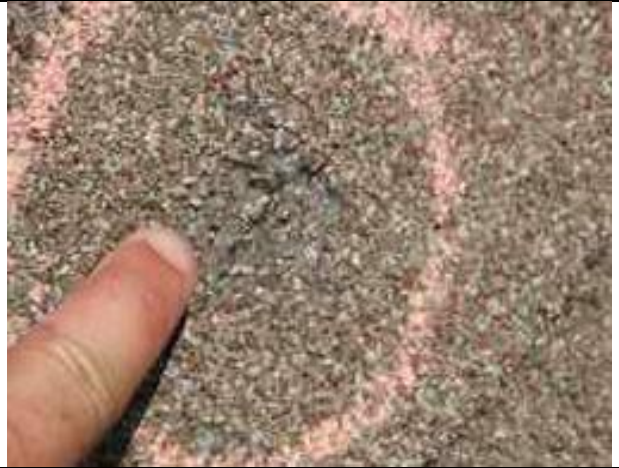
2.06-2. Weathered shingle bruise at ridge.

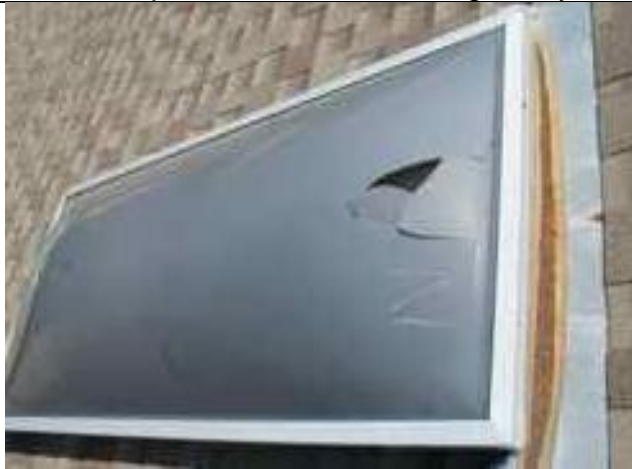
2.06-3. Broken skylights.

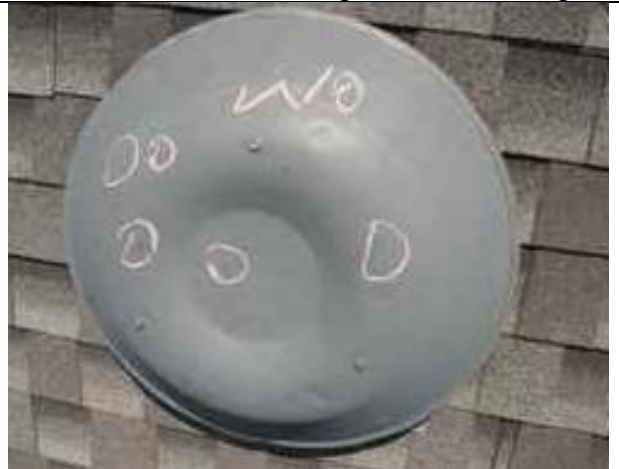
2.06-4. Dents in vent cover.

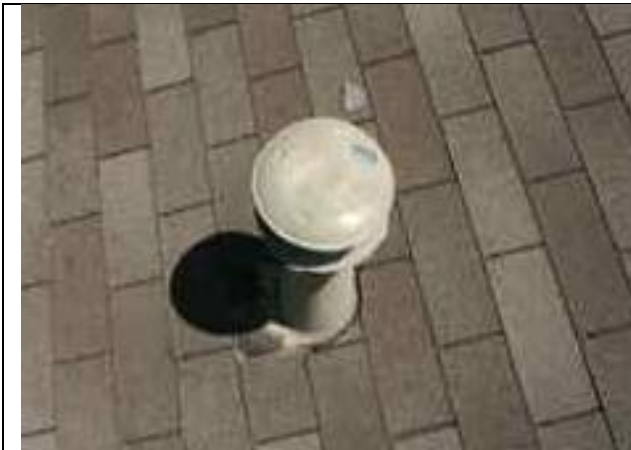
2.07-1. Dented flue cap.

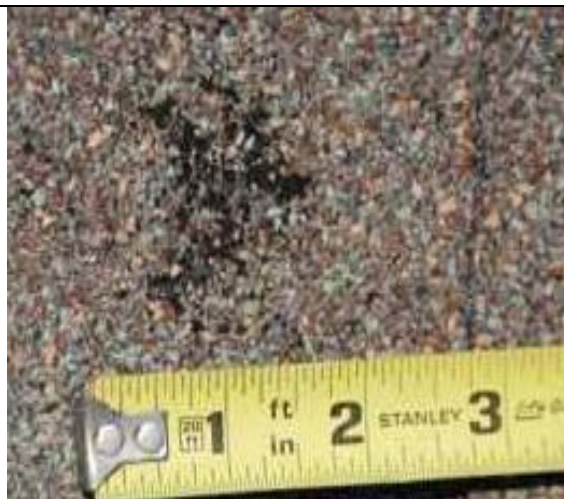
3.03-2. Typical hail damage for this site.

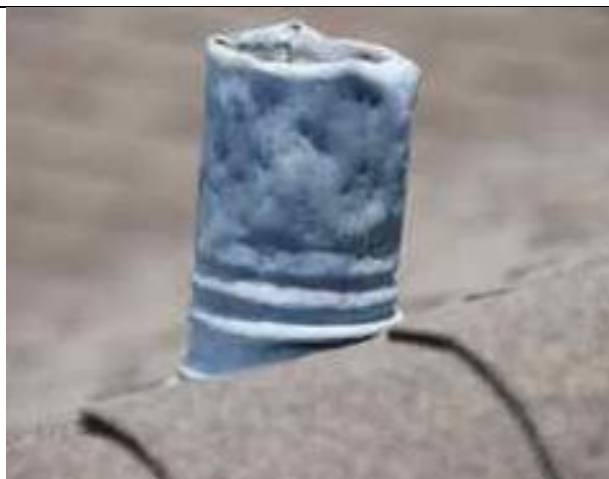
3.03-3. Dents on vent stack indicating hail impact from southwest.

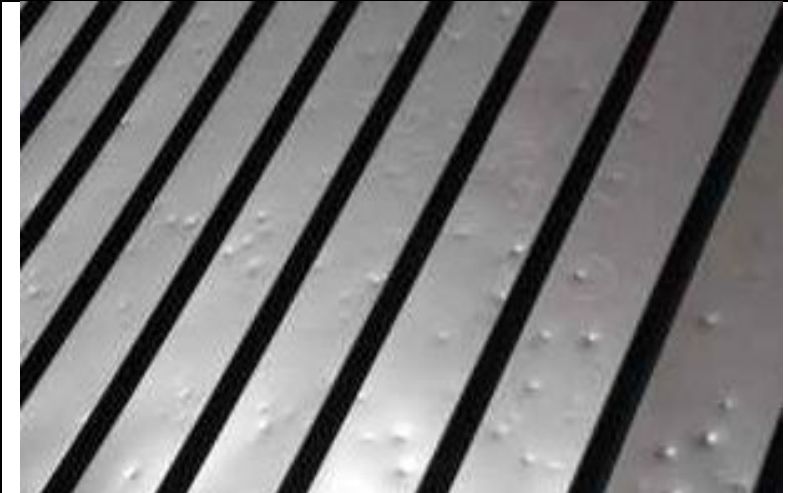
<b>Comments Regarding Inspection</b>	<b>Severe denting of metal roofing, but no apparent functional damage. Did not climb on roof due to steep slope, but could observe damage from a lower flat roof surface.</b>

3.09B-1. Dents in standing seam metal roof from hail impact.

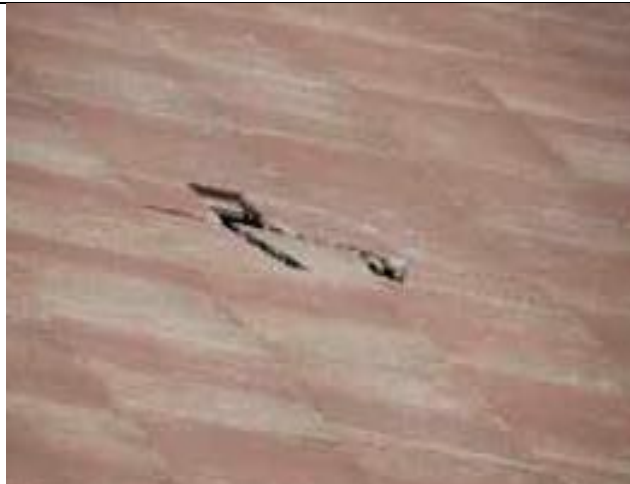
3.11-3. Tile fractured. Note white "splatter" marks indicating hail impact.

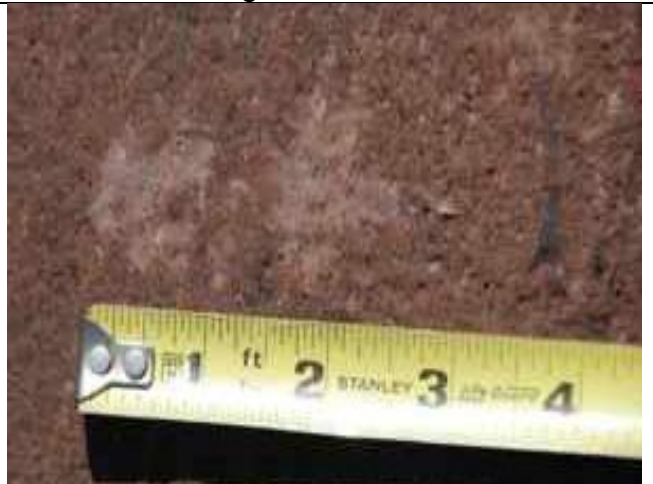
3.11-4. Typical hail splatter mark on tile.

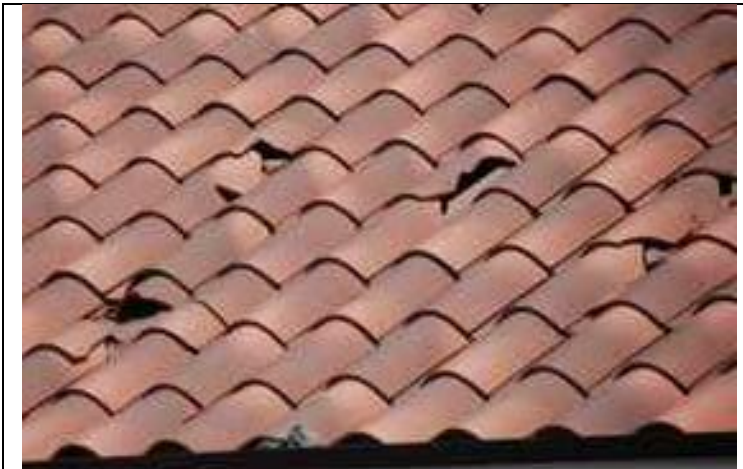
3.12B-1. Typical tile roof damage due to hail impacts at this site.

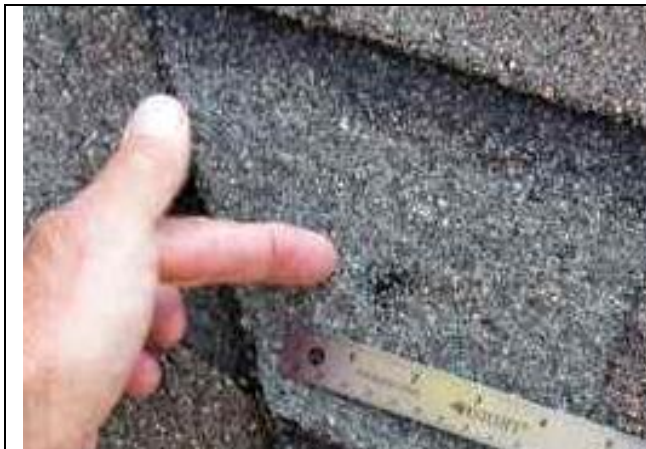
4.04-1. Possible hail damage on class 4 shingles.

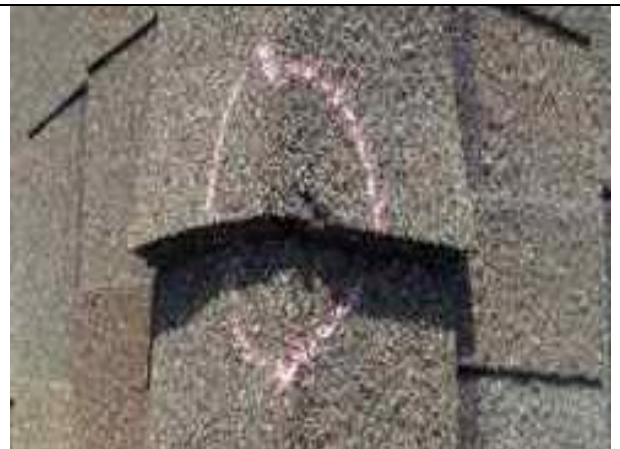
4.04-2. Hail bruise mark on class 4 shingles.

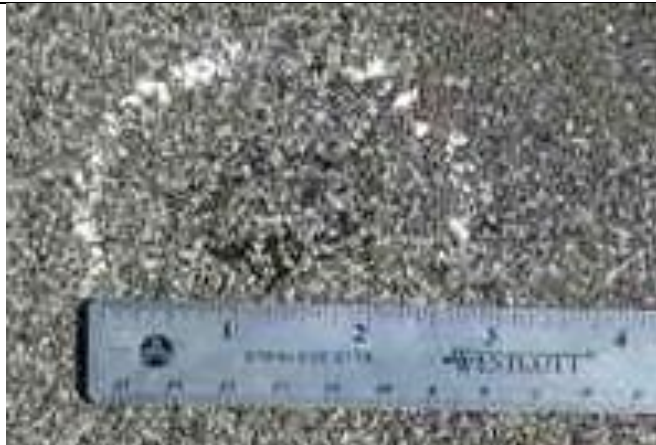
4.05-1. Bruise mark on the laminated shingle.

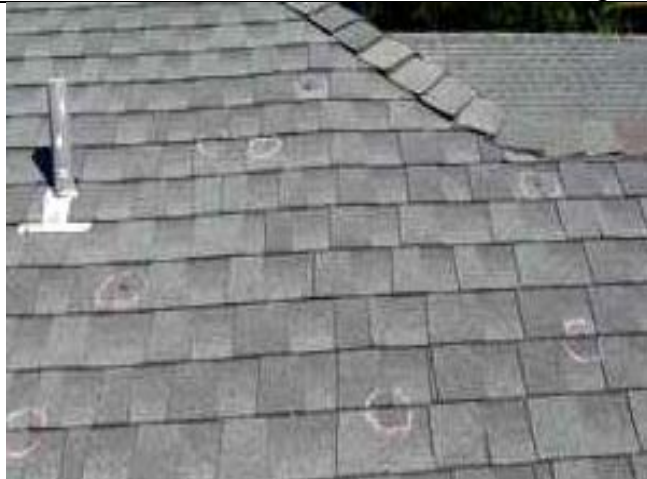
4.05-3. Several damaged asphalt shingles on the roof.

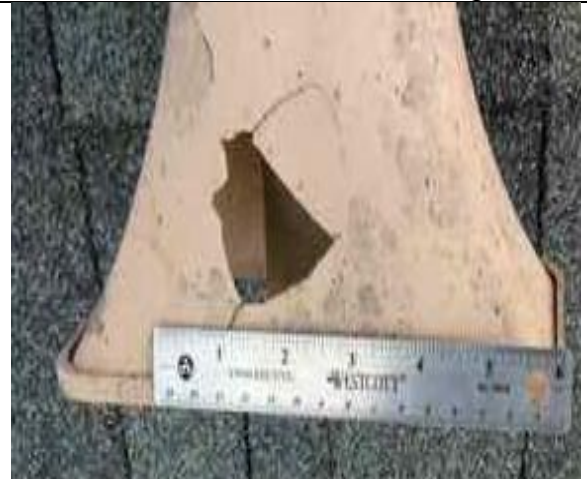
4.05-4. Punctured plastic equipment on the roof.

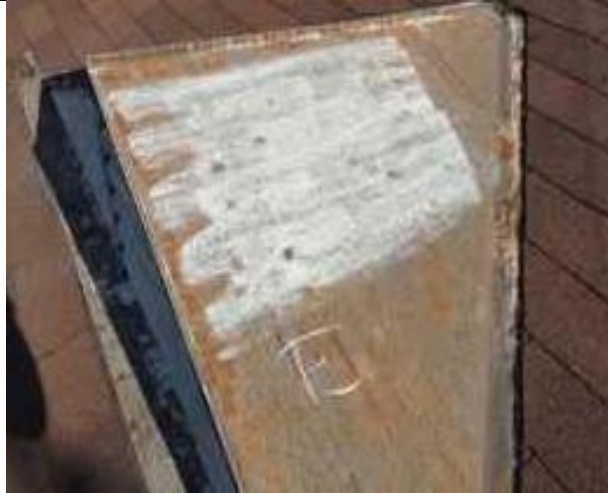
5.01-1. Impact on metal dormer.

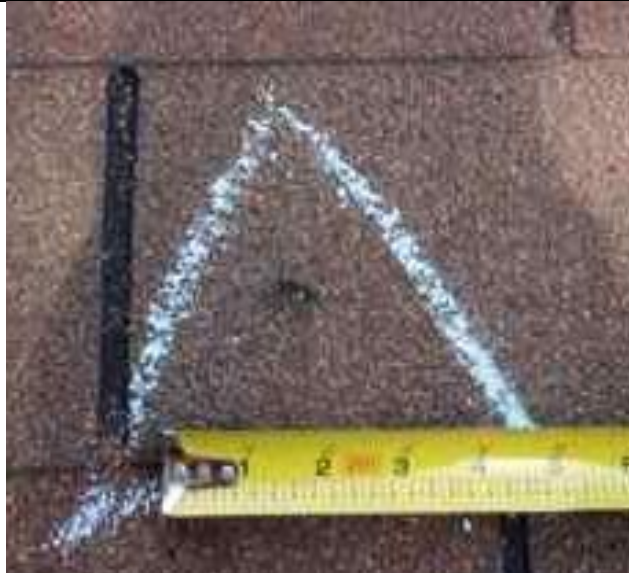
5.03-1. Damage mark from hail.

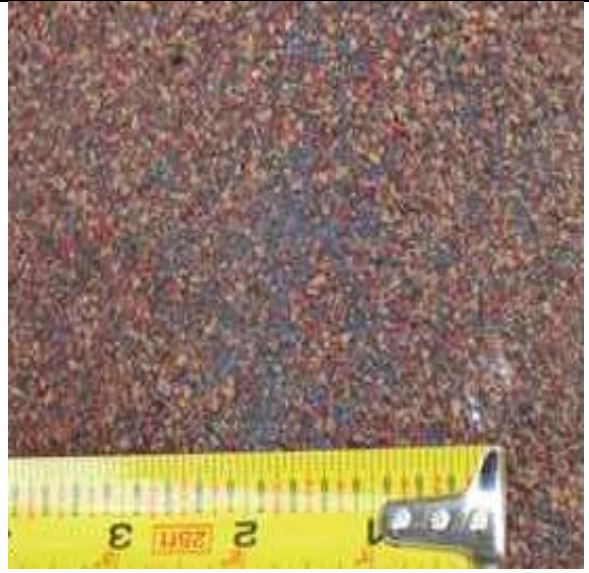
5.03-2. Damage mark from hail.

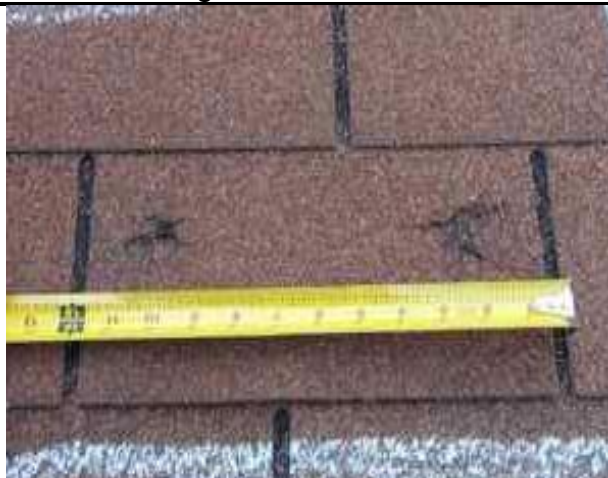
5.03-3. Large marks from hail.

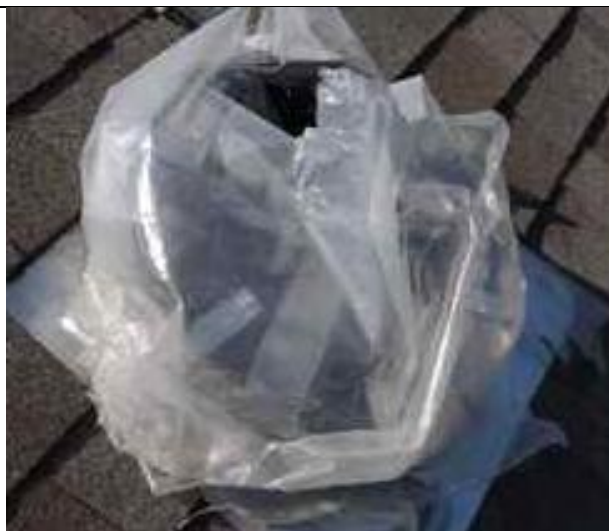
5.12-1. Severe damage to plastic static roof vent.

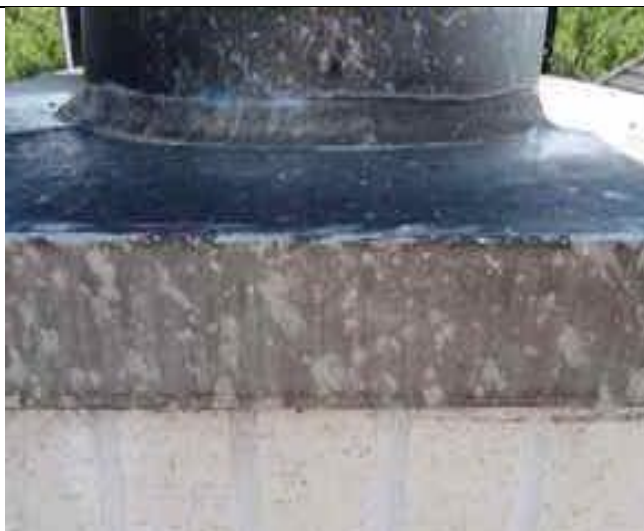
5.12-2. Splatter marks on chimney vents.

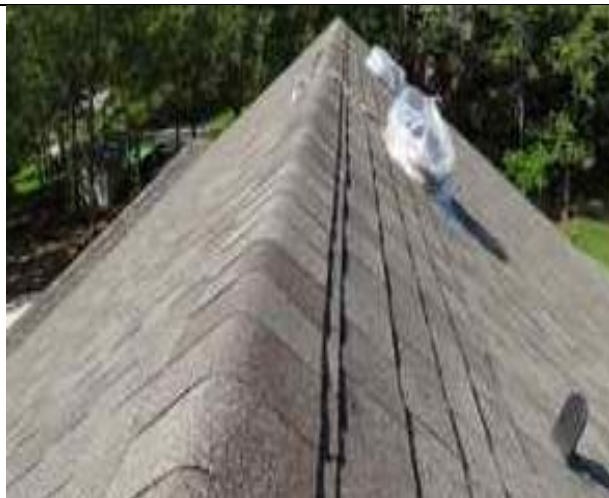
5.12-3. Damage to multiple roof turbine vents.

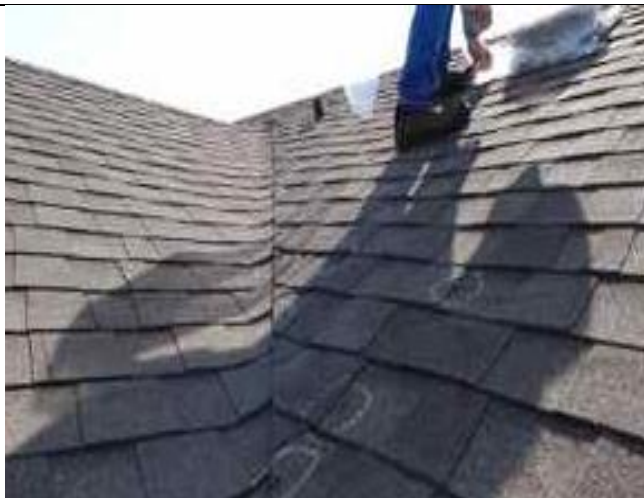
5.12-4. Multiple impact locations along closed-cut valley of IR roof.

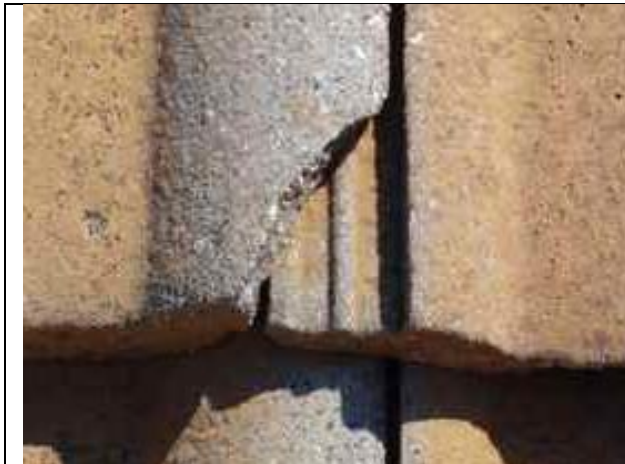
5.16-1. Right corner fracture on concrete barrel tile.

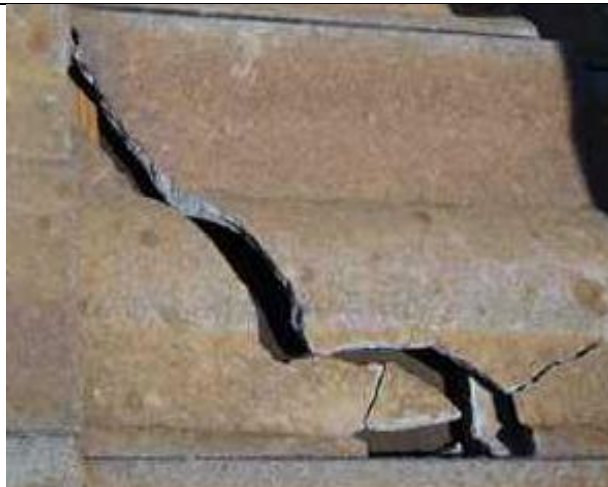
5.16-3. Fracture from large hail impact.

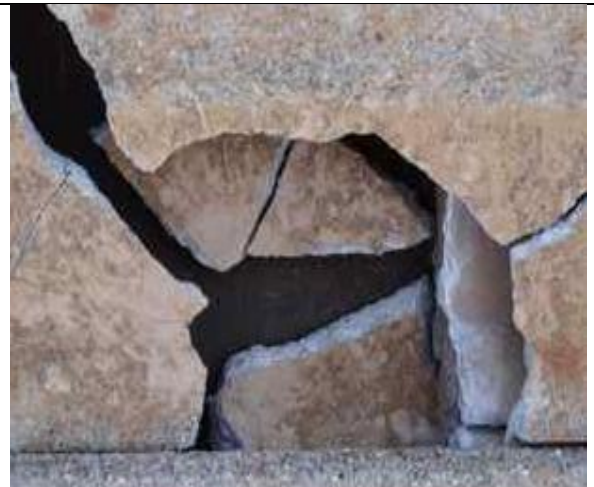
5.16-4. Close up of fracture from large hail impact, with splatter mark.

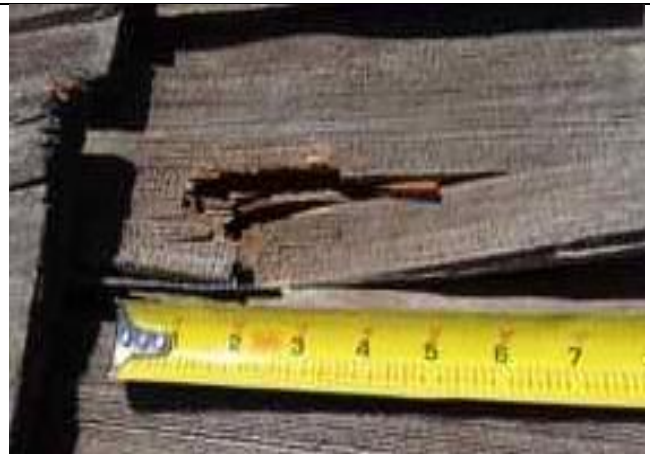
5.17-4. Large impact and broken cedar shake.

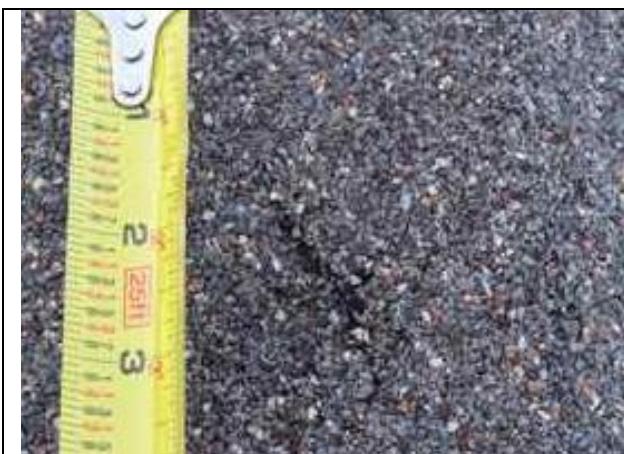
5.18-1. Fracture in asphalt shingle.

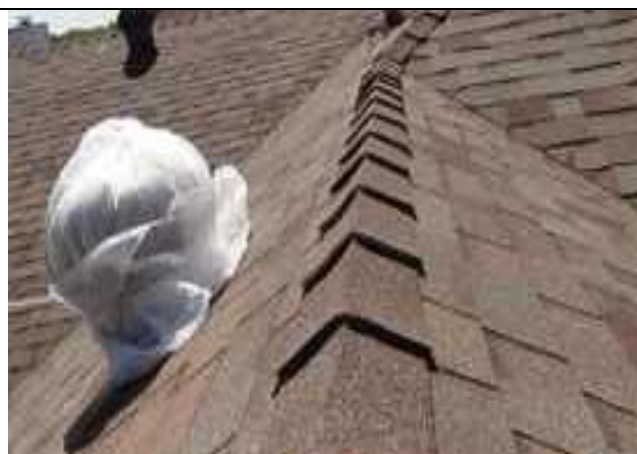
5.18-2. Ridge and damaged turbine vent.

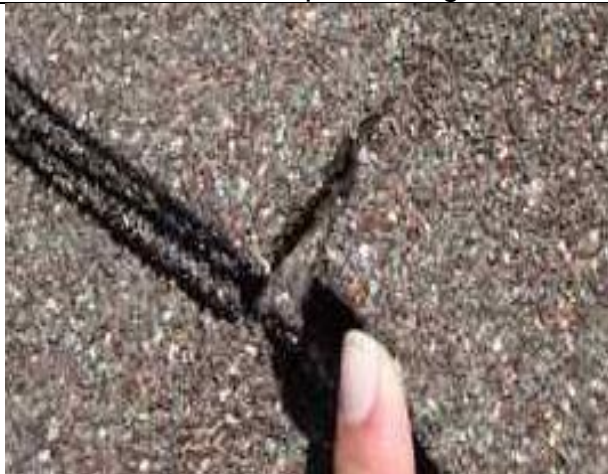
5.18-3. Tear on shingle edge.

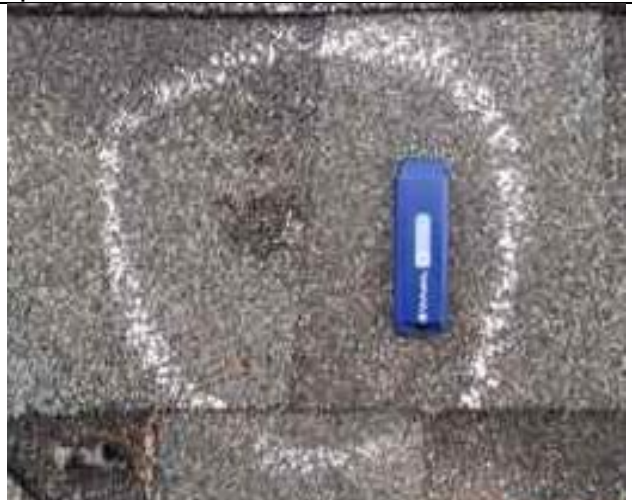
6.01-4. Impact damage.

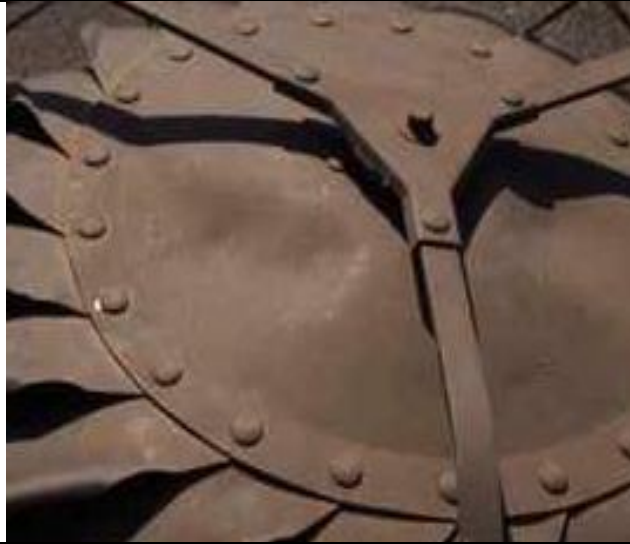
6.11-1. Dents in turbine vent.

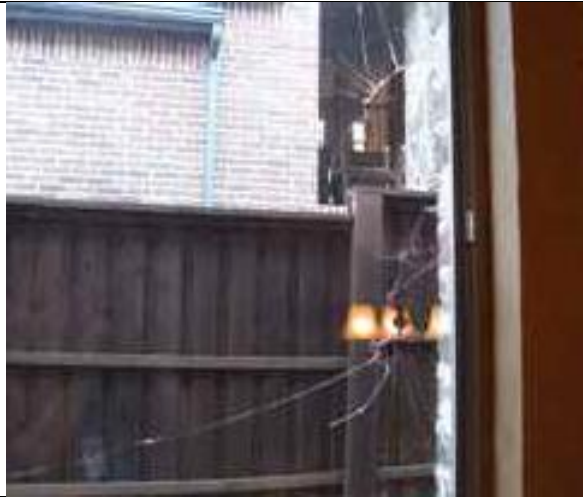
6.14-1. View of broken windowpane on east side of the residence.

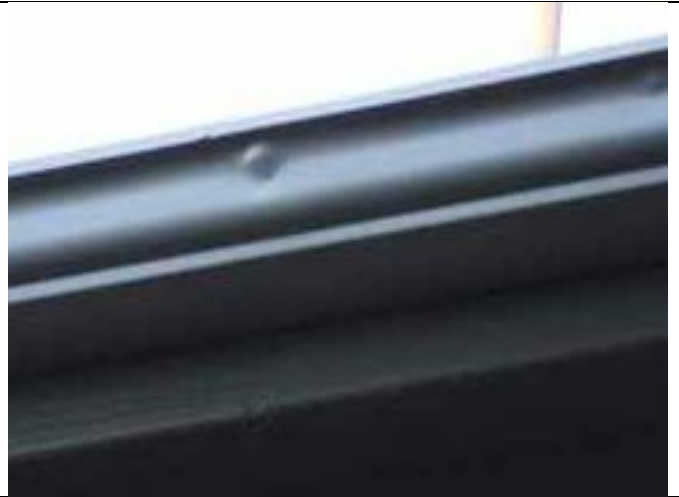
6.14-2. View of dents in a gutter.

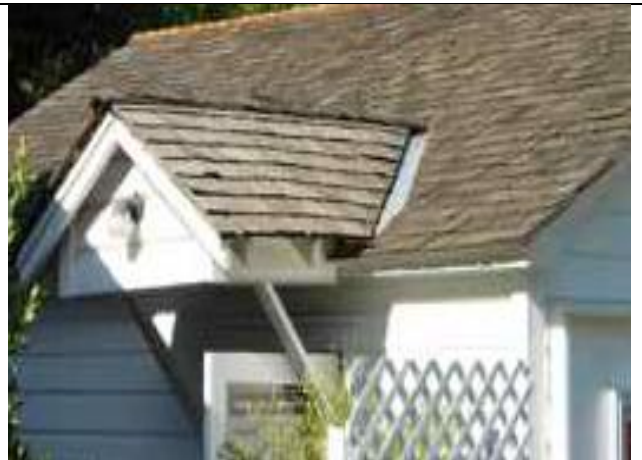
7.02-4. New ridge from Christmas light damage.

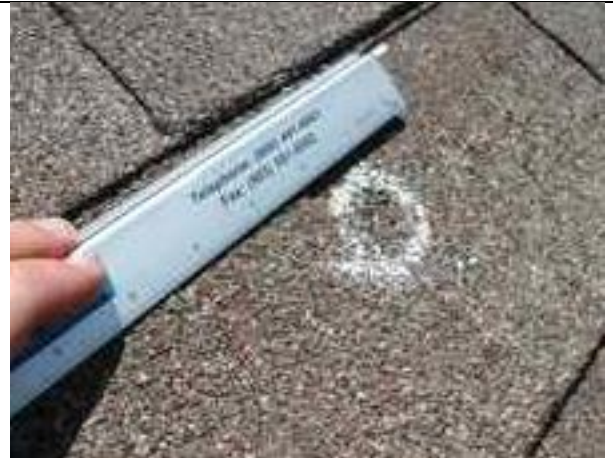
7.05-2. Hail-caused bruise on asphalt shingle.

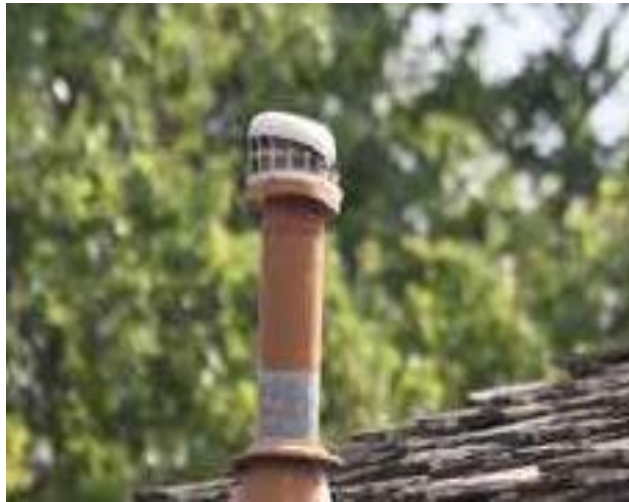
7.06-3. Damaged hot vent cap.

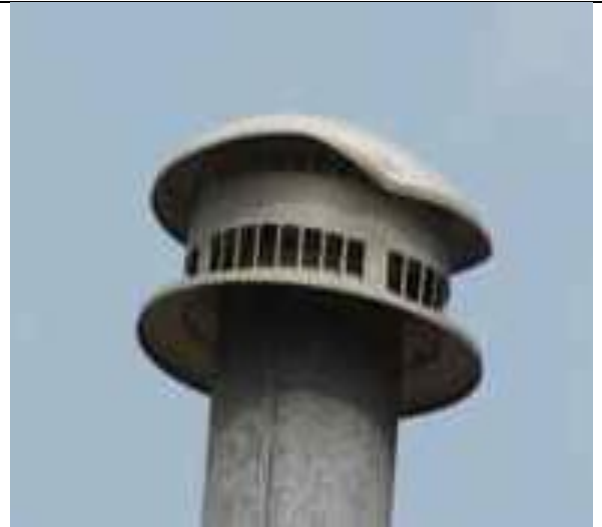
7.06-4. buckled vent cap.

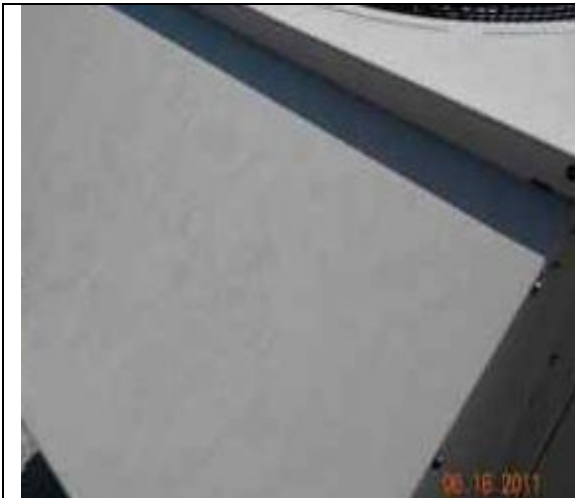
1.17-1. Metal damage from hail.

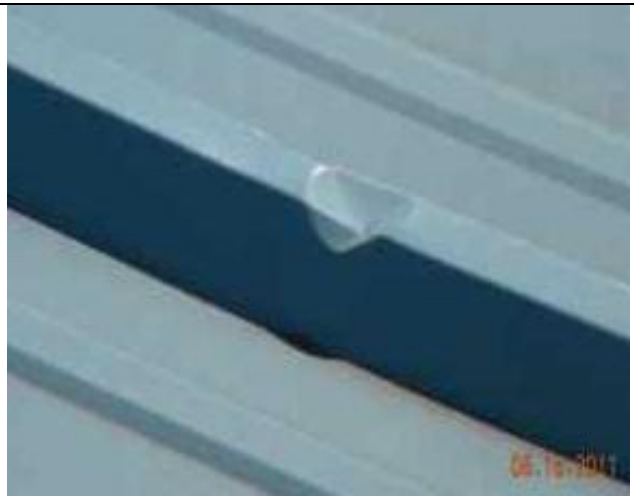
1.17-2. Dent from hail.

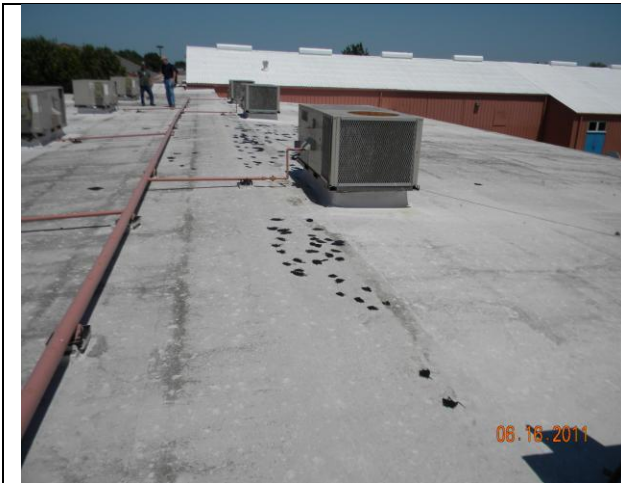
01.20-1. Overview of impact repairs on coated membrane with damage.

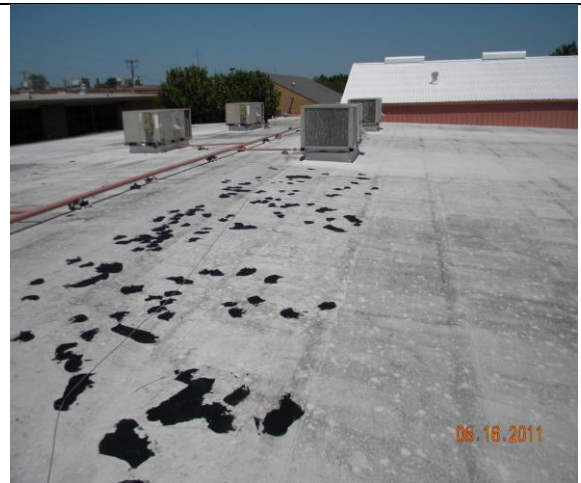
01.20-2. Overview of impact repairs on coated membrane with damage.

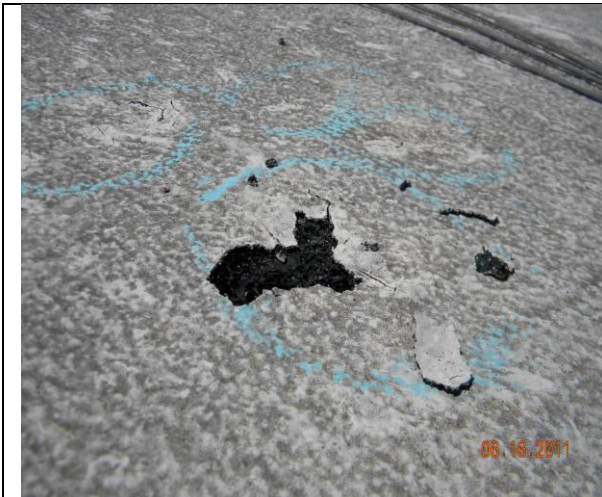
01.20-5. Close view of impact damage.

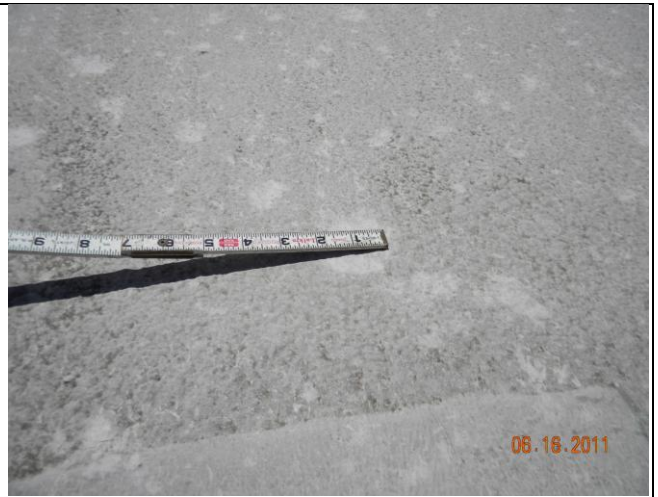
01-20.6. Hail bruising marks on roof top unit.

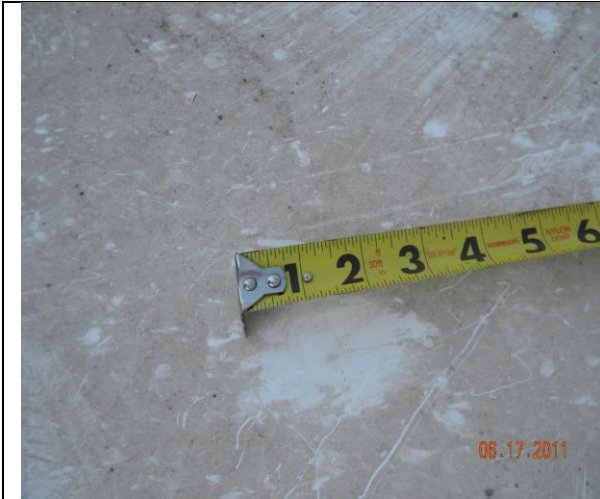
01.26-1. Close view of impact marks on TPO membrane with no damage.

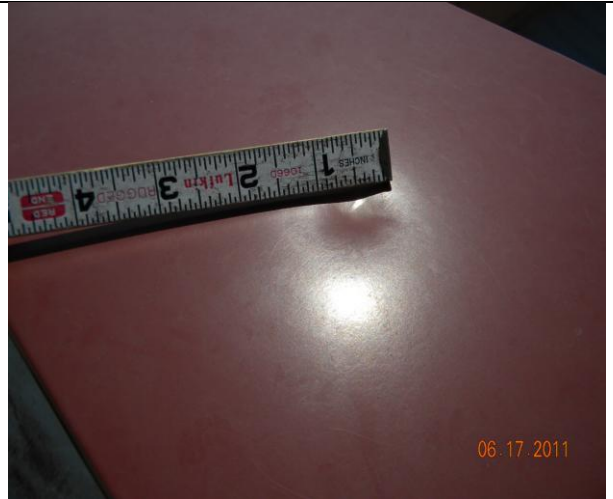
01.26-2. Close view of impact damage in coping ~ 1-inch.

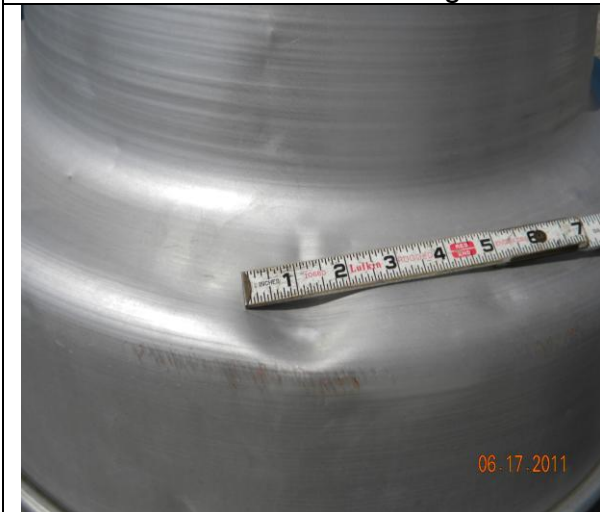
01.26-3. Close view of impact damage in vent cover ~ 1.5-inch.

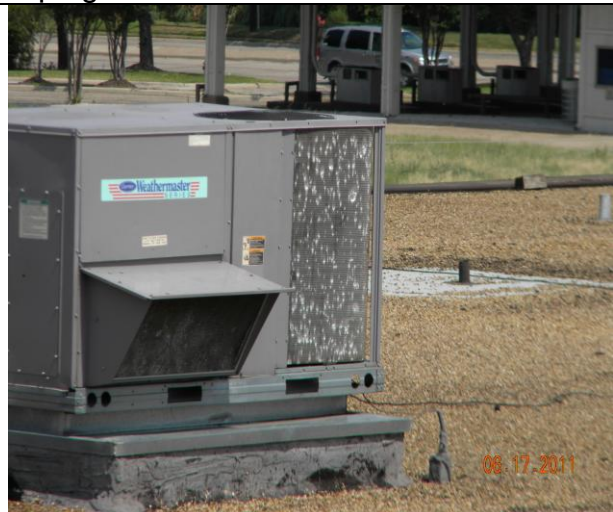
01-26.4. Hail-caused dents to RTU fins.

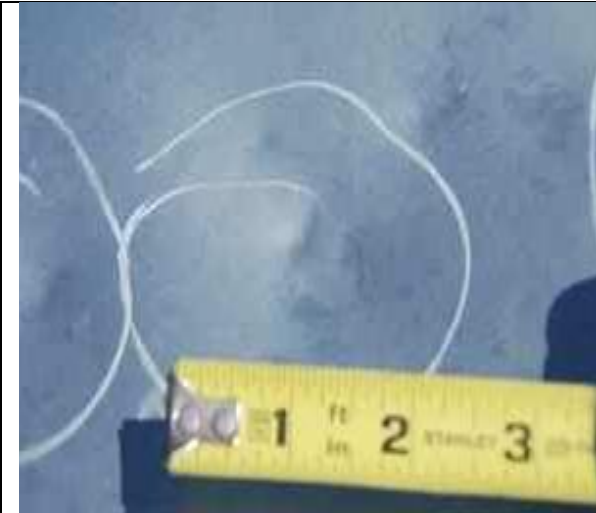
3.10-1. Typical hail impact damage to exhaust vent.

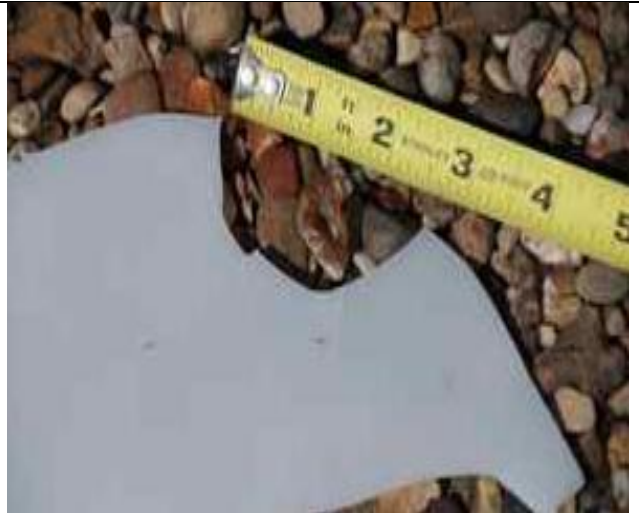
3.10-2. Sample of broken skylight due to hail impact.

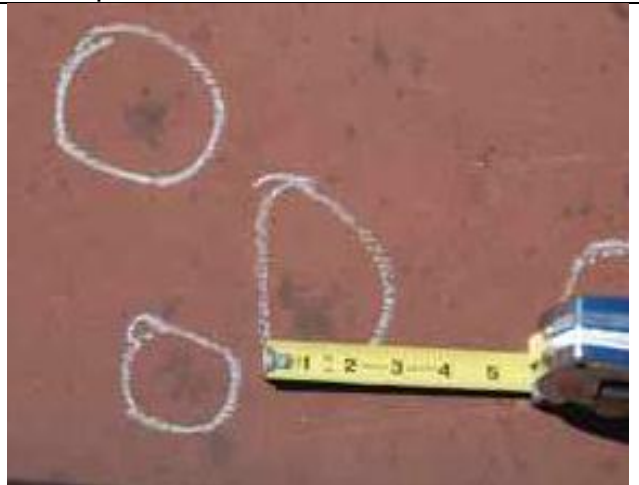
3.10-4. Typical hail impact damage to parapet cap flashing.

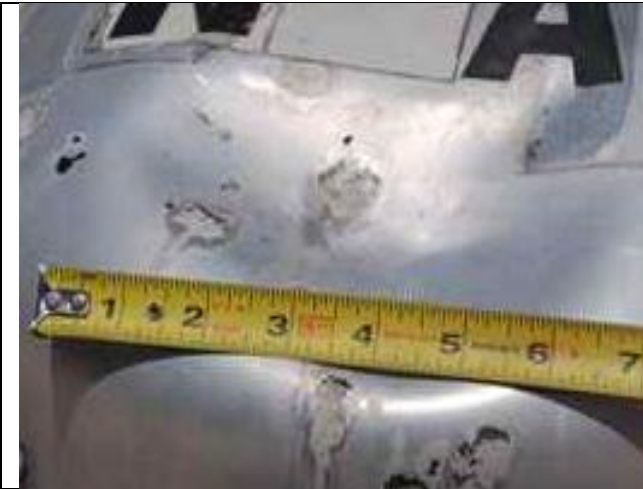
3.12-1. Large hail dent in vent stack.

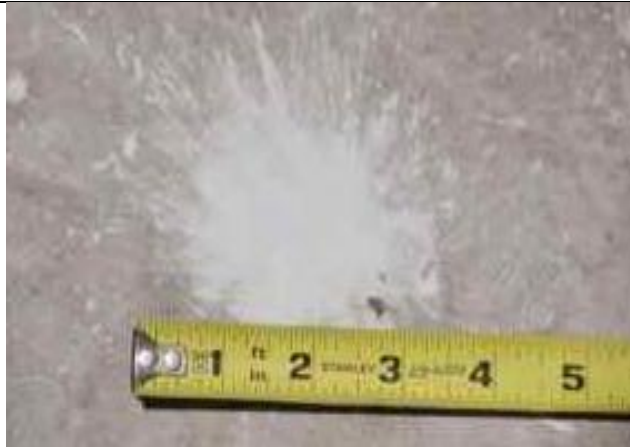
3.12-3. Typical large hail strike to single ply roof covering. Would need core sampling to determine underlying damage at this site.

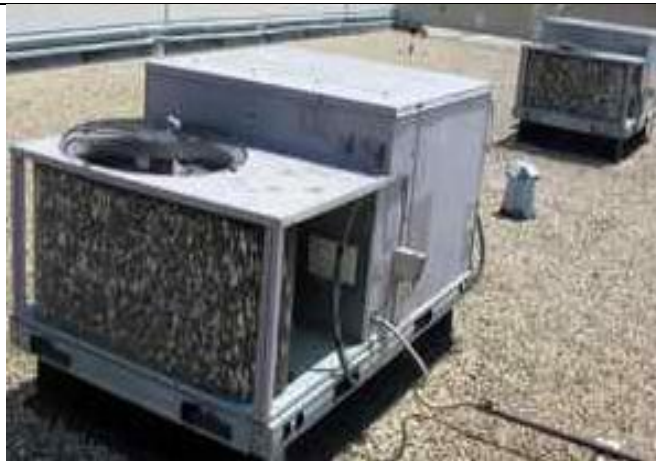
4.02-7. Cooling fins on both of these HVAC units show widespread damage from hail strikes.

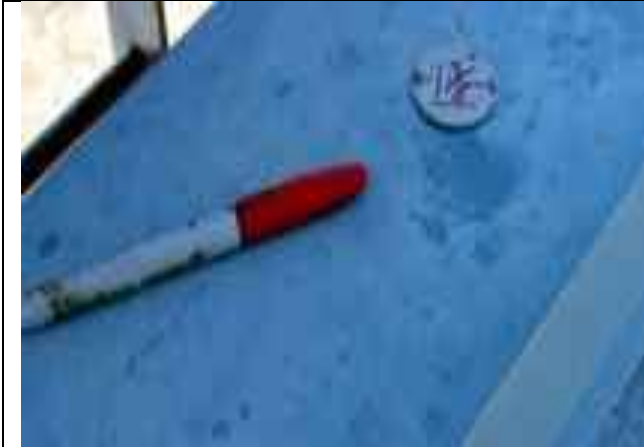
4.08-1. Spatter marks on the metal coping.

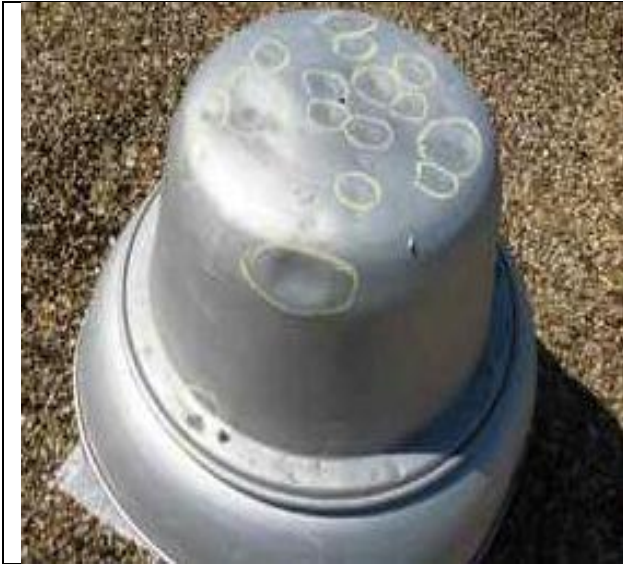
4.09-1. This exhaust unit was hit by numerous hailstones of moderate to large size.

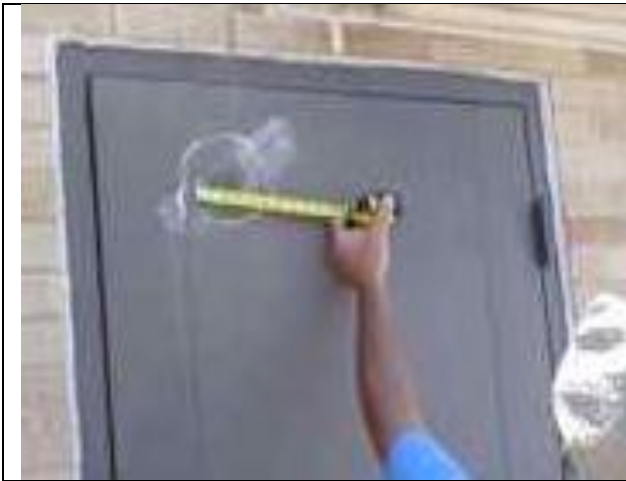
4.10-5. Indentation on the metal door apparently caused by a large hailstone.

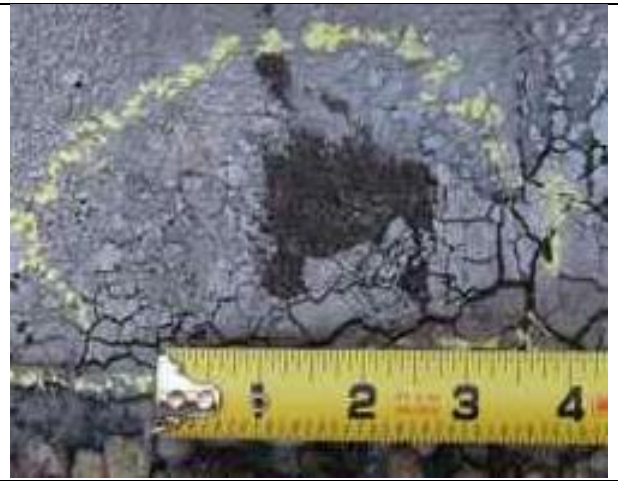
4.10-6. Chipped aluminized coating on the base flashing.

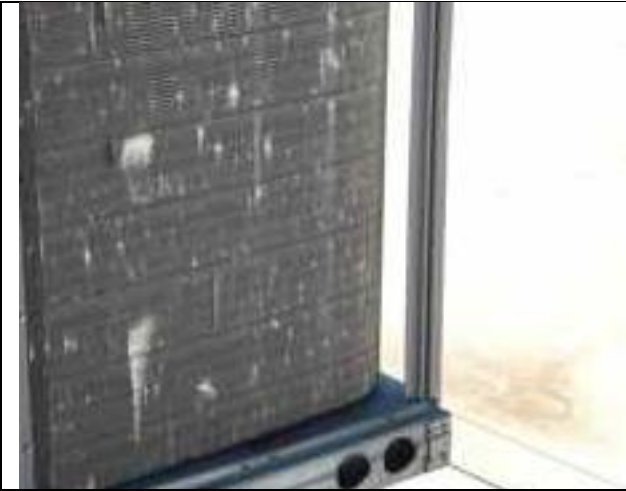
7.03-1. Damaged rooftop unit impacted by hail sideways.

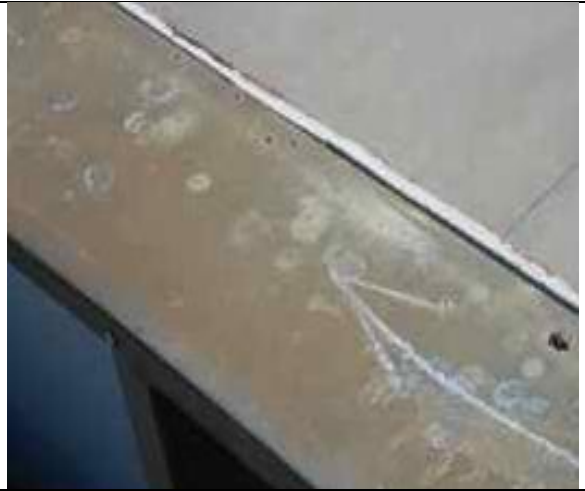
7.03-2. Pockmarks on parapet.

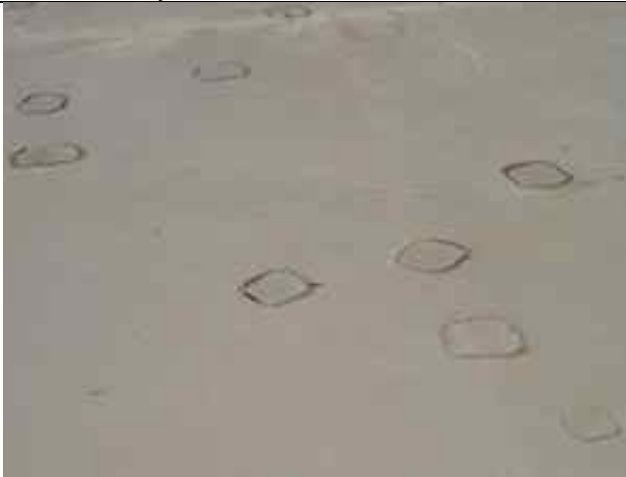
7.03-3. Repaired punctures on flat roof.
