RICOWI, Inc.

Roofing Industry Committee on Weather Issues, Inc.

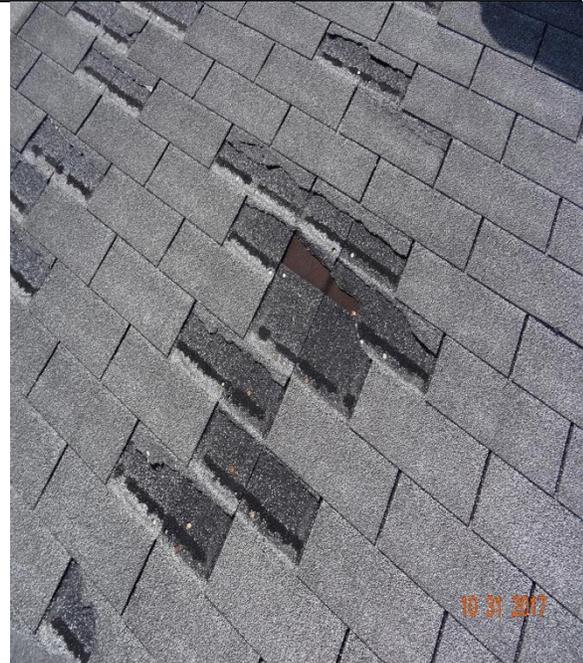
Partially missing shingles

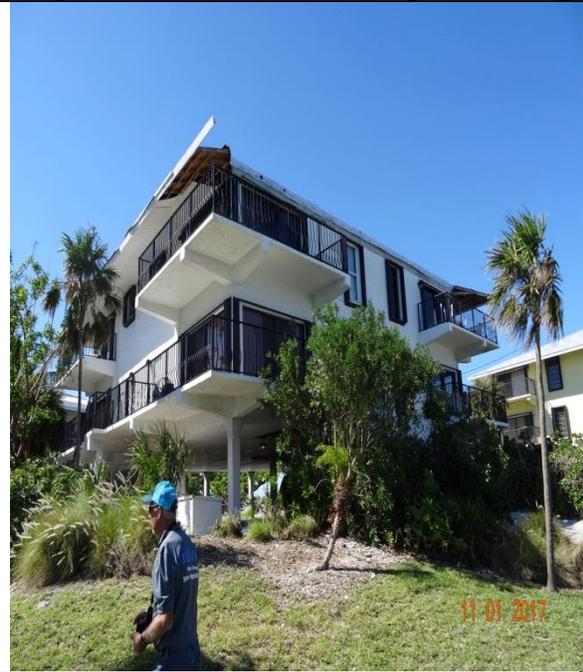
Entire Water Side Soffit Missing

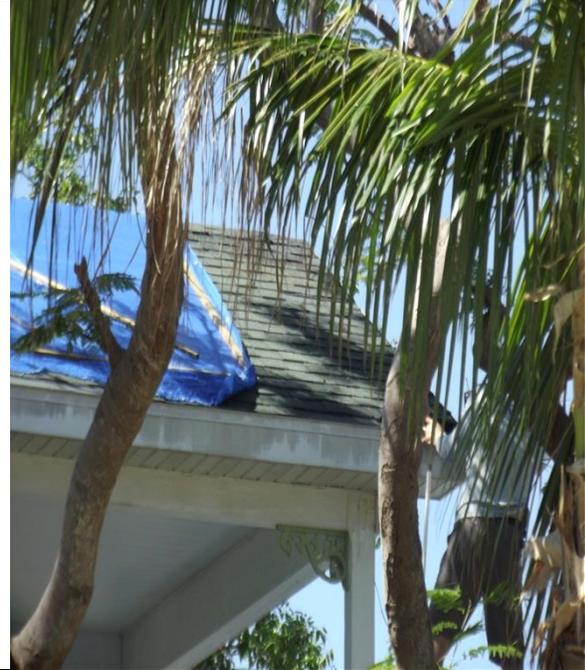
Asphalt Shingle Roof

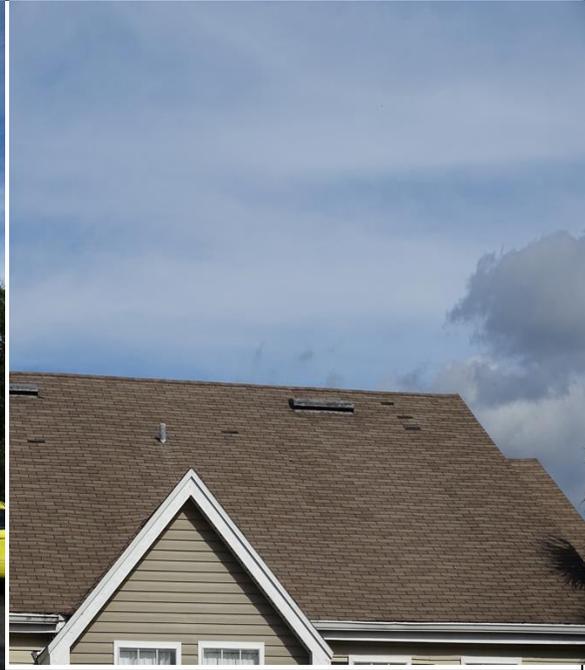
Overview of Apartments

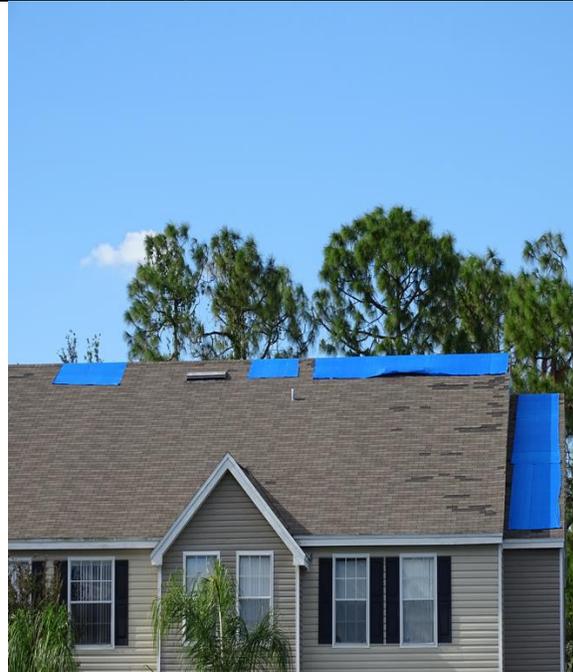
Typical South East Facing Roof

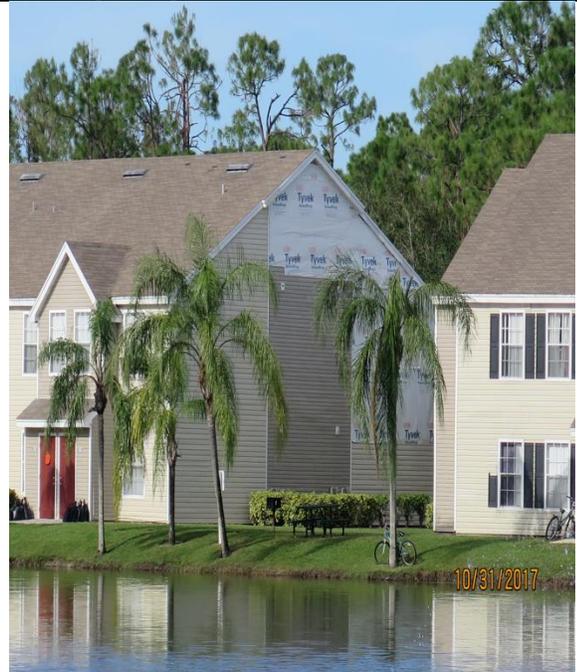
Missing siding and a few shingles

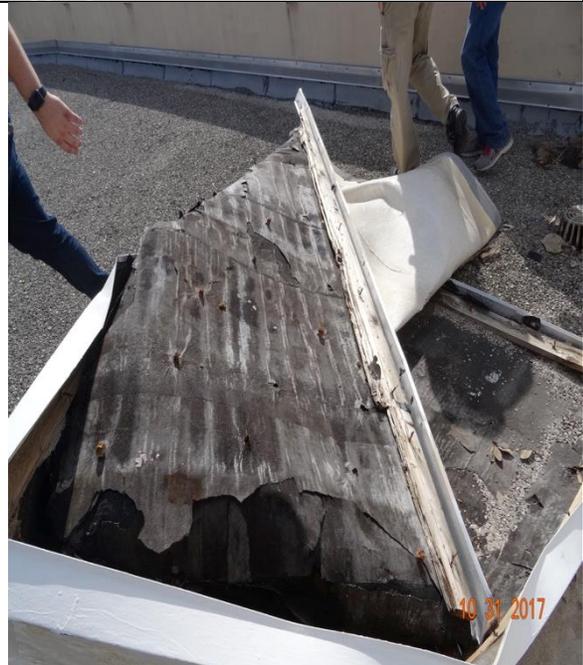
Note Uneven and Rusted Fasteners

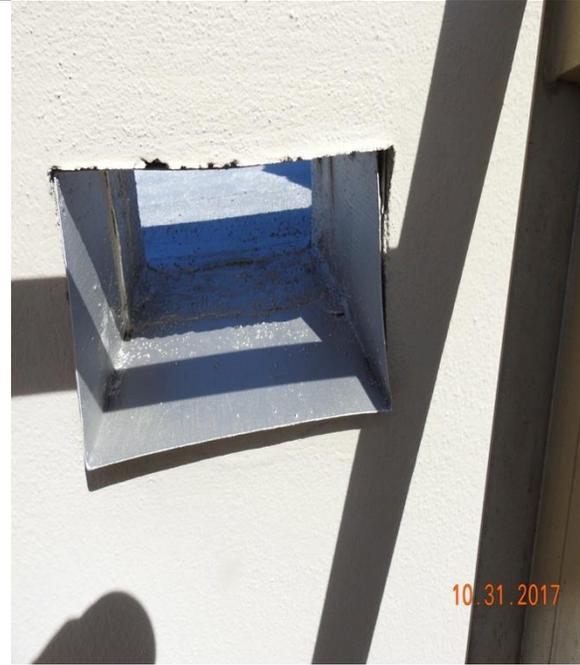
Scupper pulled loose.

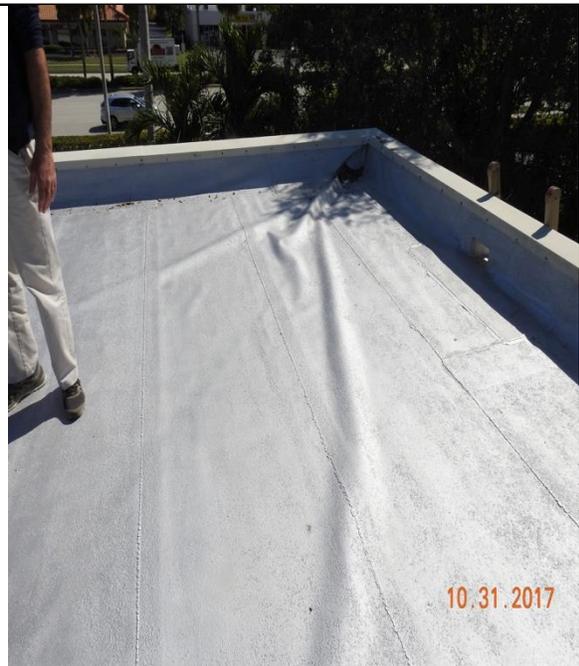
The Southeast corner.

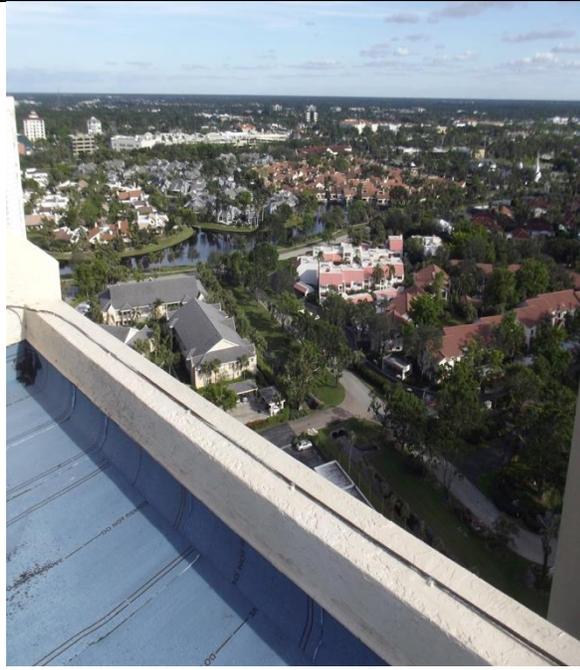
Replaced Section of Mod Bit

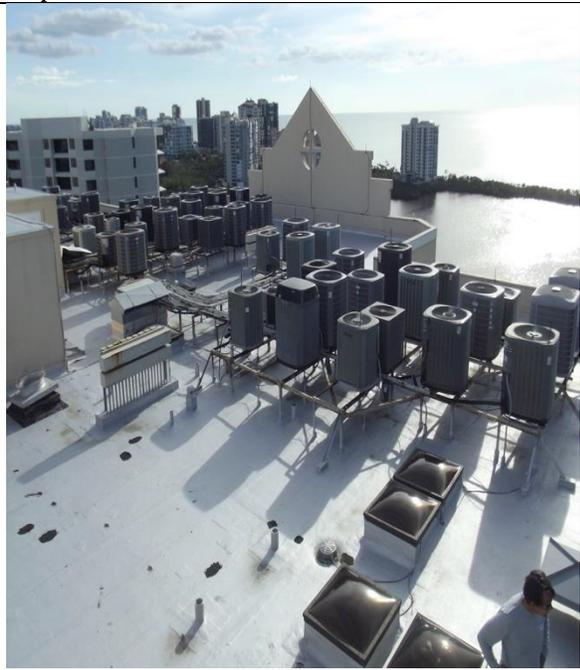
Punctures and Clutter

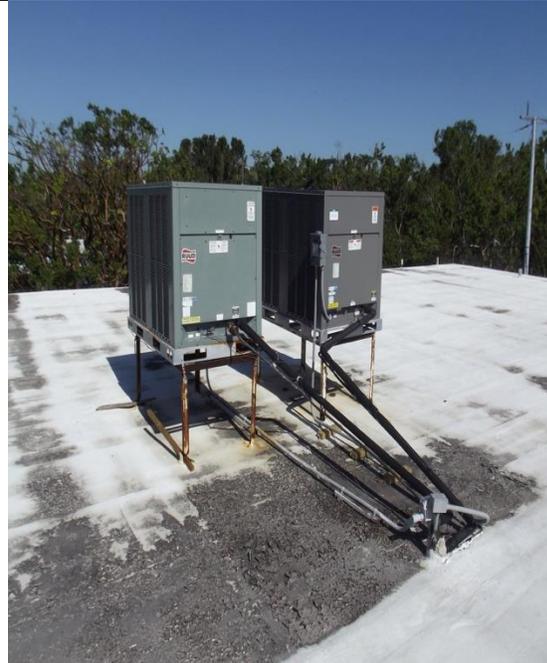
Membrane Deterioration in Ponding Area

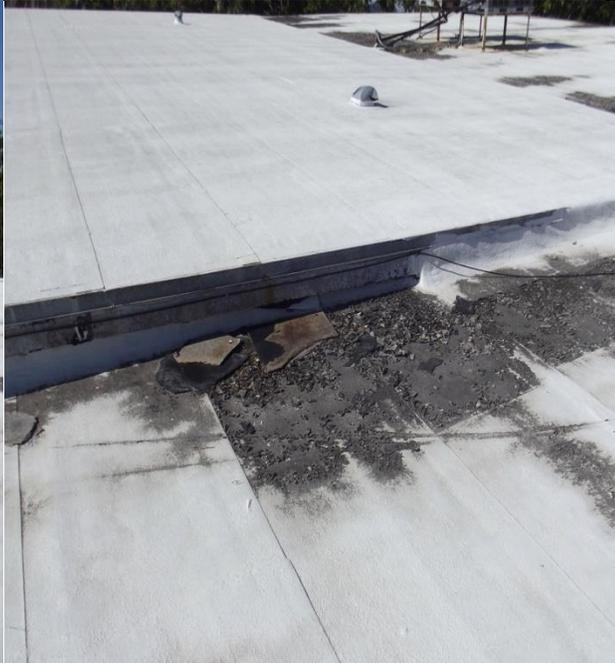
Membrane Deterioration, No Wind Damage

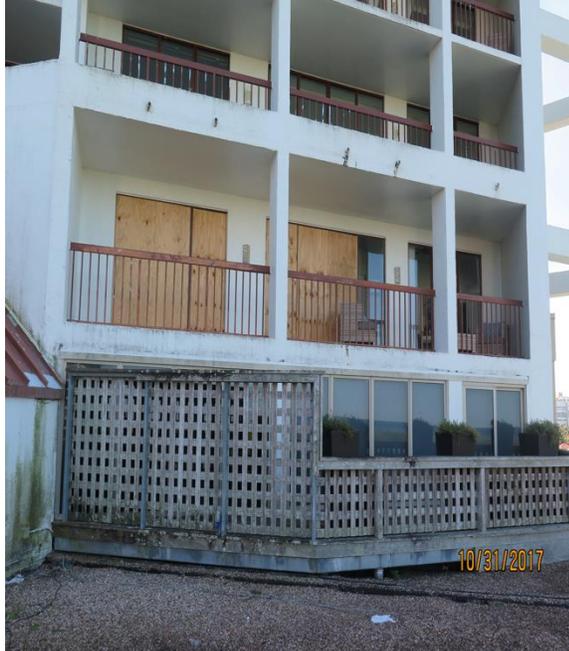
<p style="text-align: right; color: orange;">10/31/2017</p>
<p>Edge metal is also missing on upwind side. No parapet.</p>	<p>Damage to impact resistant windows from pea gravel and debris.</p>

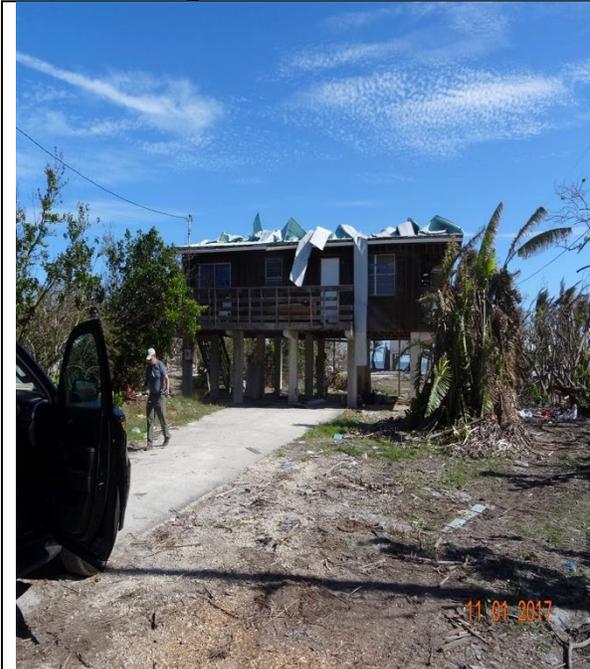
1.2.4 Through - Fastened Metal

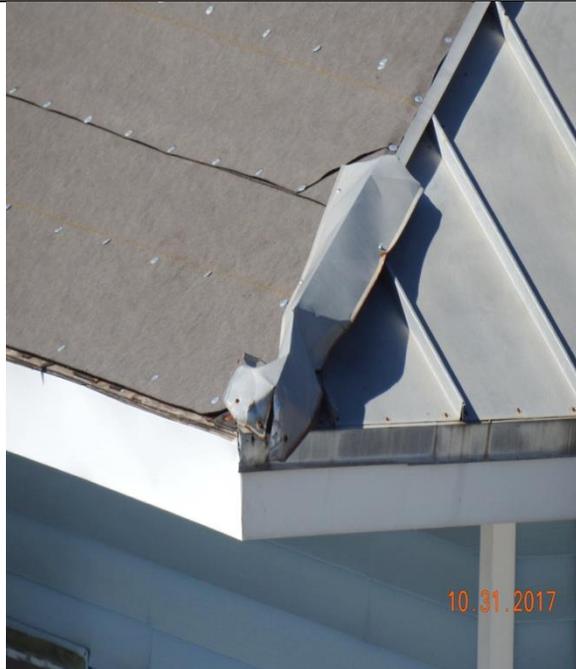
Standing Seam Metal Dislodged

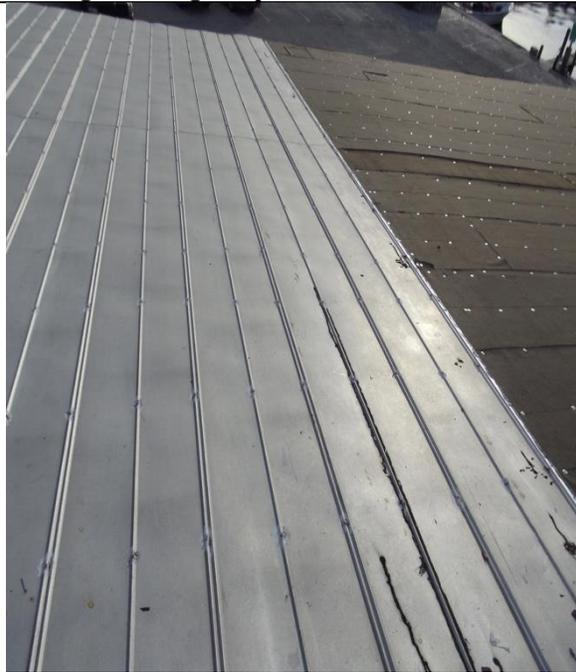
Damage to Adjacent Though Fastened Metal Roof.

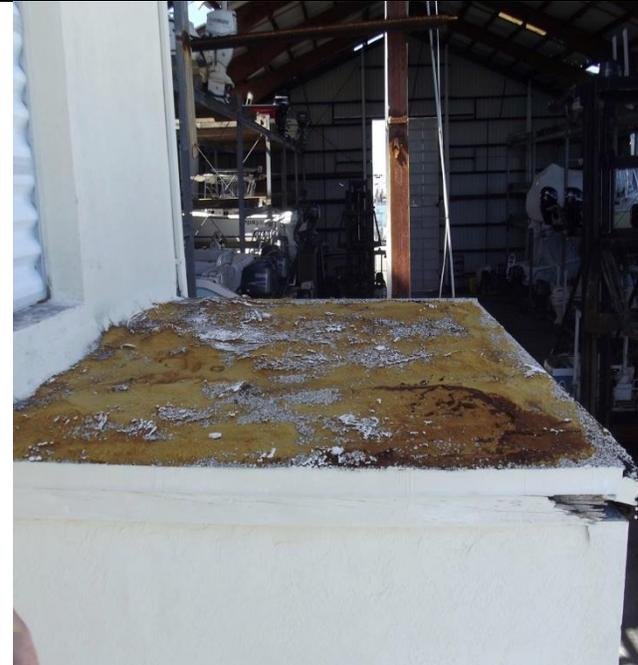
Small SPF Roofs with Missing Aggregate

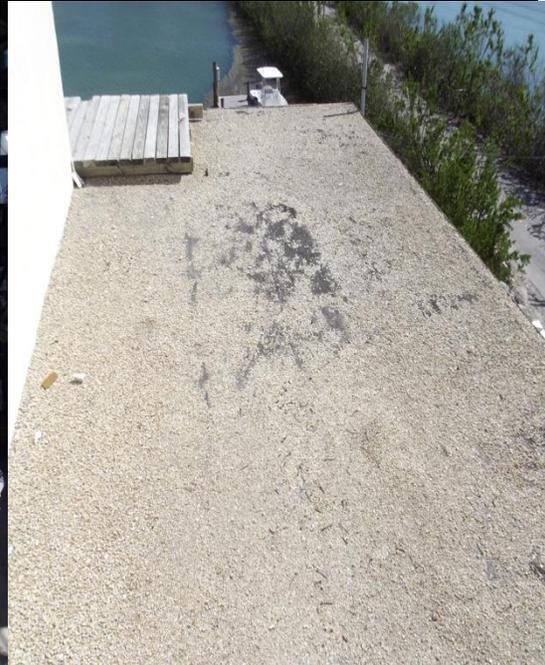
Graveled BUR, with Some Aggregate Scour

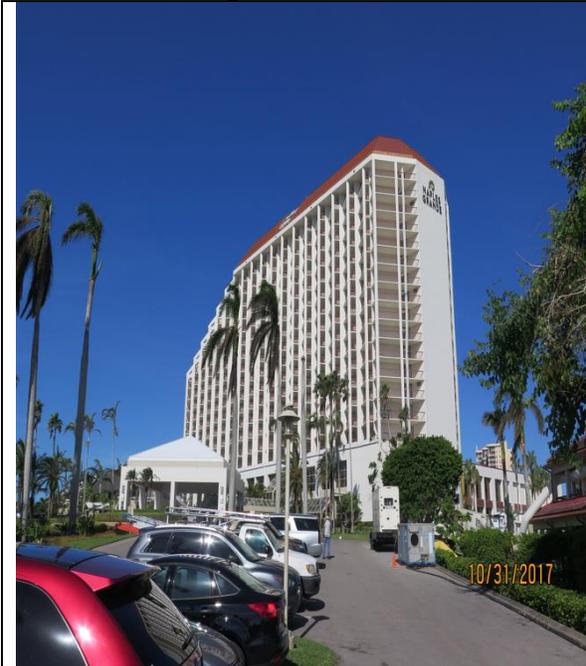
Tower Building with missing panels on decorative mansard

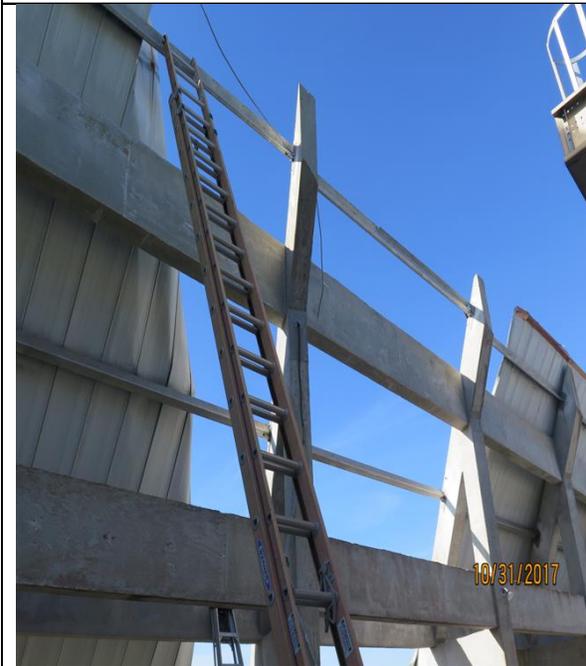
View from under mansard

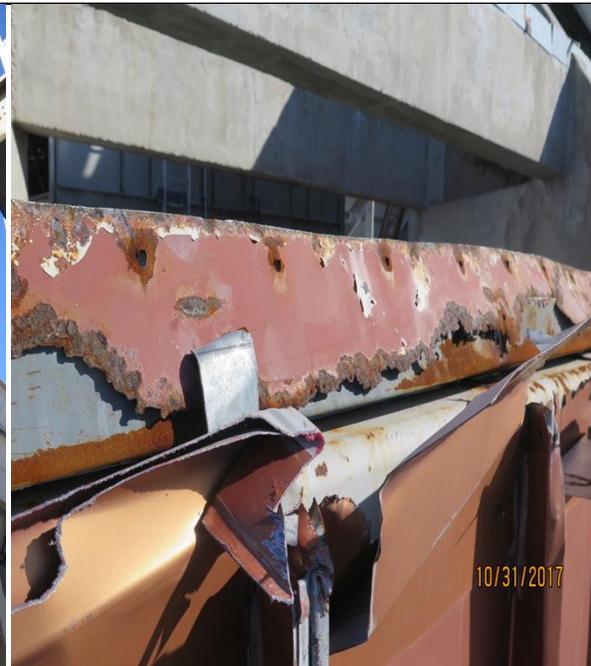
Totally deteriorated metal

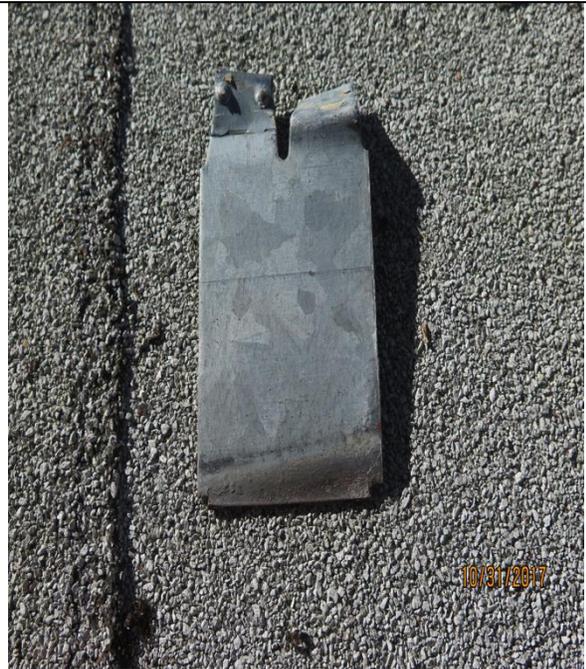
Clips spaced about 6 ft. on center

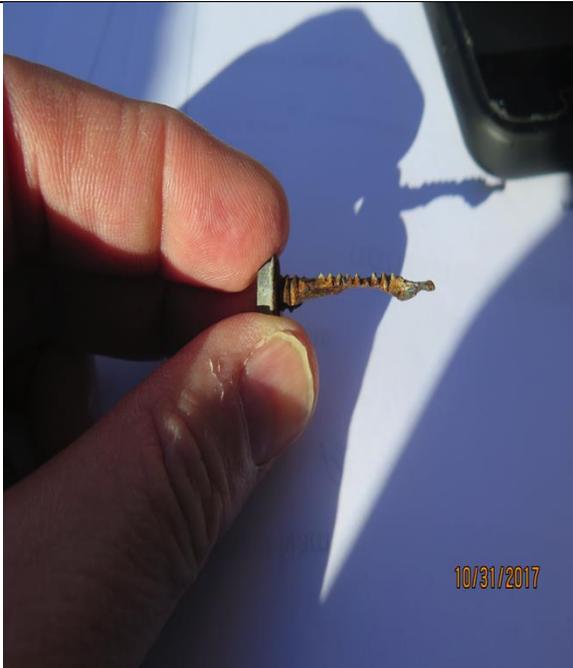
Fastener deterioration

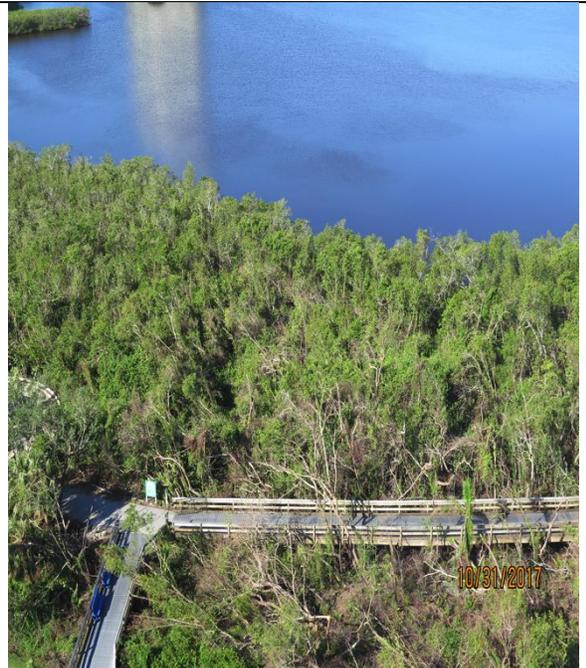
Localized very high wind

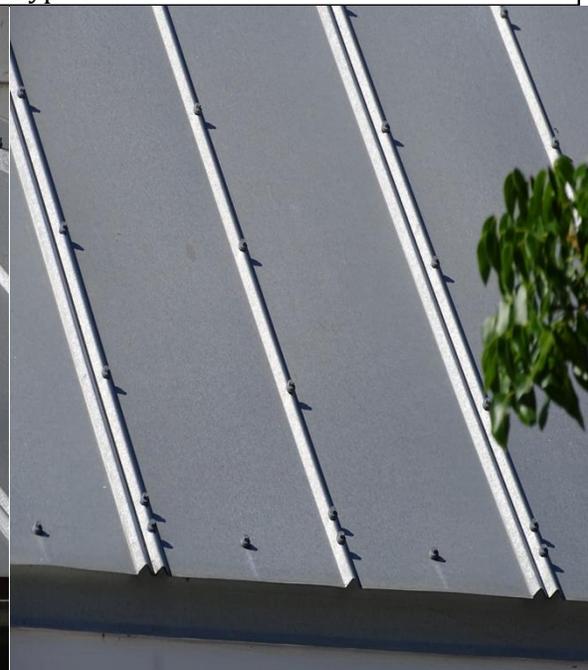
Excellent Workmanship and design

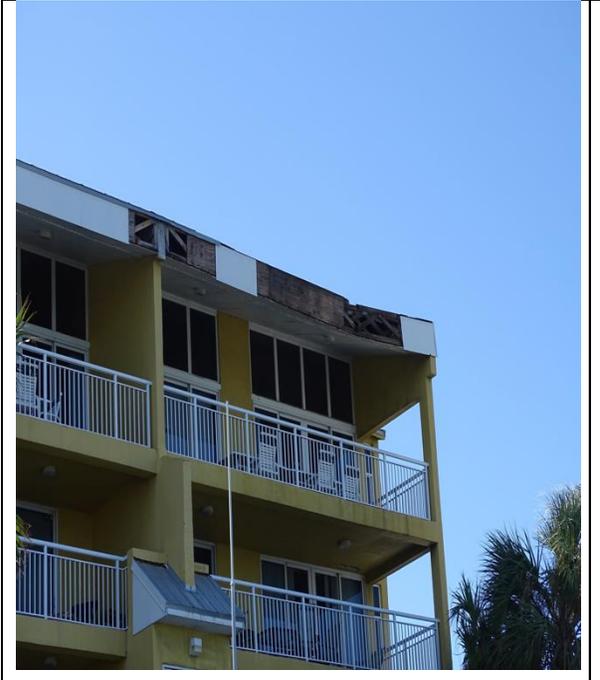
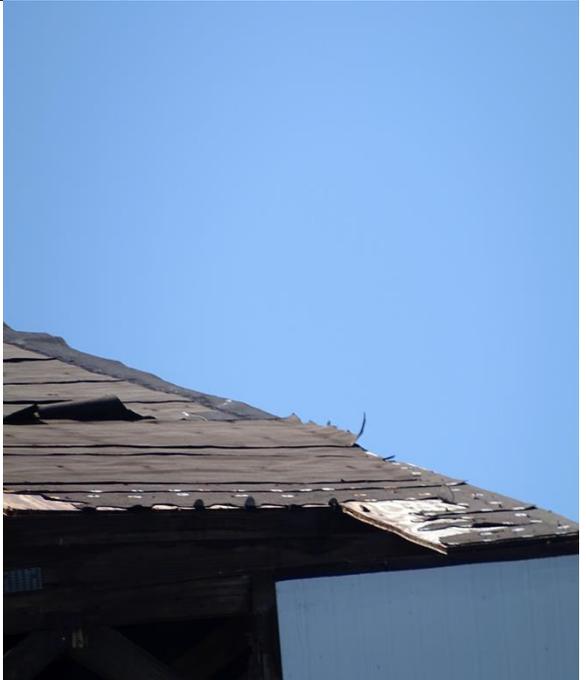
Missing Fascia	Stripped to the deck

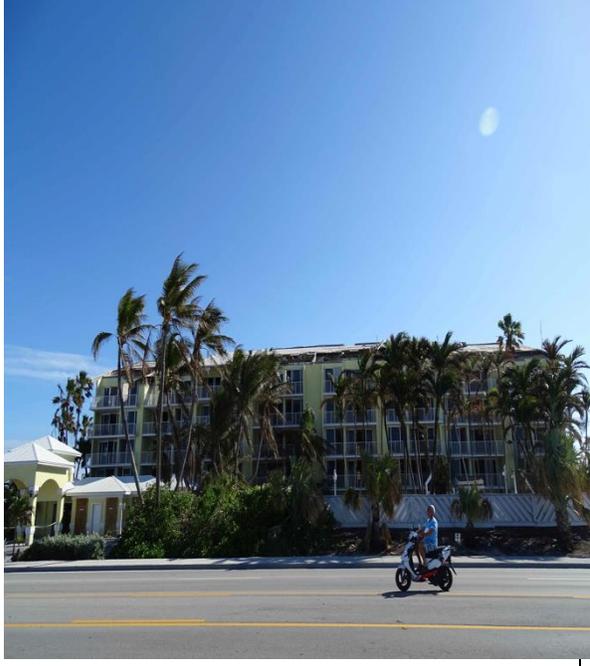
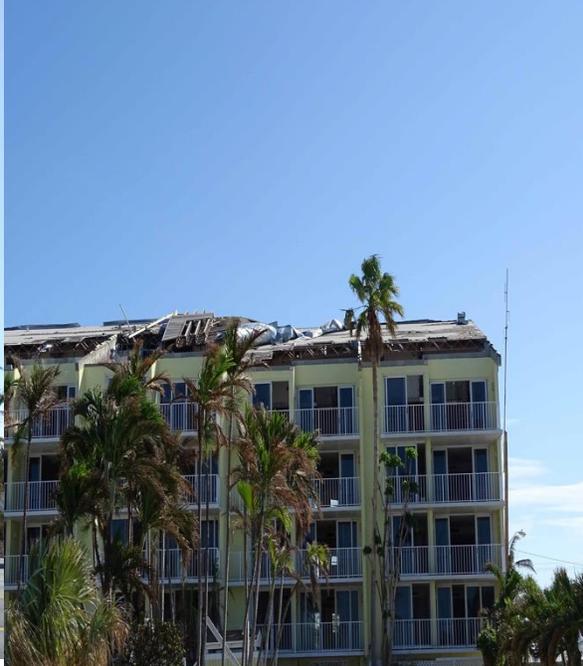
<p>Overview, Structural Damage</p>	<p>5V crimp totally blown off, fasteners pulled from deck, Structural damage</p>

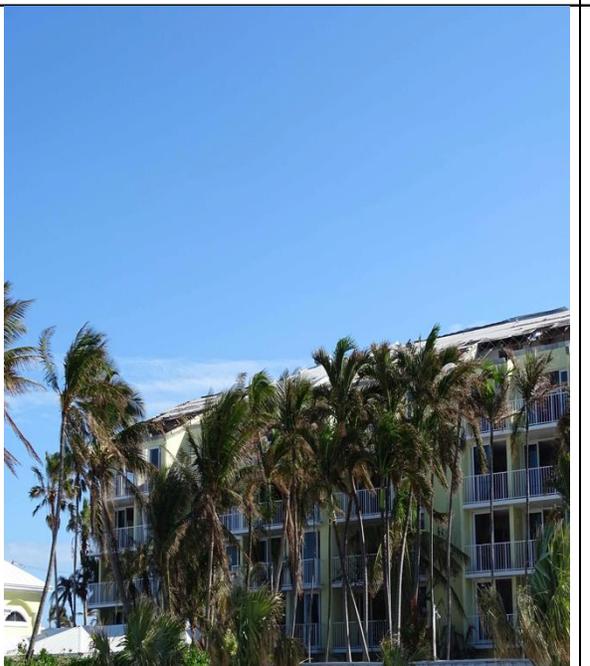
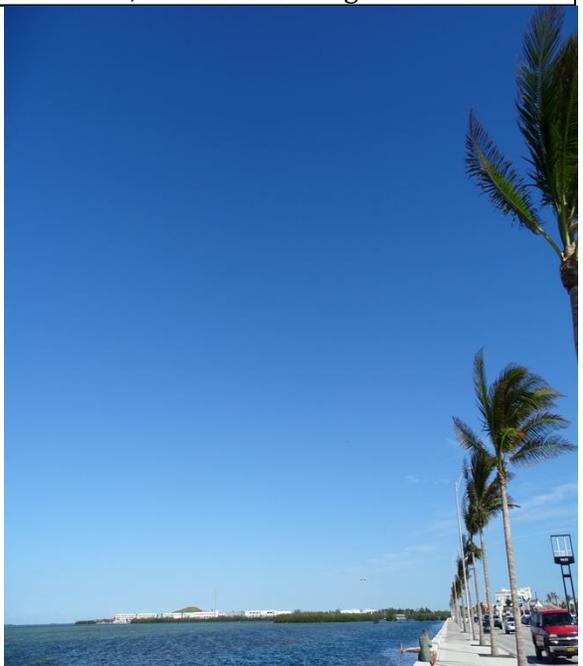
<p>More Structural damage</p>	<p>Building faces open water</p>

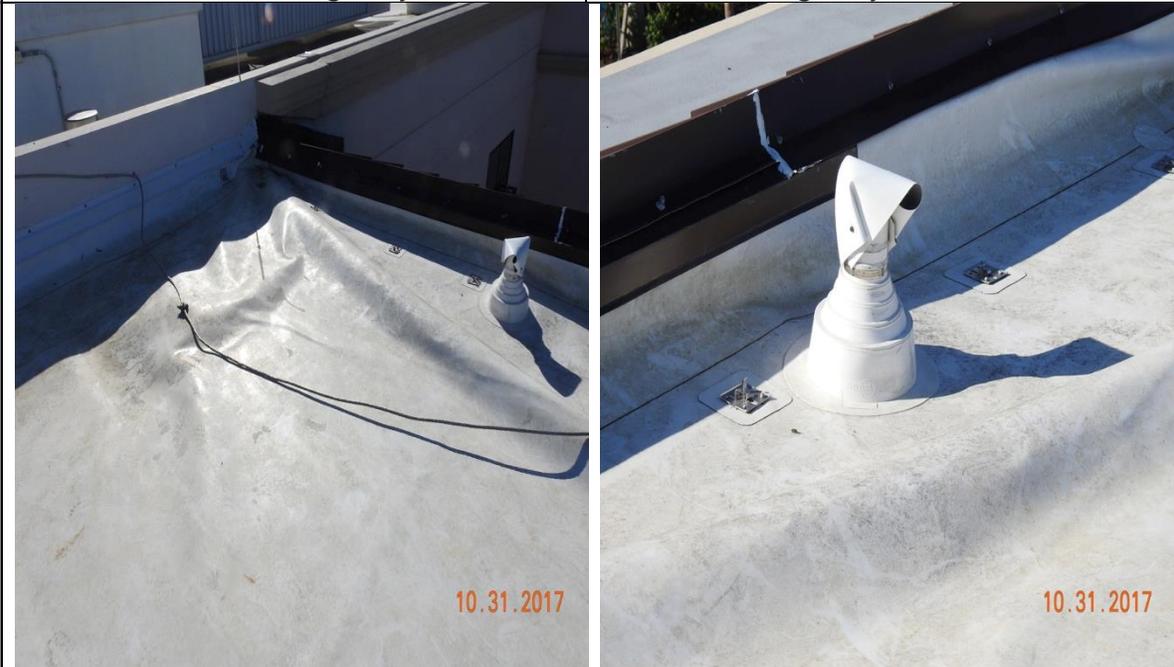
Disbonded Single Ply

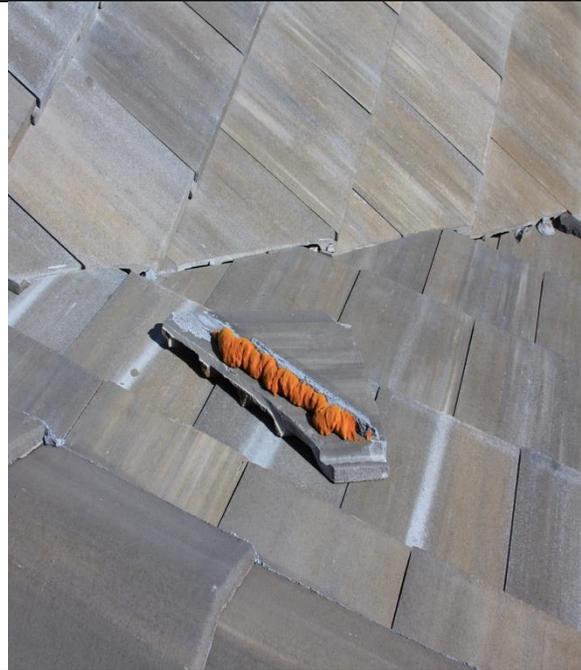
Foam Adhesive on Tile

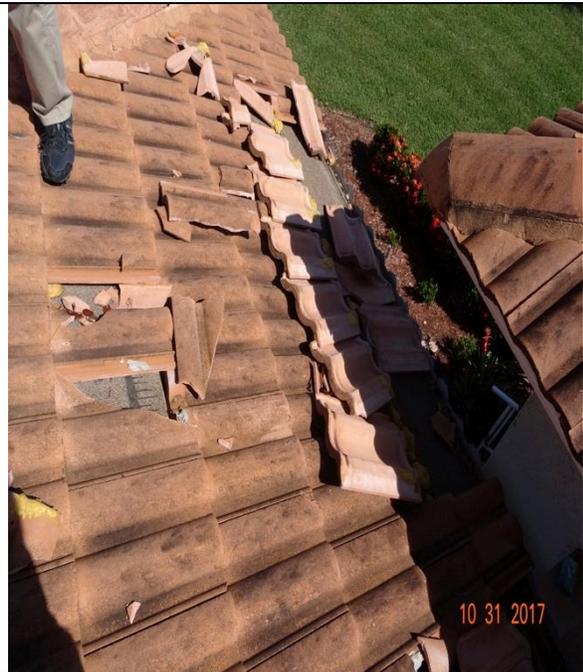
Missing Tiles Near Eave

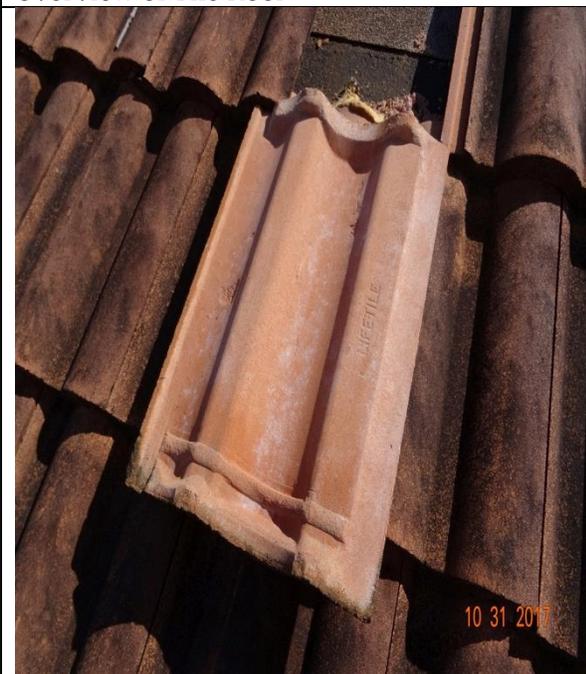
No Foam Adhesive contact

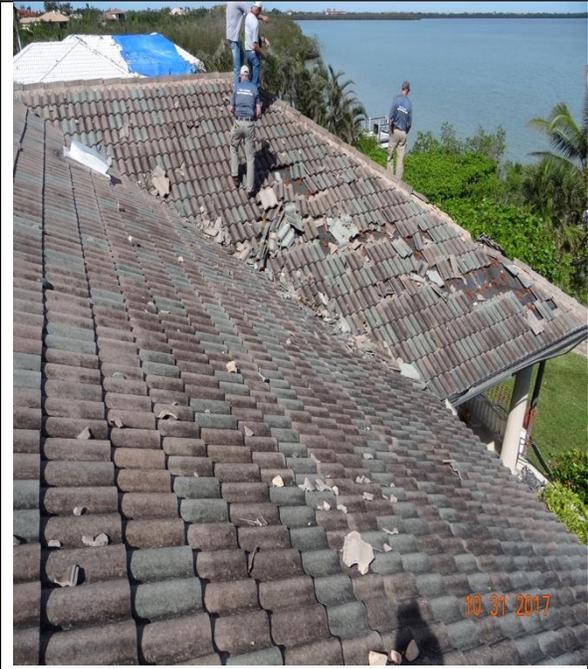
Overview Directly Exposed to Water

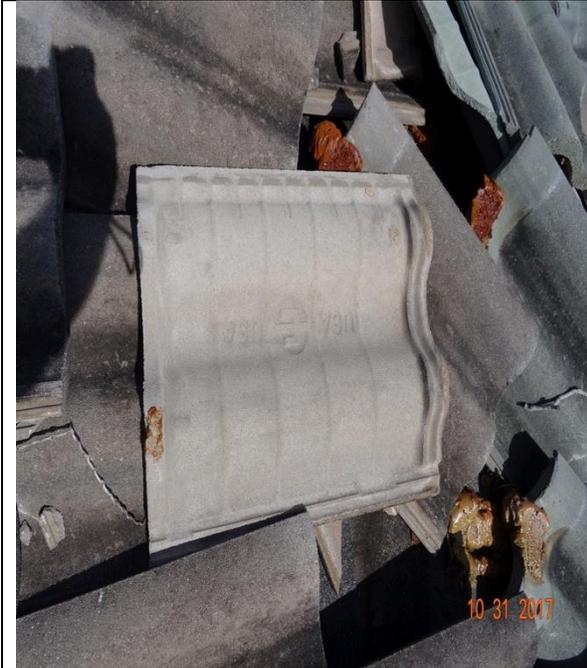
Lack of Foam Adhesion

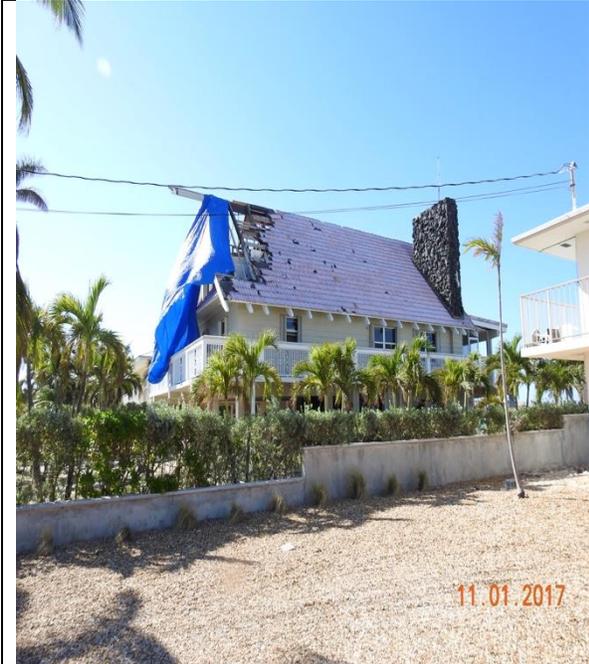
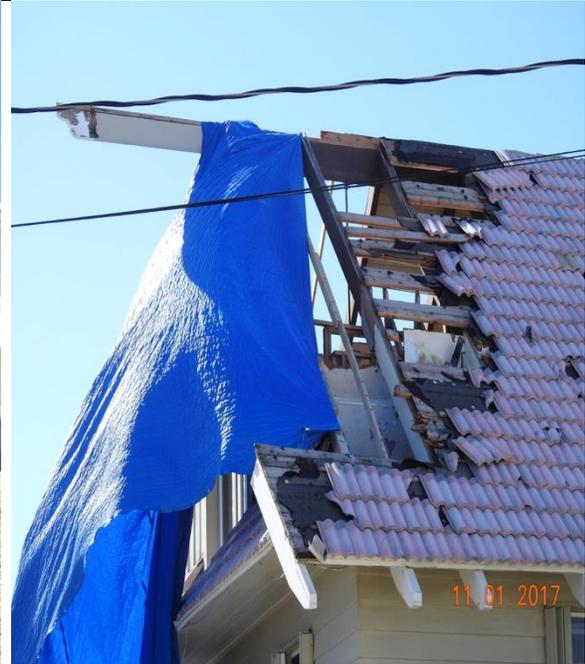
Tile Roof With Large Overhang

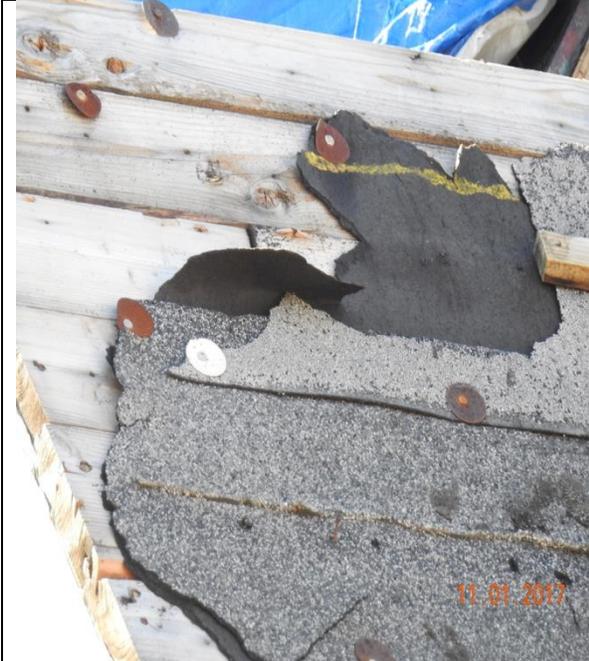
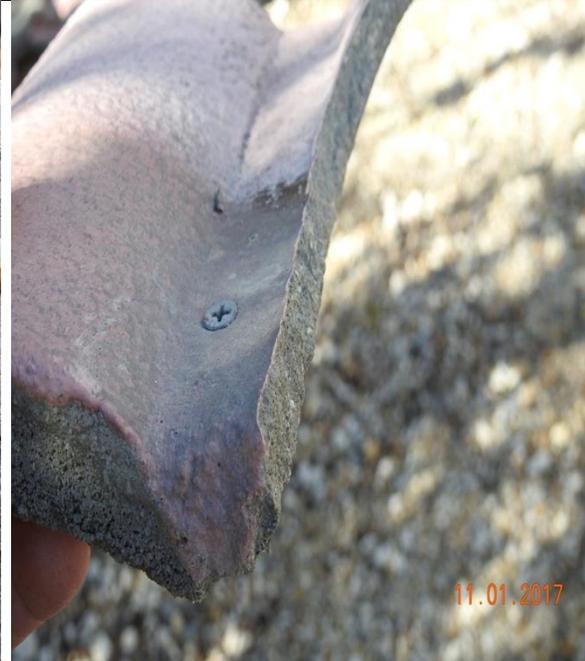
Deck and Underlayment with Screw

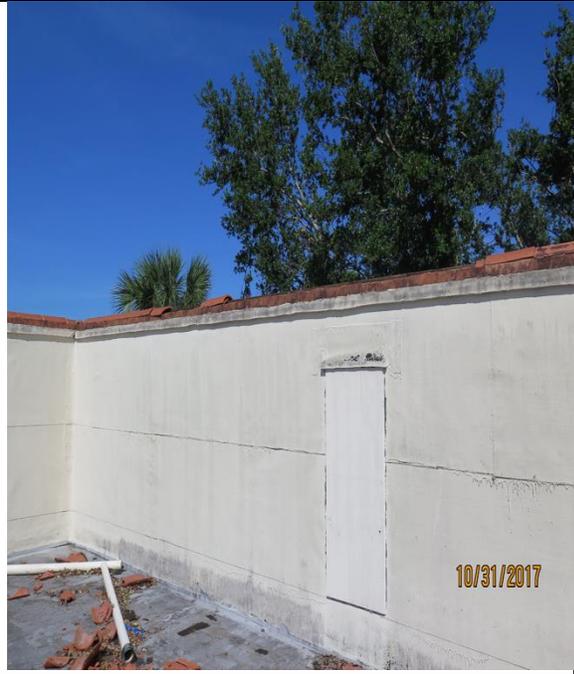
Ridge Tile from Mansard Missing

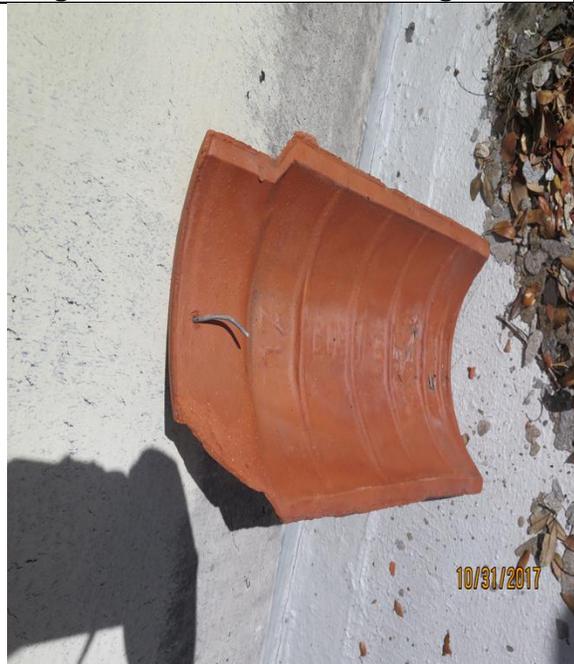
Typical One Nail per Tile

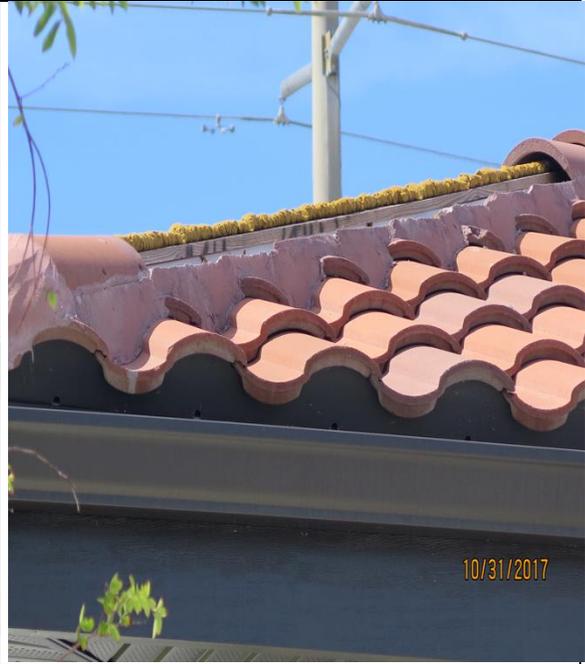
Ridge Tile Missing as Foam did not expand to underside of tile.

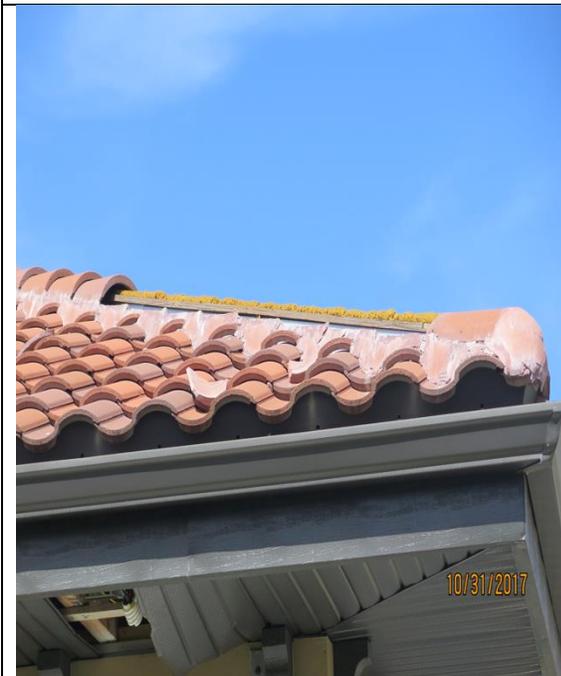
Ridge Tile Not Attached

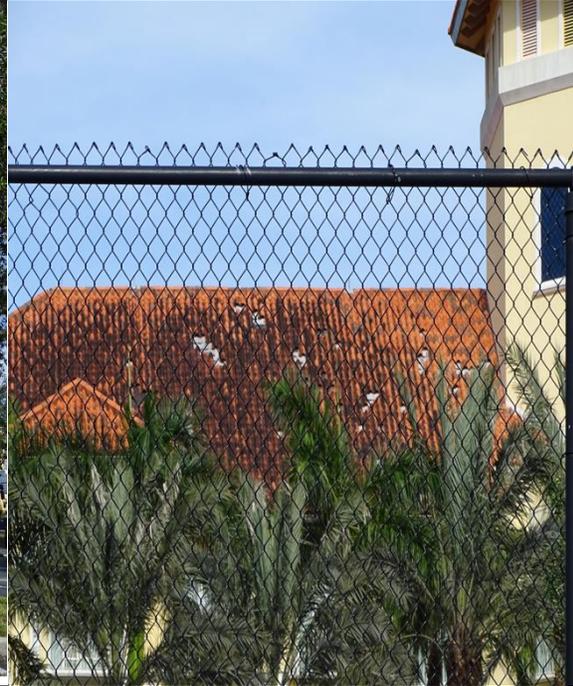
Some ridge tiles missing creating downslope damage

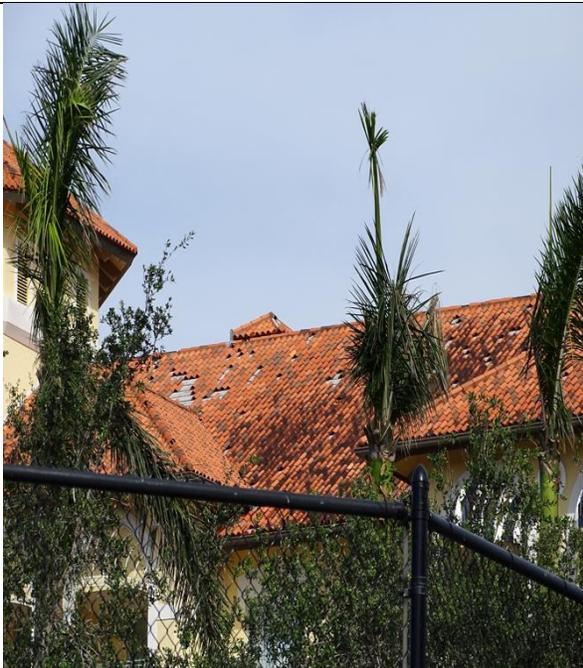
Missing Ridge tiles and downslope damage.

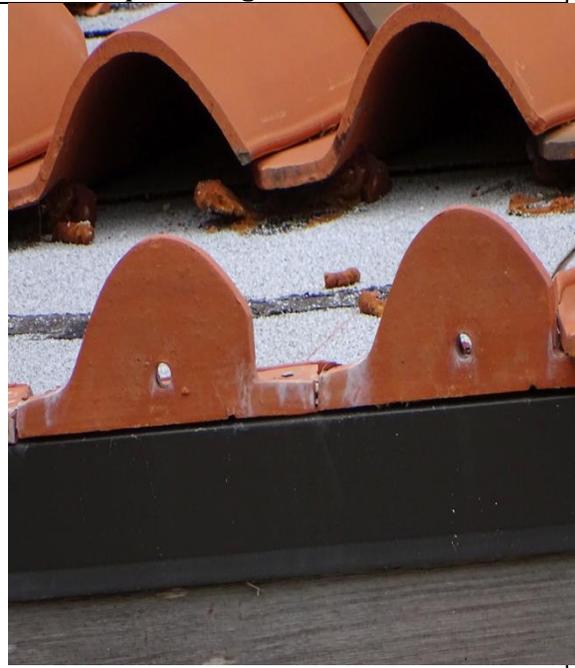
Venezuelan clay tiles were thinner than typical and were nailed through a granular surfaced asphaltic material.
