RICOWI, Inc.

Roofing Industry Committee on Weather Issues, Inc.

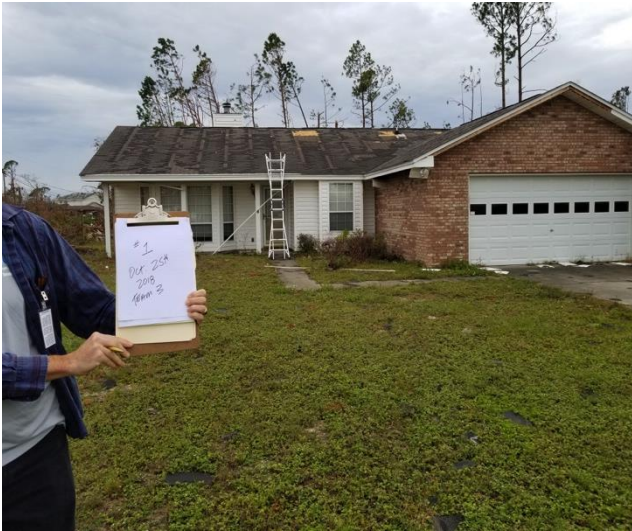
3.1.1 Overview of front showing racked shingles

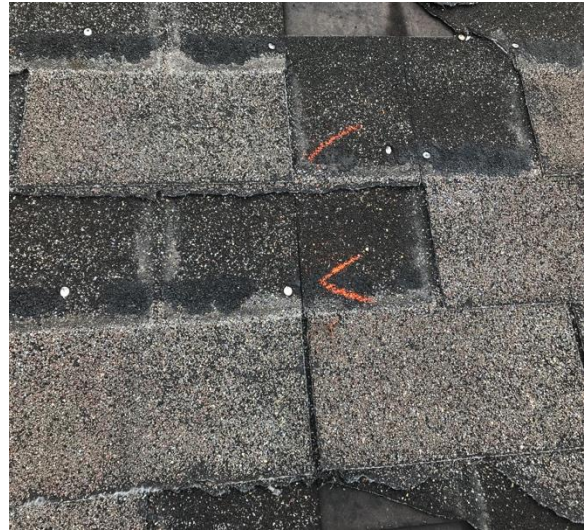
Typical Nailing, nails in sealant strip and missing from one end of shingle

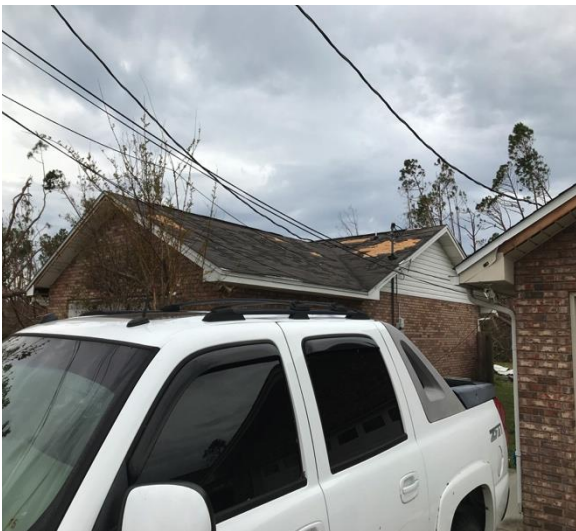
3.1.1 Shingles missing from all sides

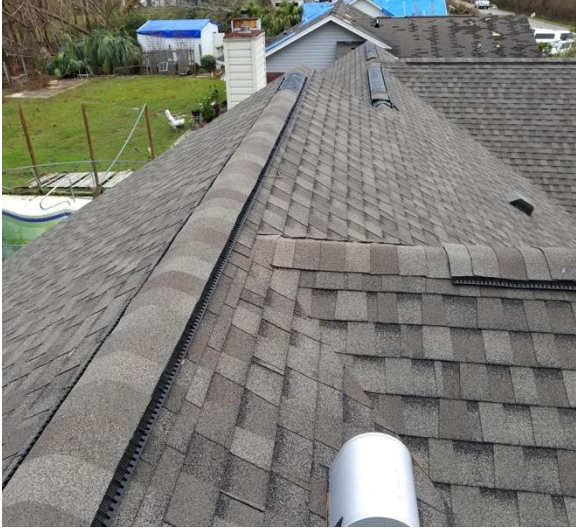
3.1.2 Overview indicating very limited damage

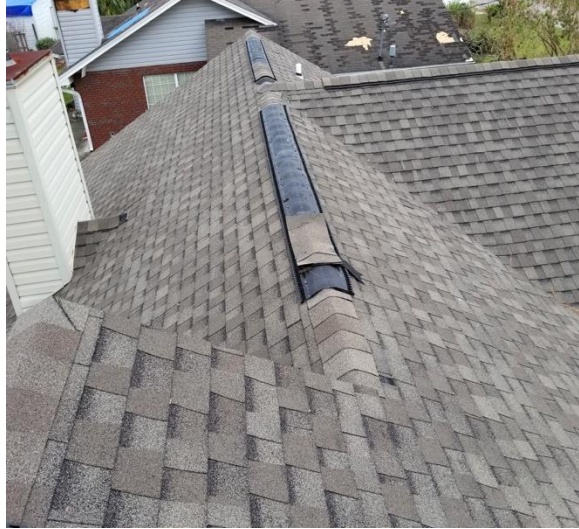
Missing ridge shingles

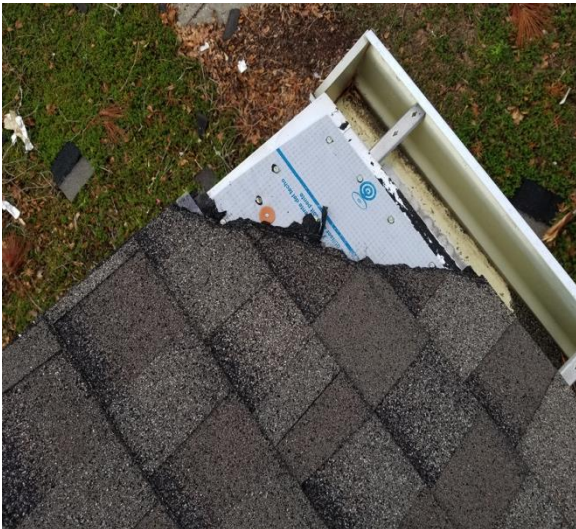
3.1.2 Corner shingles torn

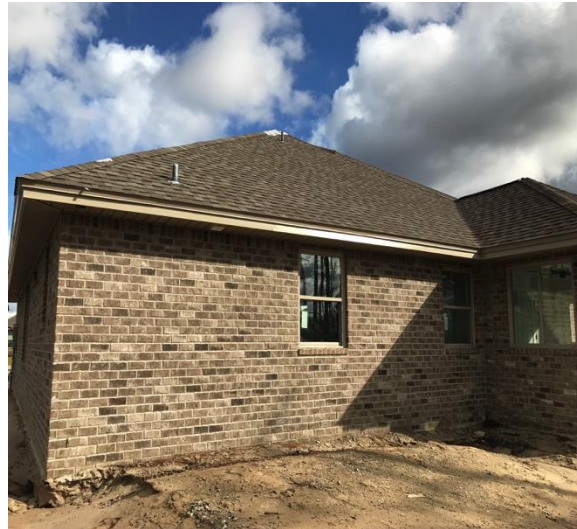
Back side limited damage

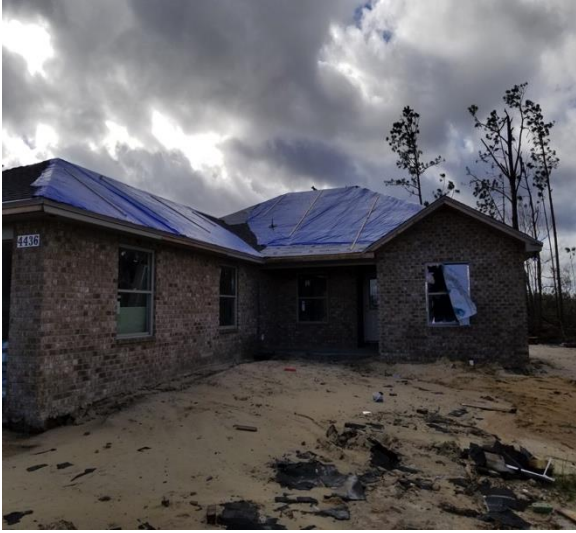
**RICOWI Wind Investigation
Hurricane Michael, Florida**

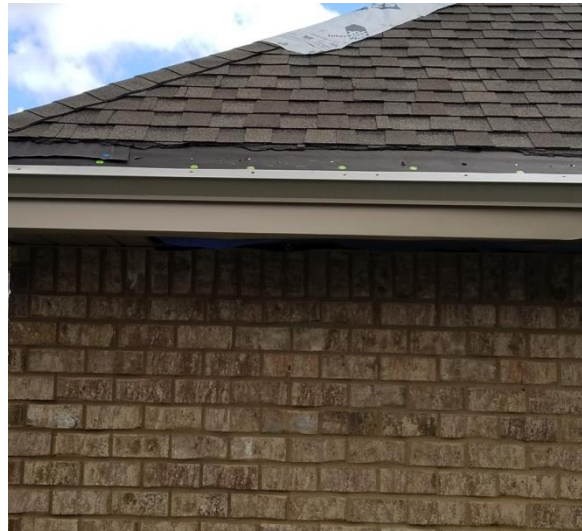
9.2.2 Dislodged shingles

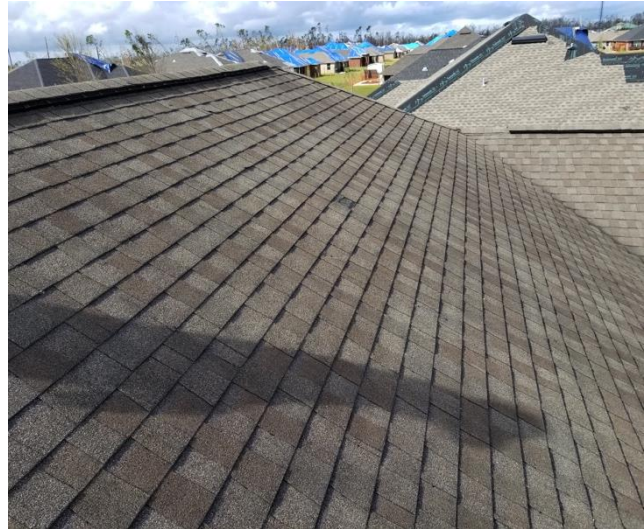
Overview: One broken shingle

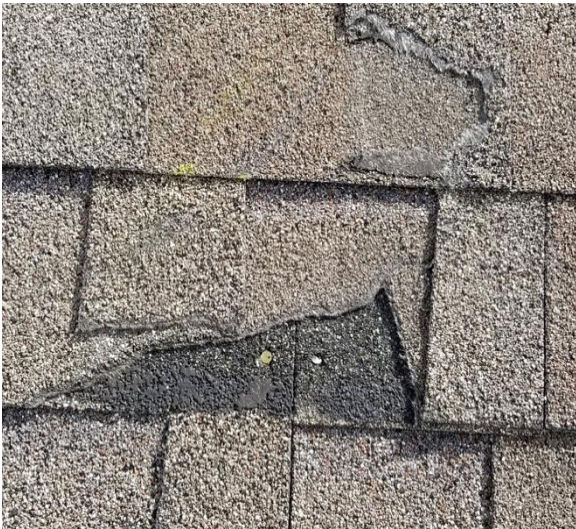
3.2.3 Broken Shingle - nailing

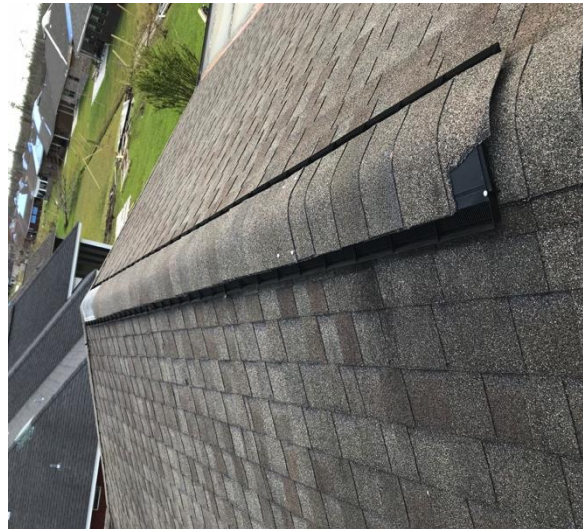
Broken ridge cap shingle

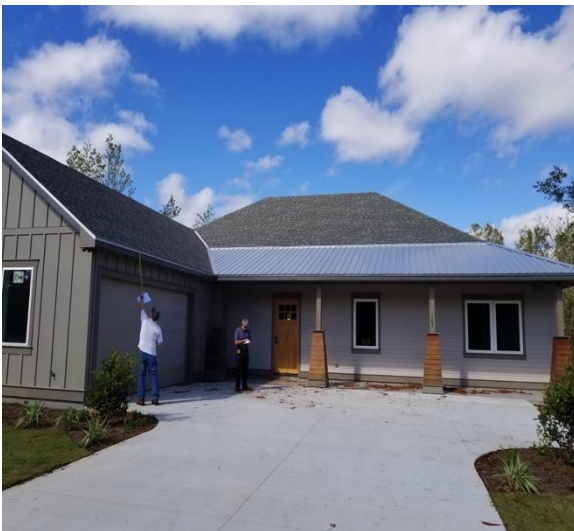
Inspection#	3.2.7
Eave Height ft.	10
Slope	Moderate 5/12 to 9/12
Shingle Type	2-ply laminated
Peak Height	30
Fasteners	Nails
Fasteners per shingle	6
Valleys	Open (metal)
Underlayment Exposed after storm	No
Underlayment Type	Self-adhered
Deck	Plywood
Ventilation	
Hip/Ridge Shingles	Standard
Solar Equipment on Roof	No
Damage Assessment	0
Location of Roof Damage	AC unit securely attached to solid concrete,
Type of Damage	Note, there is also flat panel through fastened steel with no damage
Damage initiation	None
Describe Damage	None, construction methods in this development seemed very high end for mid-range priced current homes
Damaged Area	
Deck attachment	
Number of perimeter fasteners per linear foot of deck section

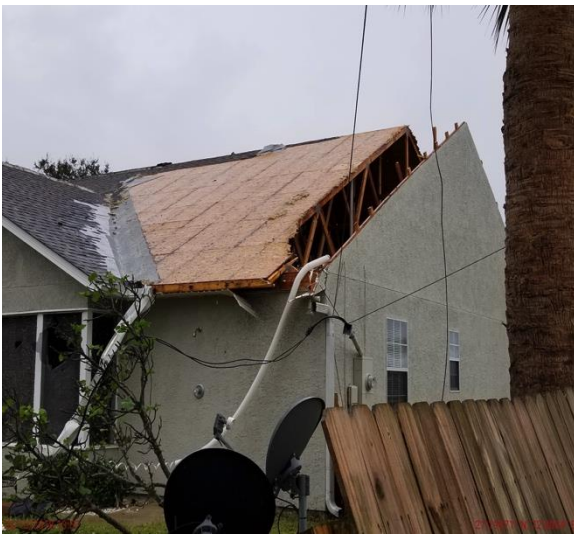
4.1.3 Structural Damage

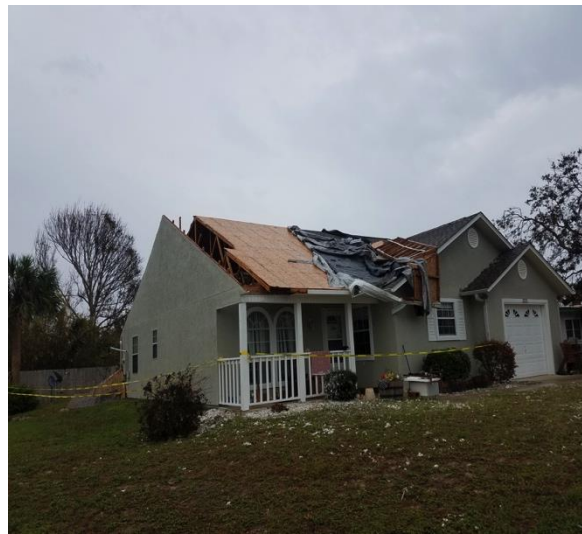
It appears the fastening of the sheathing to the rafters was inadequate. The uplift forces on the roofing underlayment may have pulled the sheathing off the rafters.

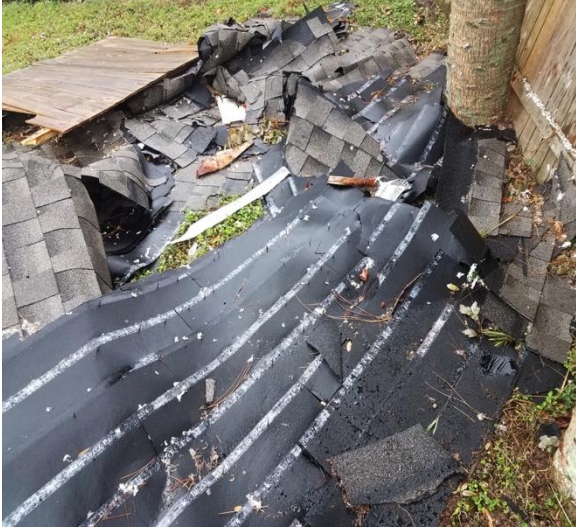
4.1.3 Nails pulled out of sheathing

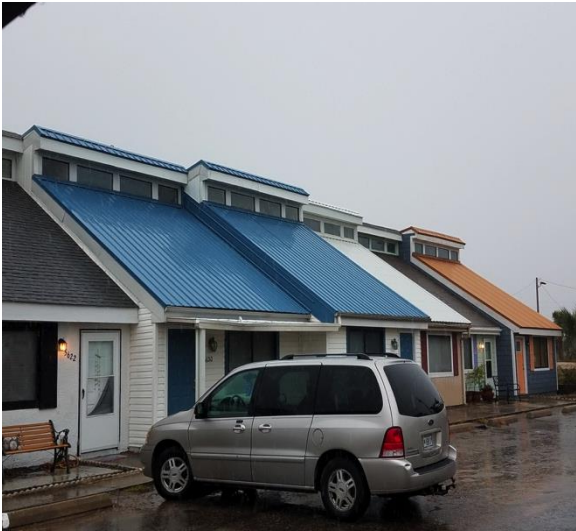
4.1.5 Interesting set of several roof types

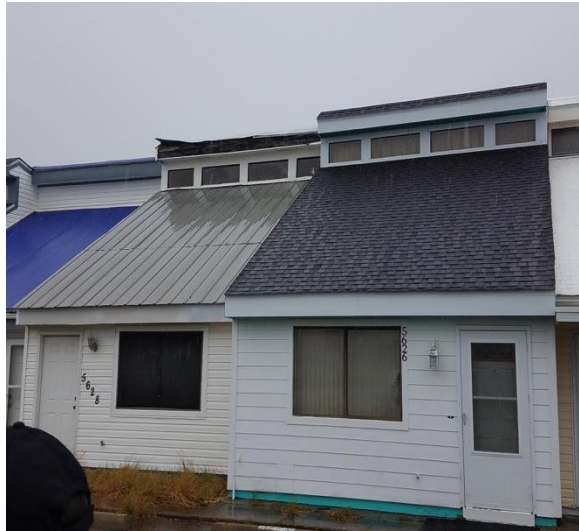
Only obvious damage is to soffit section on through fastened roof

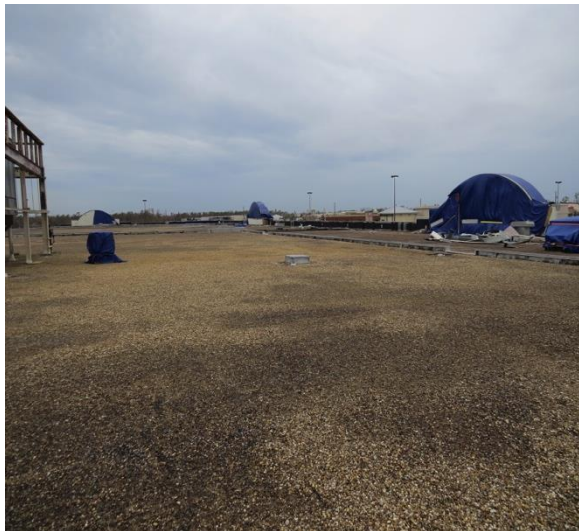
Describe damage in detail. discuss all references to "other"	Edge metal on front side of building (windward side) had mixed attachment of nails and screws. Nails were 6" on center over plywood. Screws were 24" on center over wood nailer (2x4). Expansion joint failure. On the backside (leeward side) of building, nails were 36" on center and failed. Edge metal failed. Aggregate blown 6' from edge.
Parapet height	36"
Roof Width	300 ft.
Roof Length	516 ft.
Total Roof Area, Square feet	155,000 ft.
Area damaged	More than 25 % but less than 50%

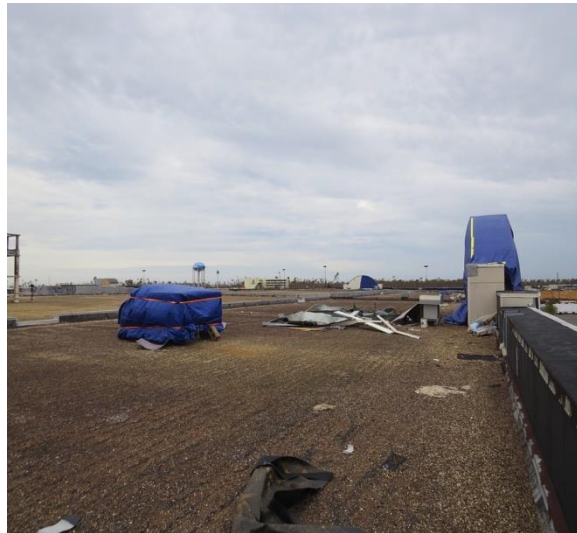
Missing wall covering

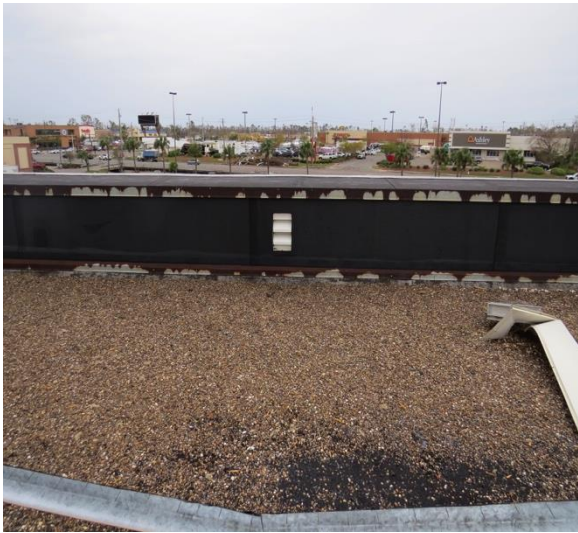
Parapet wall covering missing

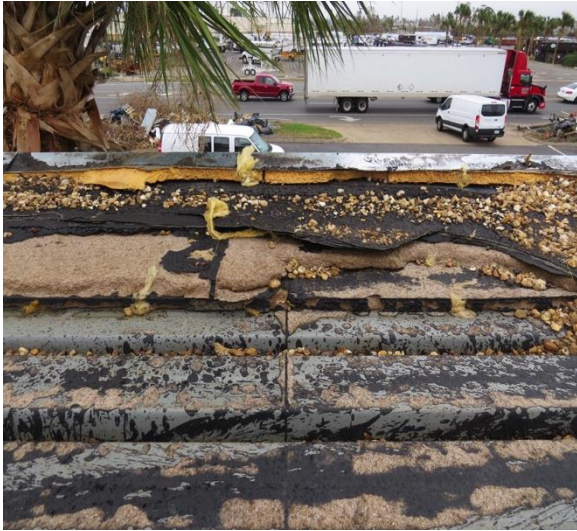
1.1.3 Roof profile with modified bitumen mopped to 1" Iso that was mechanically fastened to perlite that was strip mopped to the metal roof deck

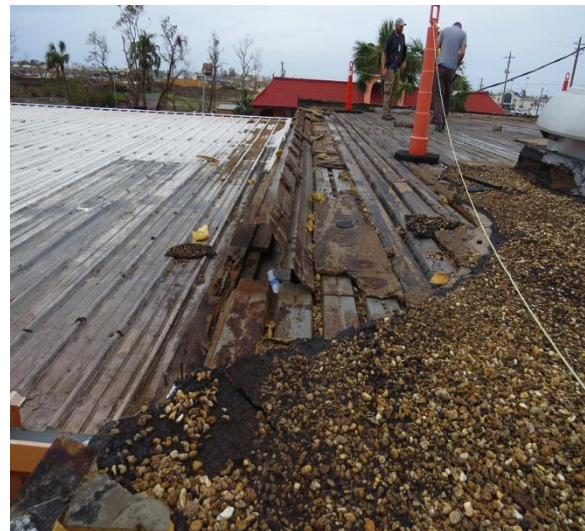
Overview of deteriorated system

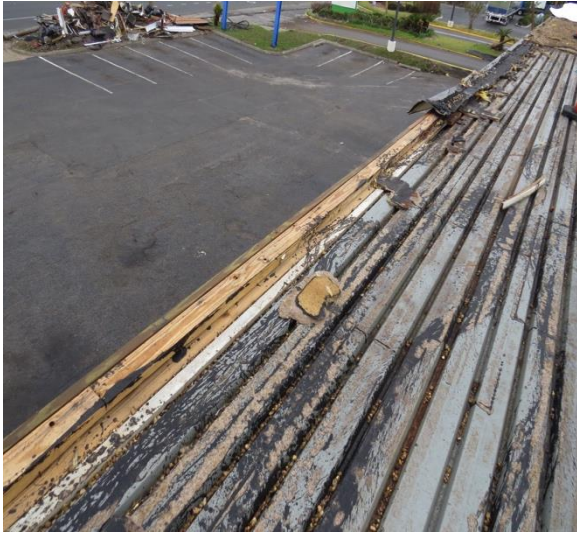
1.1.3 Original perlite was strip mopped to the deck with irregular pattern

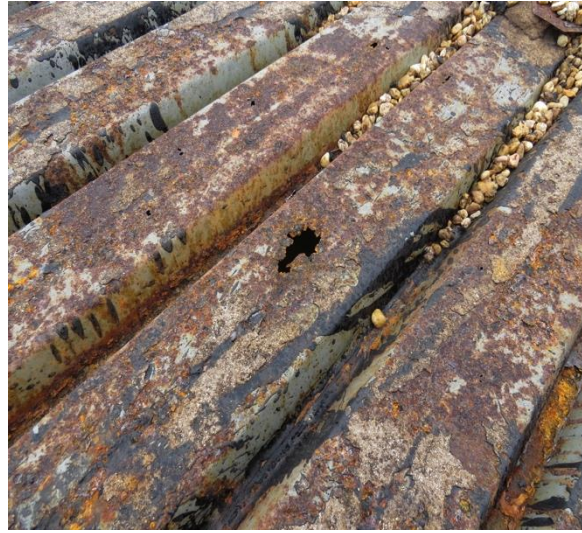
Deck was rusted through indicating earlier leaks

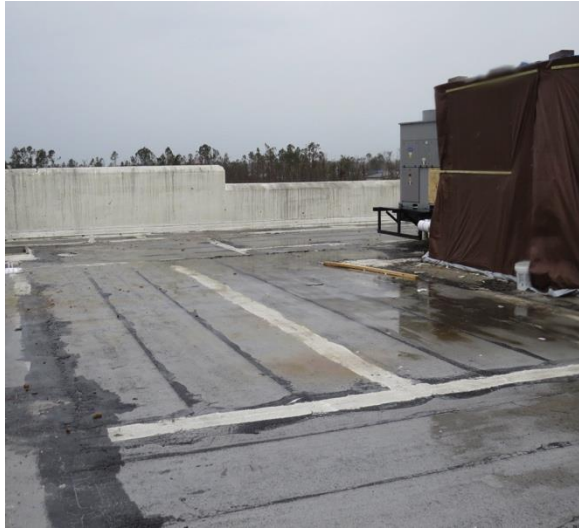
Total Roof Area, Square feet	24500
Area damaged	More than 50%

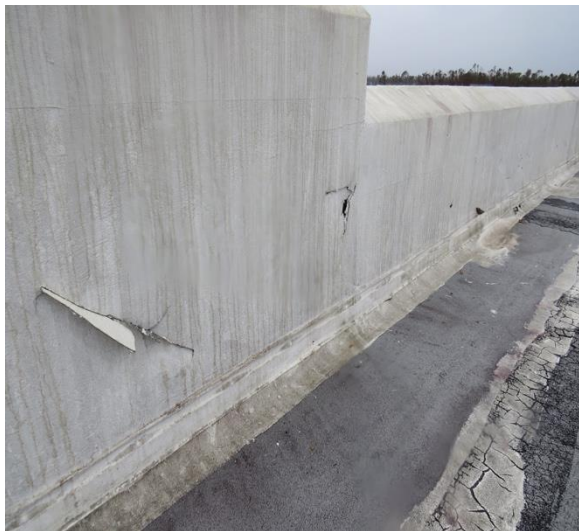
1.1.6 Puncture damage to parapet

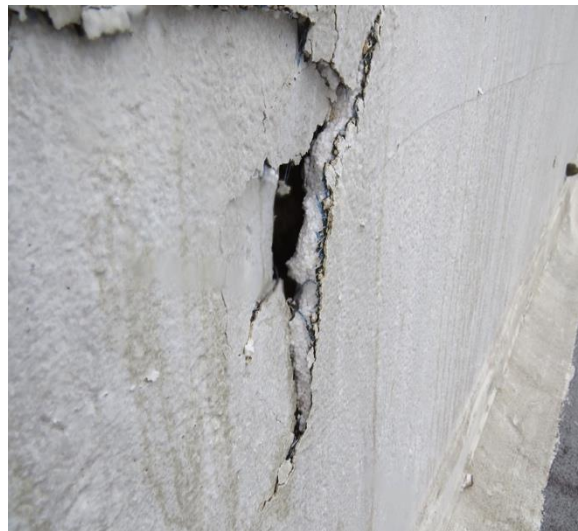
Debris damaged parapet

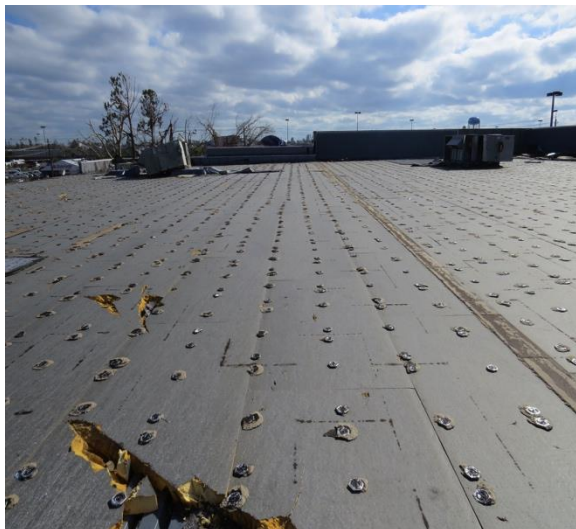
Describe damage in detail. discuss all references to "other"	<p>Failure initiated with the perlite cover board pull through the fastener plates. The plates and fasteners remained anchored to the deck. No elongation of the deck at the punctures from fasteners was observed.</p> <p>The outer edge metal cleat was missing at the entire roof area perimeter. A limited number of interior cleat lengths were missing. No failure of the nailer was observed.</p>
Parapet height	7'
Roof Width	130'
Roof Length	184'
Total Roof Area, Square feet	24,000 ft ²
Area damaged	More than 50%

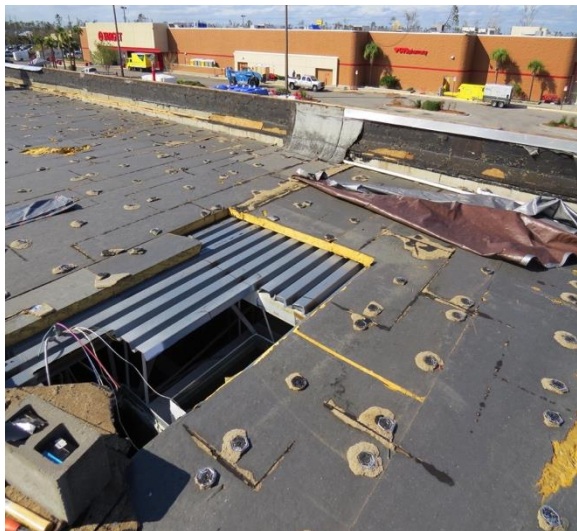
RICOWI Wind Investigation Hurricane Michael, Florida

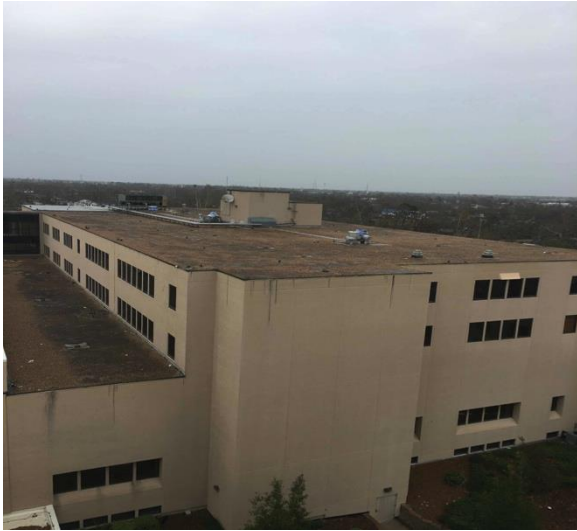
2.1.5 Overview of pea graveled BUR, far side appears to have had membrane issue

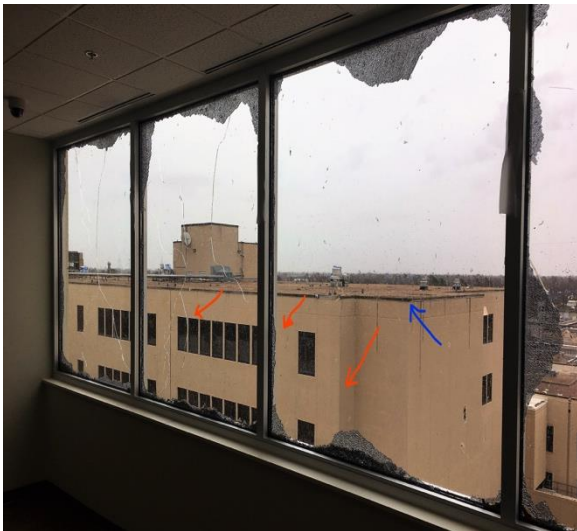
Glass broken by debris, sacrificial exterior layer shatters, interior layer may crack. Typical of all windows on the east side of this hospital tower.

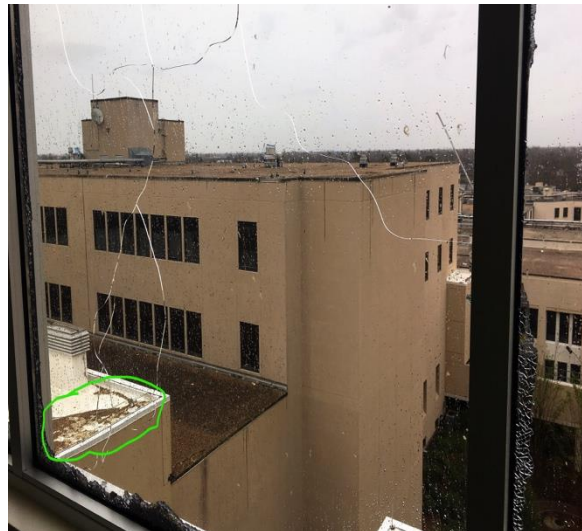
Gravel & debris that accumulated on lower roof

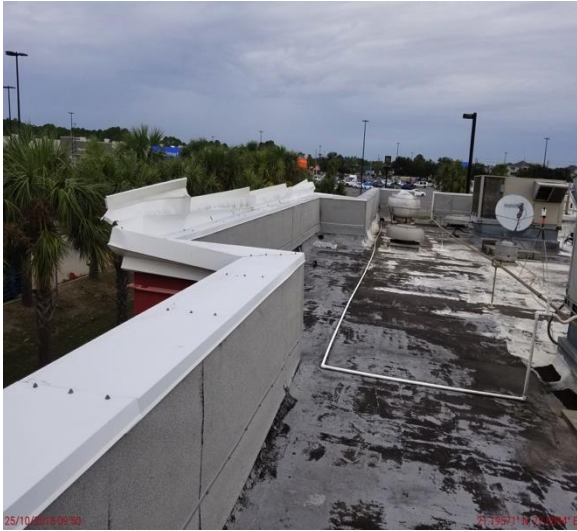
4.1.1 Overview with damaged coping

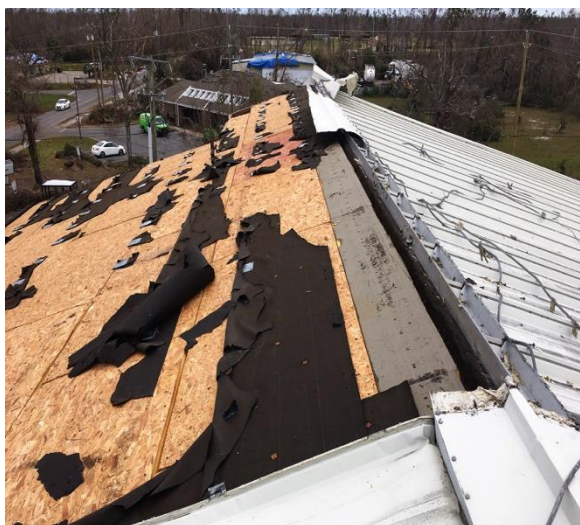
2.1.1 Overview of area of dislodgement

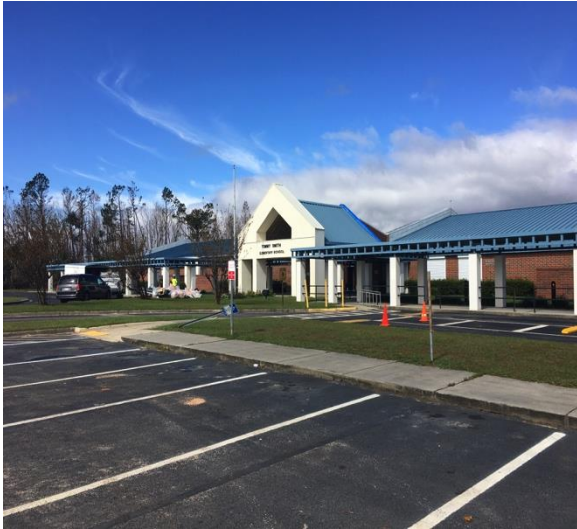
2.2.2 Overview of large complex with Standing seam metal panels

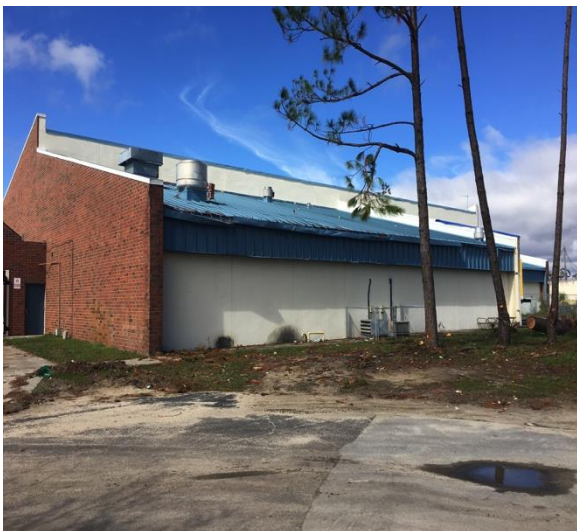
Edge damage; some due to trees and other to uplift

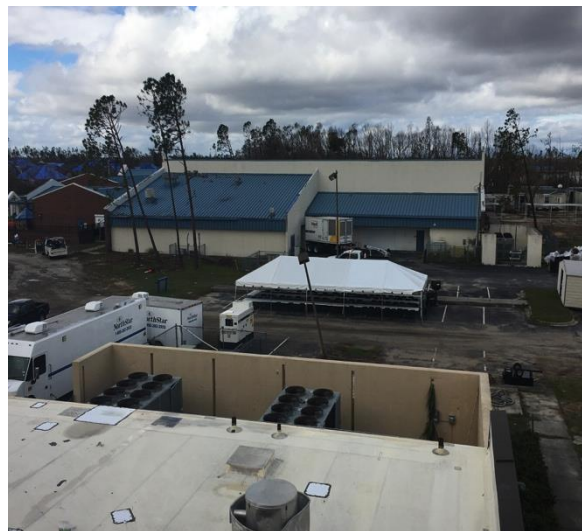
No observed damage on other sections

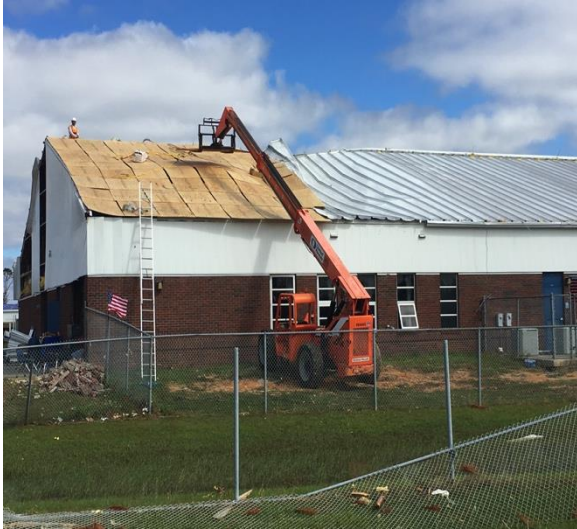
2.2.3 Overview: Missing & bent panels

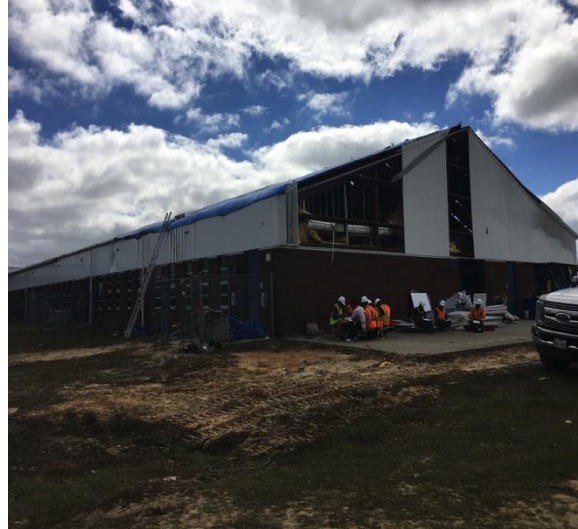
Collapsed wall and missing panels

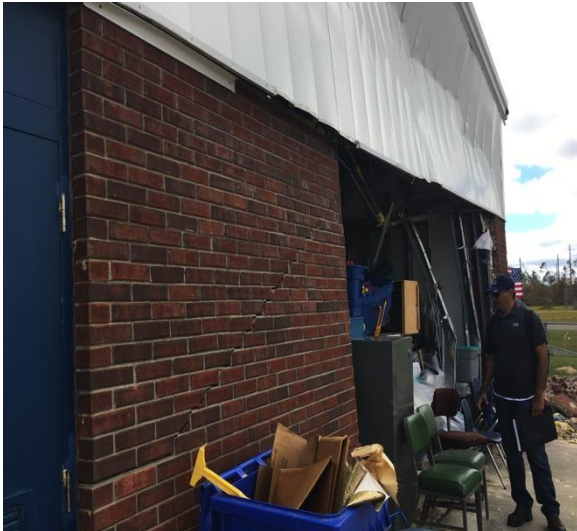
Collapsed Brick Wall

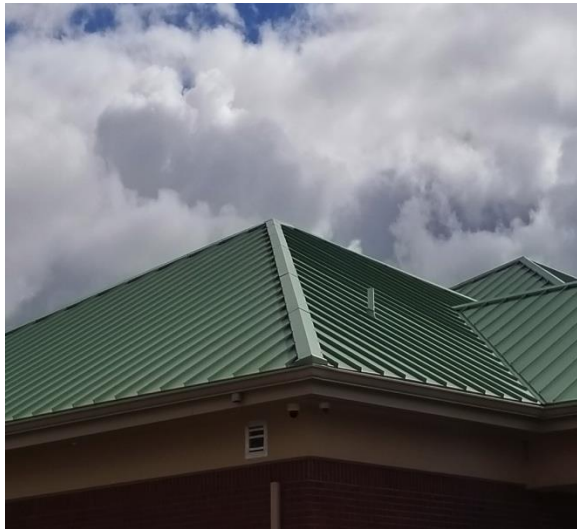
3.2.4 No roof damage

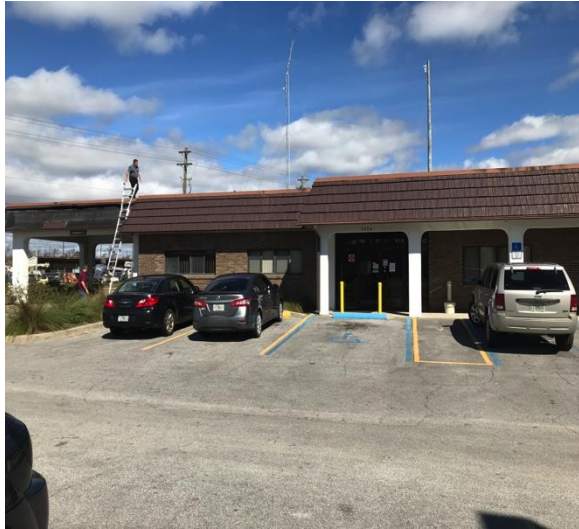
Describe Damage	Aluminum mansard shingles, stamped, simply pulled off. Al cleats, disengaged, cleats 16 to 24" only one nail each, but the al clips simply disengaged
-----------------	---

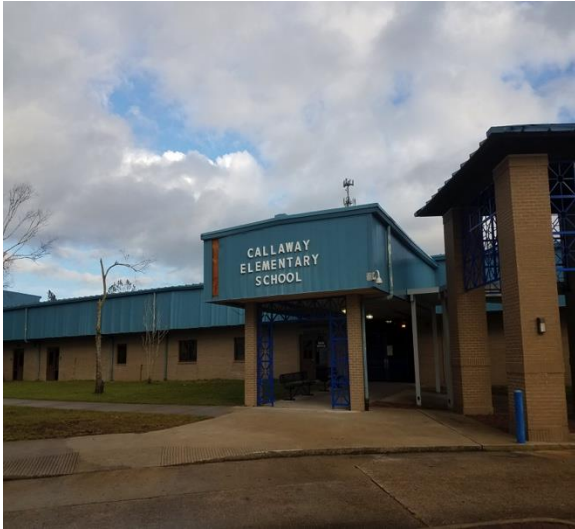
**RICOWI Wind Investigation
Hurricane Michael, Florida**

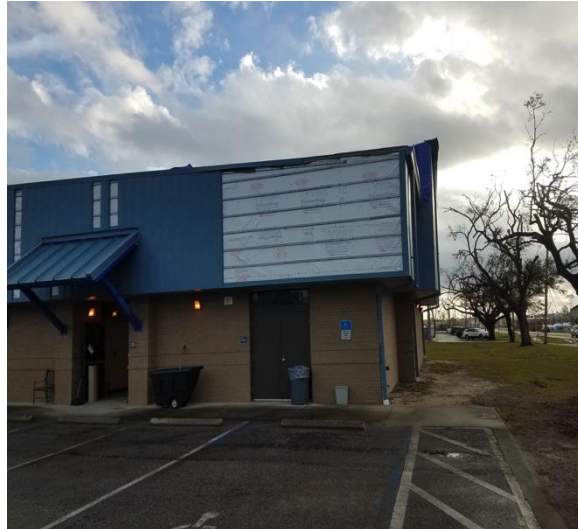
Missing Siding and roof edge damage

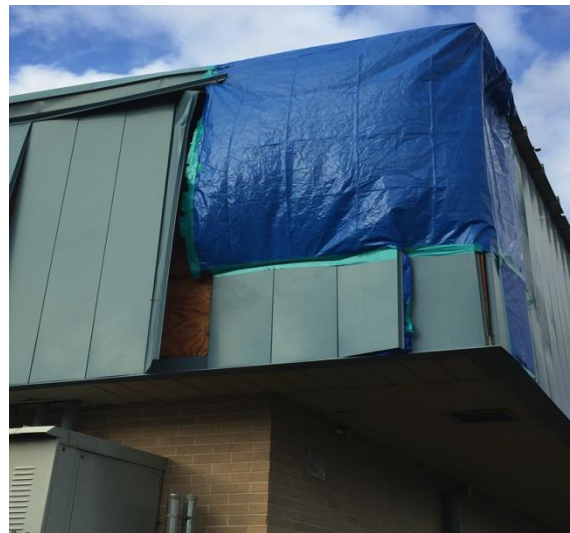
Missing siding and roof edge damage

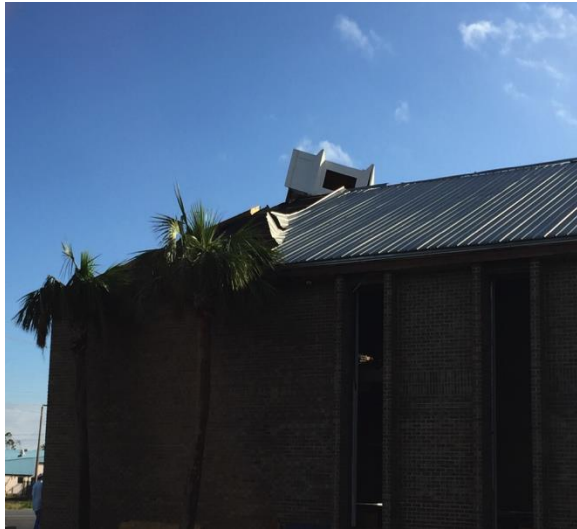
Nails or fasteners per linear foot of sheathing perimeter	4
Deck attachment	Limited nailing

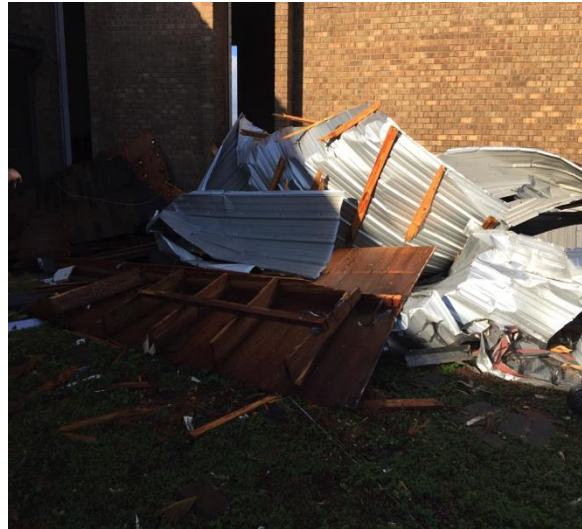
Debris showing deck and metal

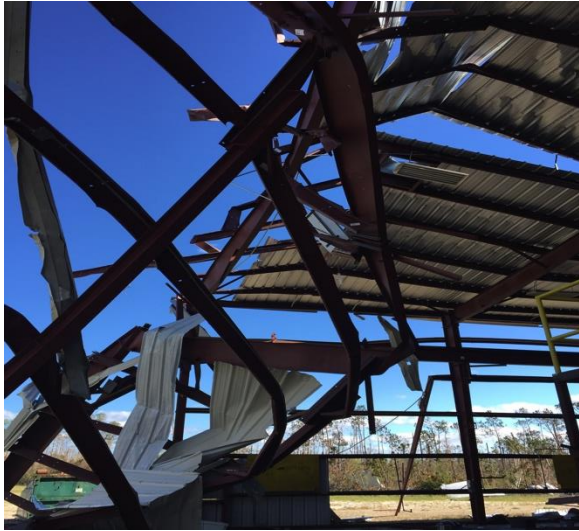
4.2.6 Metal Collapse

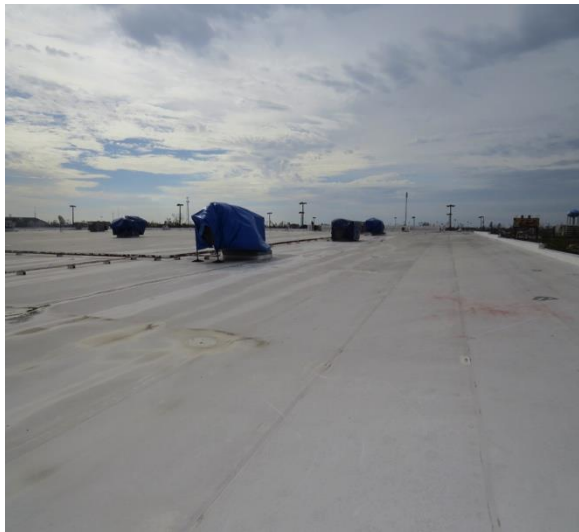
Damage initiation	1) Roof edge on back side of building 2) rooftop equipment failure
Describe damage details, include all reference to "other"	
Roof Height	20 ft.
Parapet Height	Parapet only on 2 sides, variable height
Roof Width	335'
Roof Length	377'
Roof Area	118,000 Sf.
Damage Area	10% or more but less than 25%

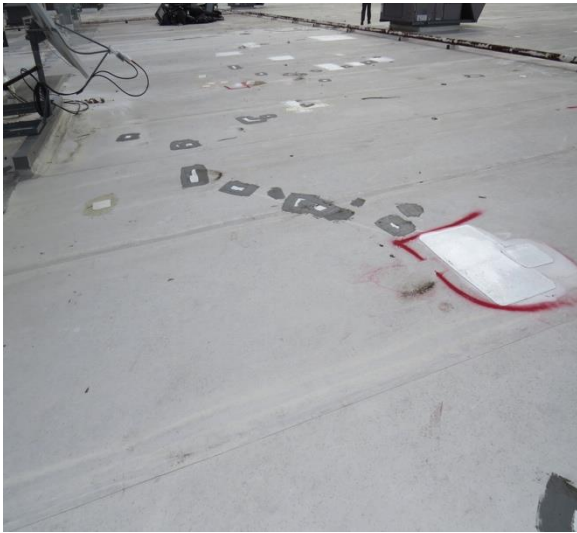
1.1.1 Trail of puncture damage from dislodged

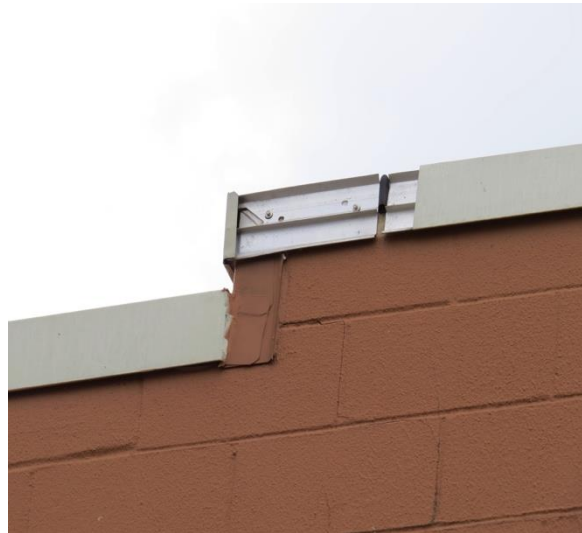
Edge metal missing, not typical

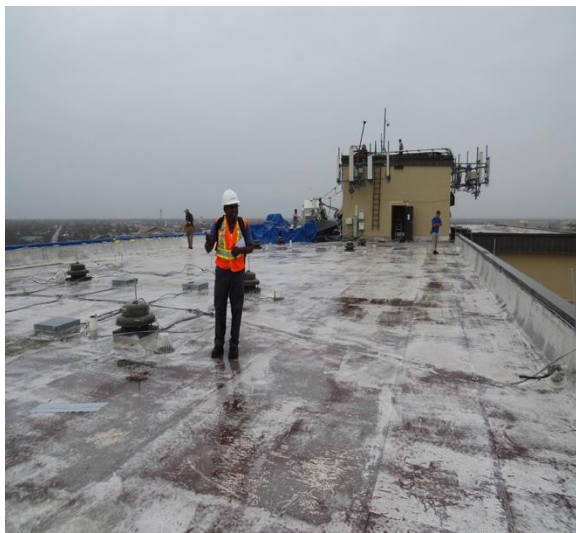
Describe damage details, include all reference to "other"	Rooftop equipment failure. Parapet cladding failure, caused parapet failure which led to membrane ballooning. Ballast from old roof below was blown on top of new membrane.
Roof Height	14 stories, approximately 100 ft.
Parapet Height	23"
Roof Width	80 ft.
Roof Length	211 ft.
Roof Area	11,550 ft ²
Damage Area	10% or more but less than 25%

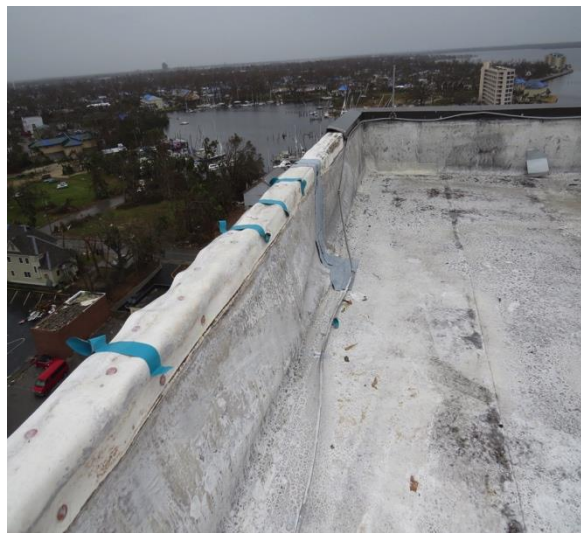
Missing Coping, bulge in parapet cladding

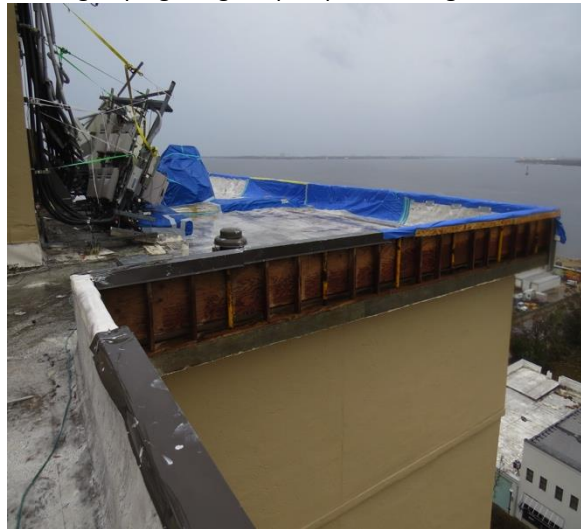
Missing Cladding over parapet

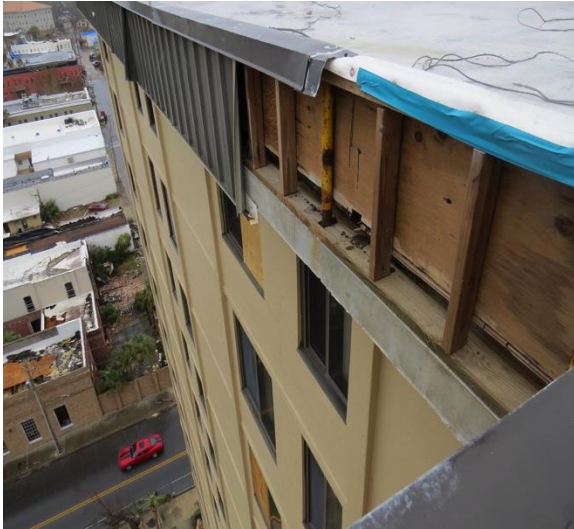
1.1.5 Parapet Cladding

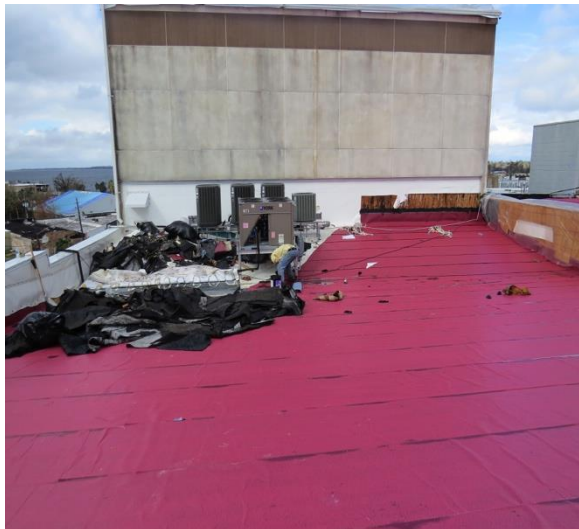
1.2.2 Overview Red temporary roof

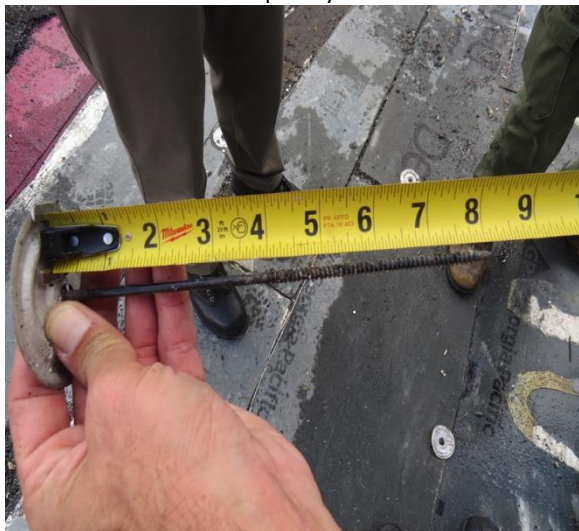
1.2.2 Fastener Some corrosion

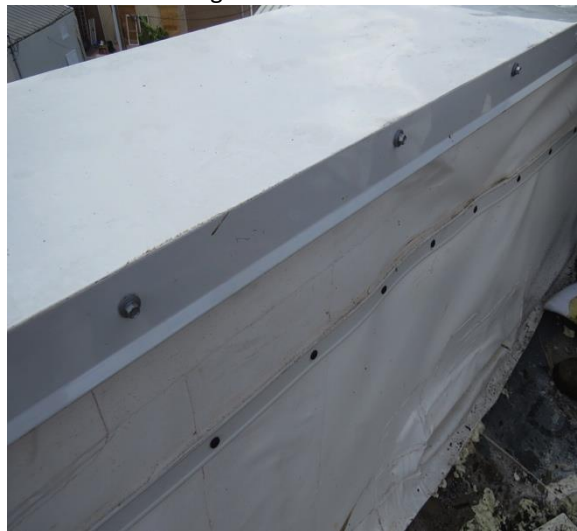
Coping and termination bar

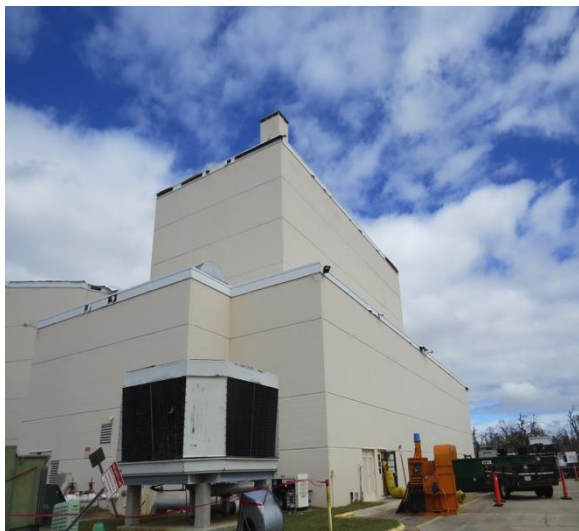
1.2.3 Outside overview showing missing coping

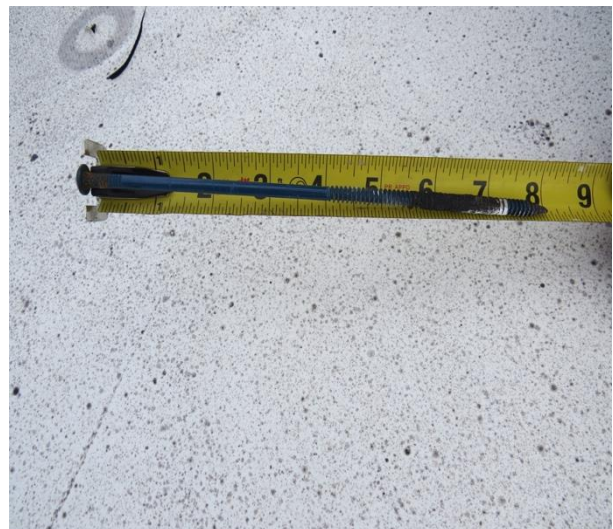
Fastener Corrosion at top and near bottom

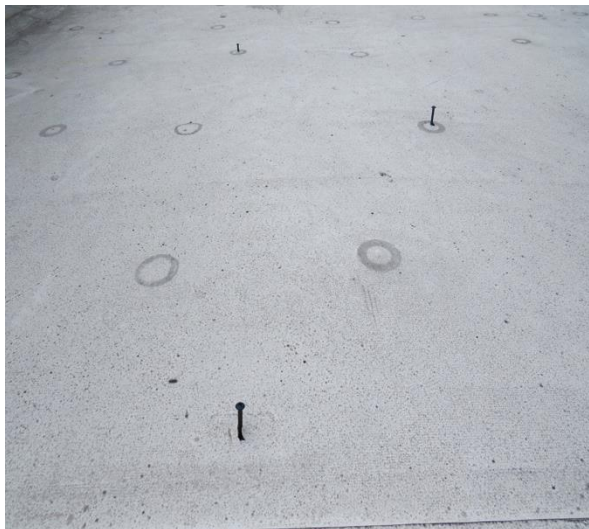
1.2.3 Fasteners that were pulled out due to membrane uplift

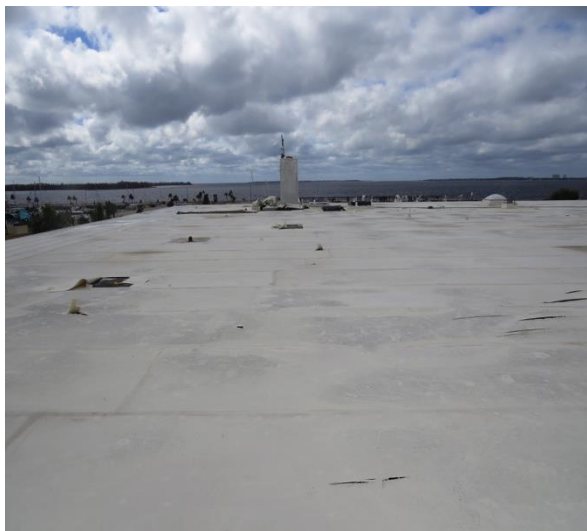
1.2.4 Overview with tares

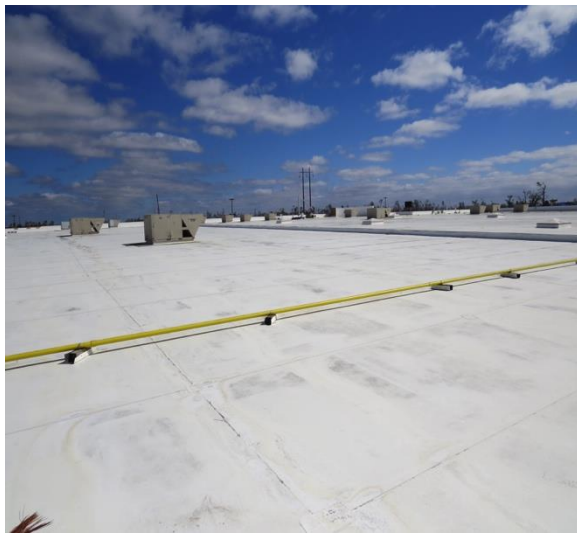
Describe damage details, include all reference to "other"	Rooftop unit failure and wind-blown debris punctured membrane. Cladding at front caused localized area of displaced coping.
Roof Height	20'
Parapet Height	3.5'
Roof Width	536
Roof Length	325
Roof Area	208,600
Damage Area	Less than 10%

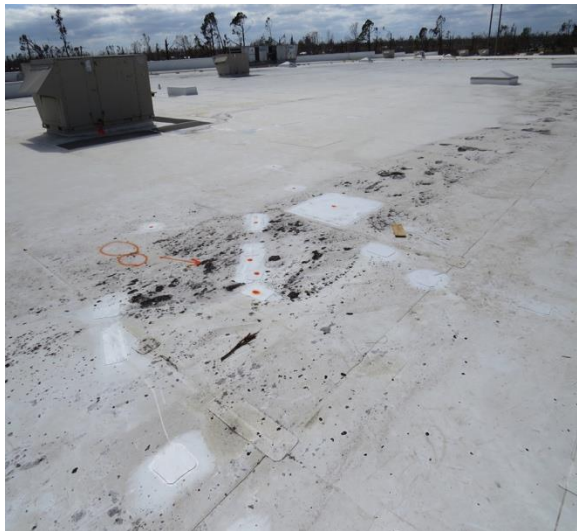
1.2.5 Trail of damage

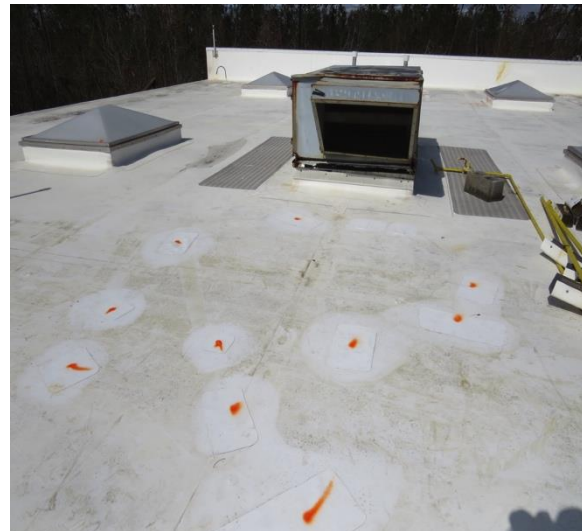
Other punctures from debris

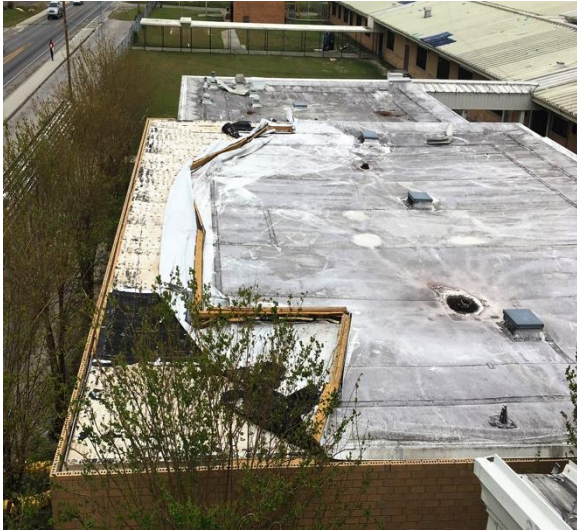
2.1.2 Overview entire edge dislodged

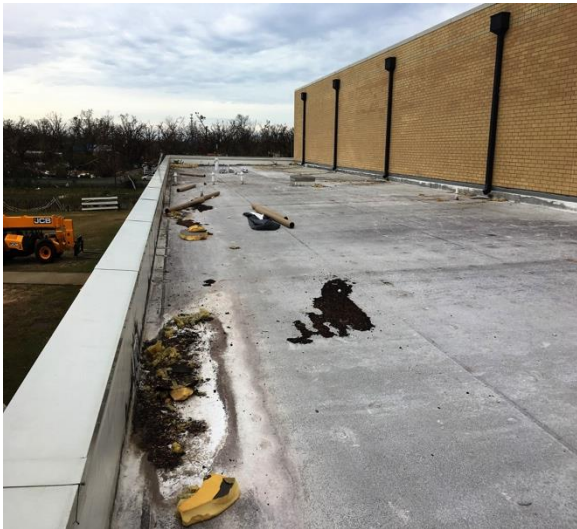
2.1.3 Undamaged lower roof

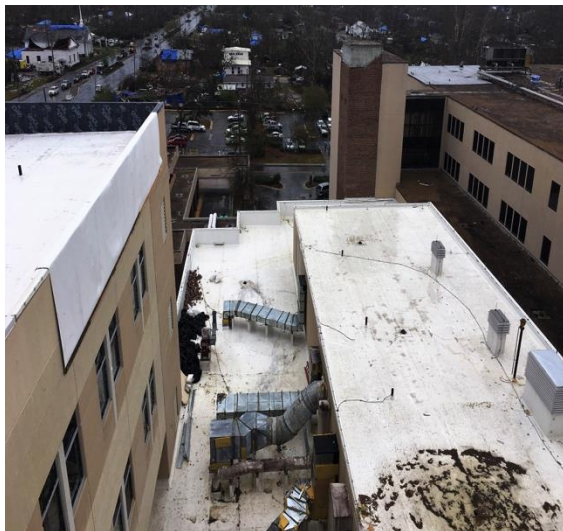
2.1.4 Exterior wall and parapet damaged and a large area of the roof already temporarily recovered. The lower roof was intact, but likely had many punctures from the bricks dislodged from the adjacent building

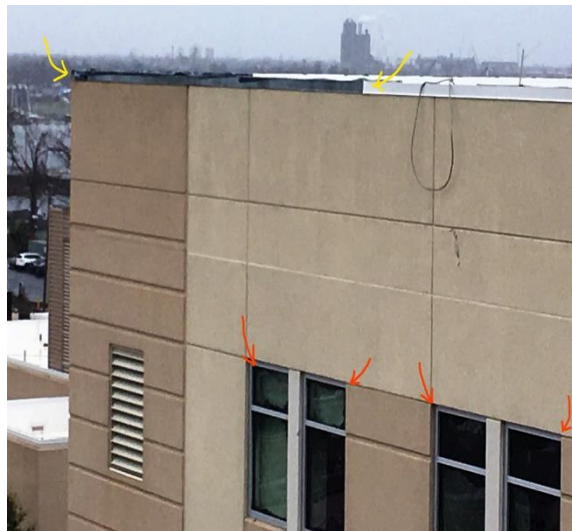
A large section of coping missing
