RICOWI, Inc.

Roofing Industry Committee on Weather Issues, Inc.

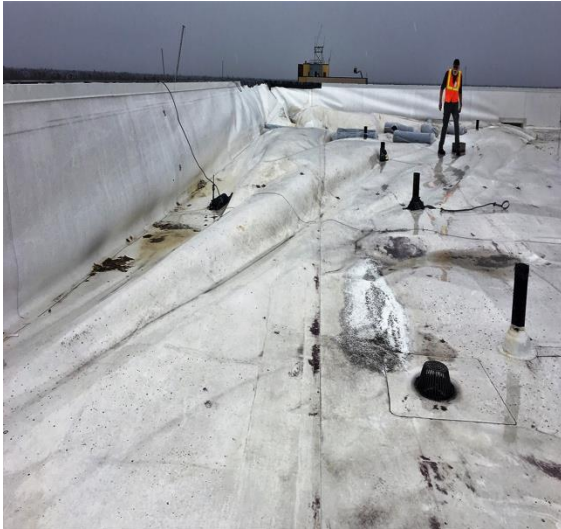
2.1.4 Air is getting into the parapet wall and under the membrane. Significant insulation scuffle

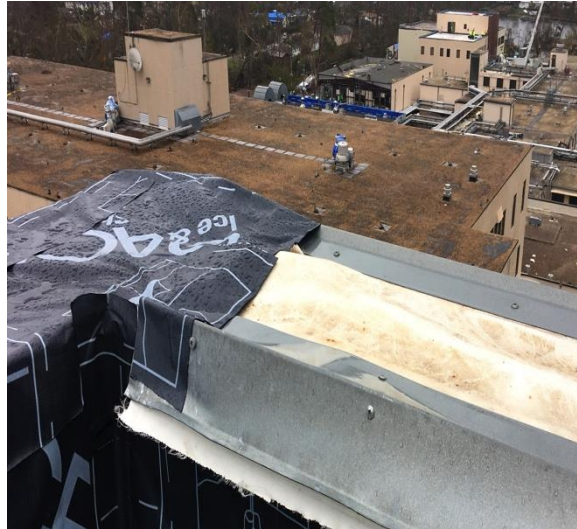
Coping cleats intact, but coping missing

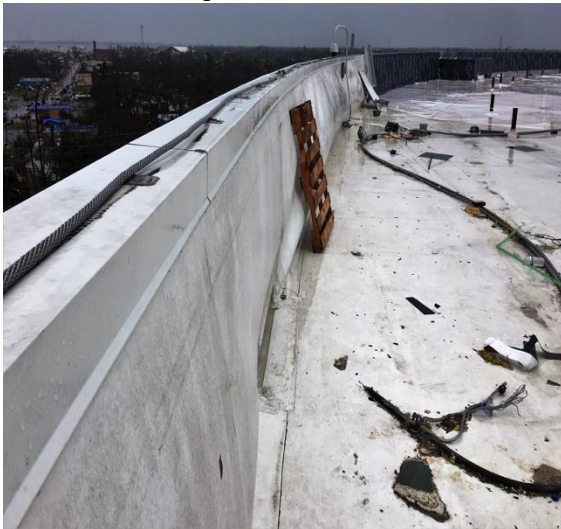
High parapet billowed

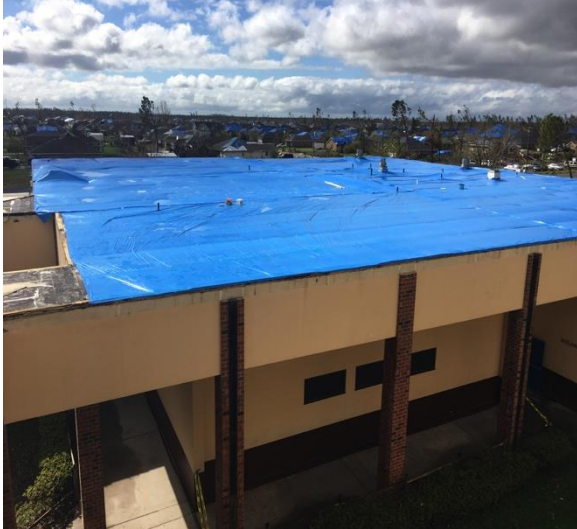
2.2.1 Overview of most damaged area. Membrane and deck dislodged.

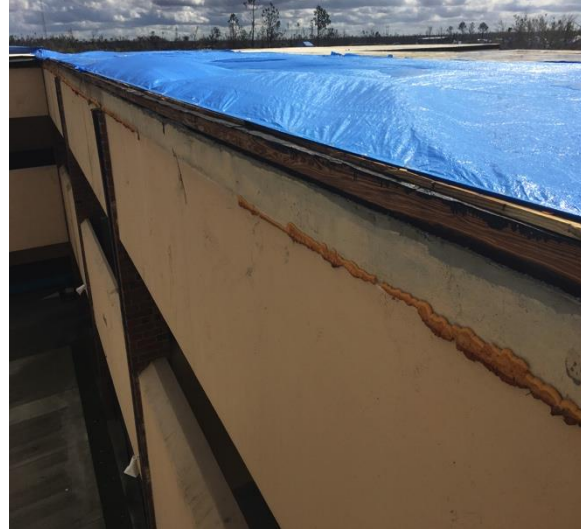
Typical gutter, metal edge and gutter dislodged

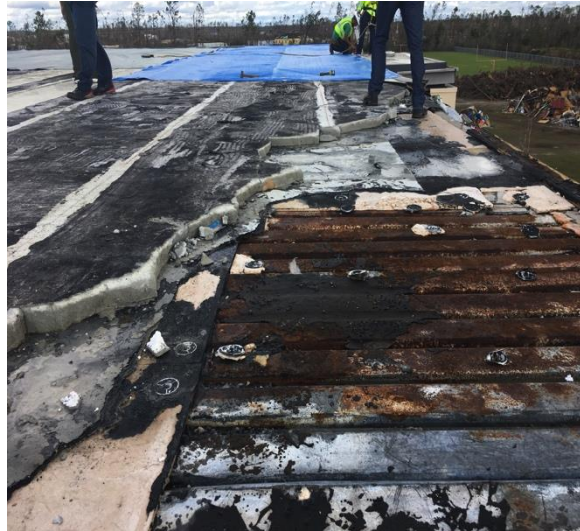
Rusted metal deck showing complete system

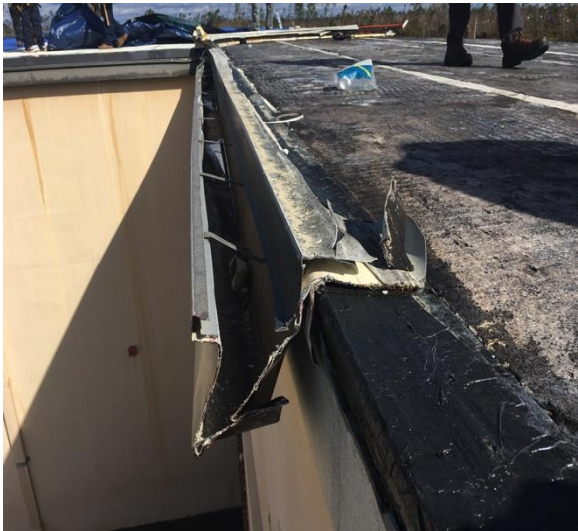
Gutter and metal edge dislodged

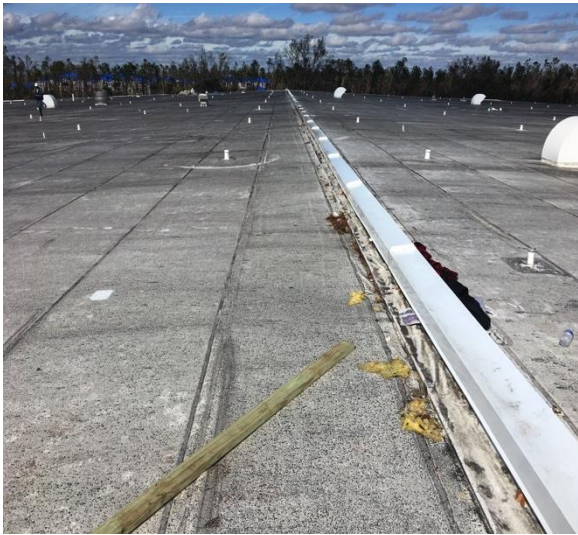
2.2.4 Overview of large roof

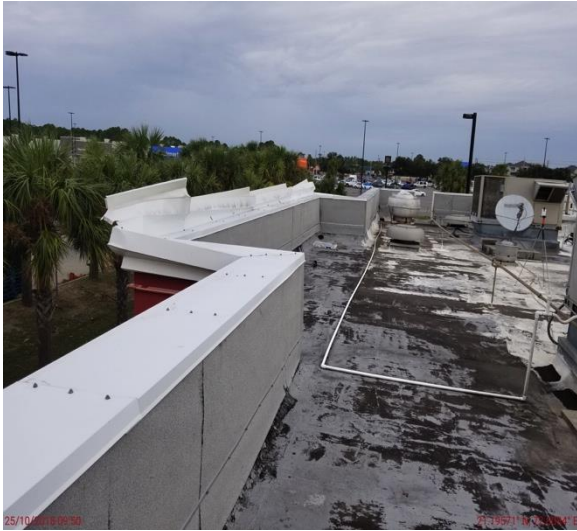
4.1.1 Overview with damaged coping

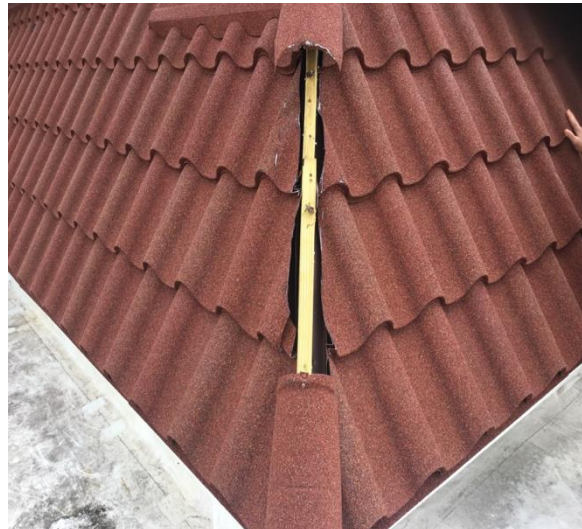
Missing composite Tile

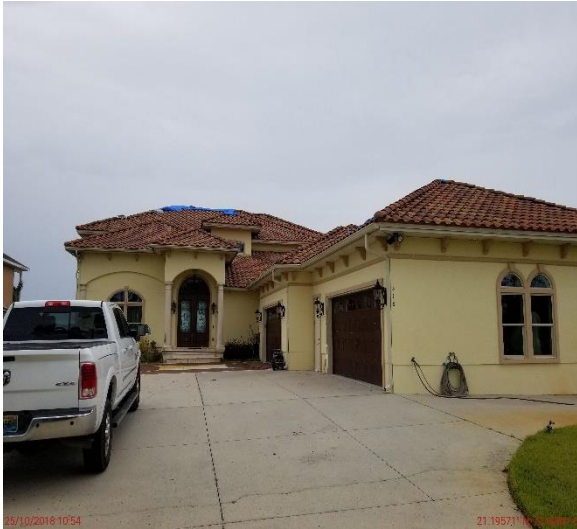
4.1.2 Street side overview

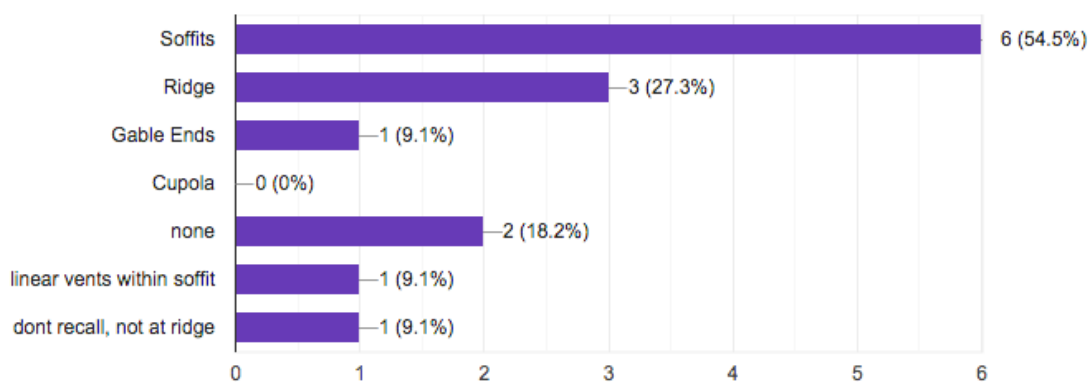
Damage Assessment State Rank

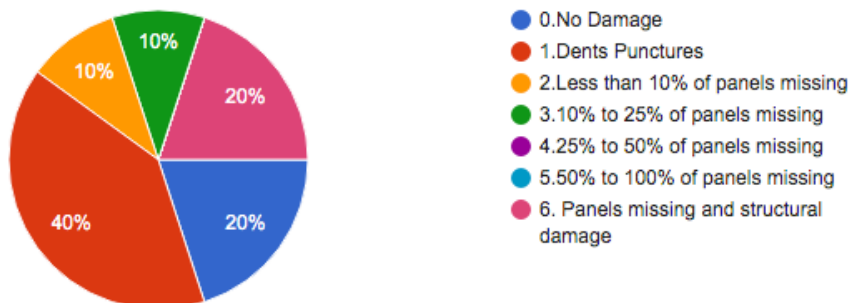
RICOWI Wind Investigation Hurricane Michael, Florida

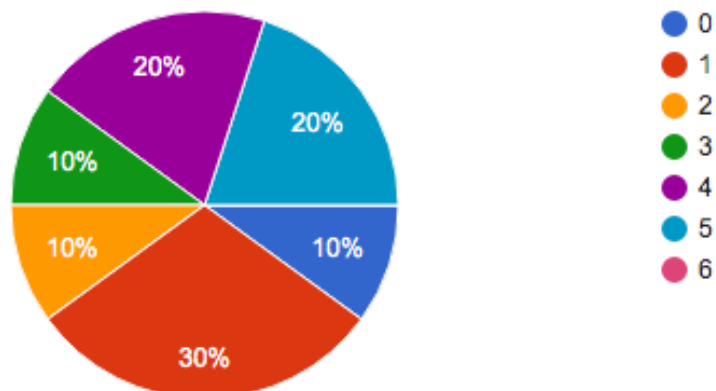
RICOWI Wind Investigation Hurricane Michael, Florida

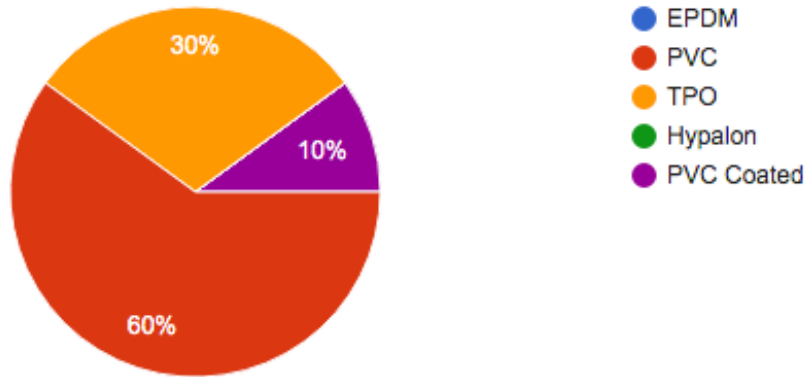
Damage Assessment State Rank

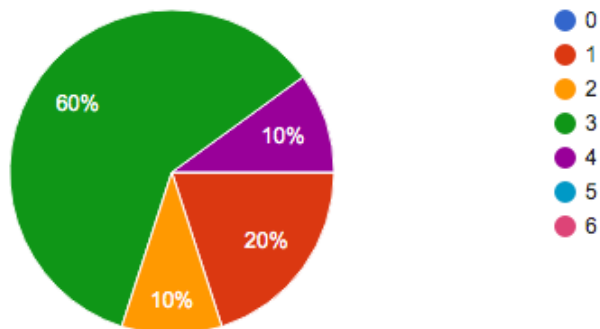
RICOWI Wind Investigation Hurricane Michael, Florida

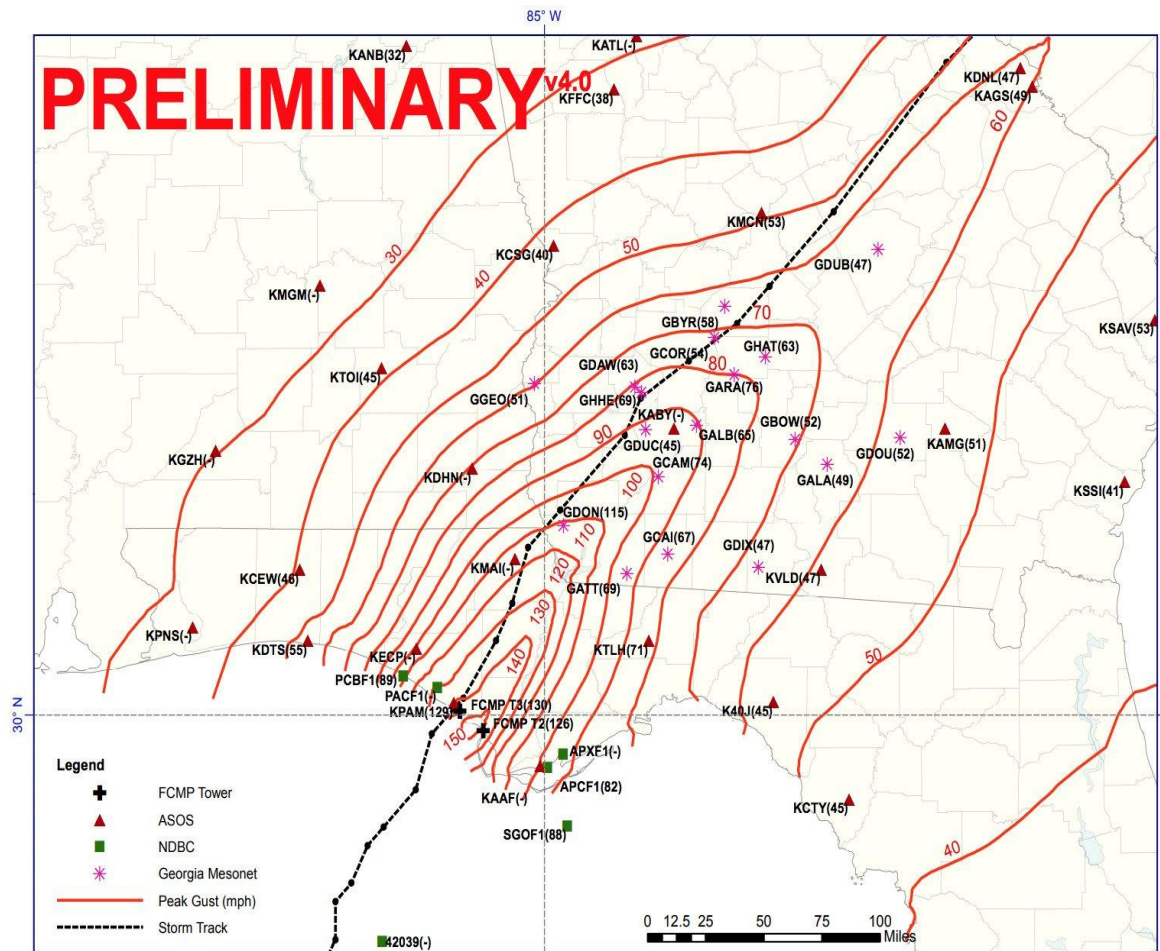
Hurricane Michael (2018): Preliminary Peak Wind Gust (mph)

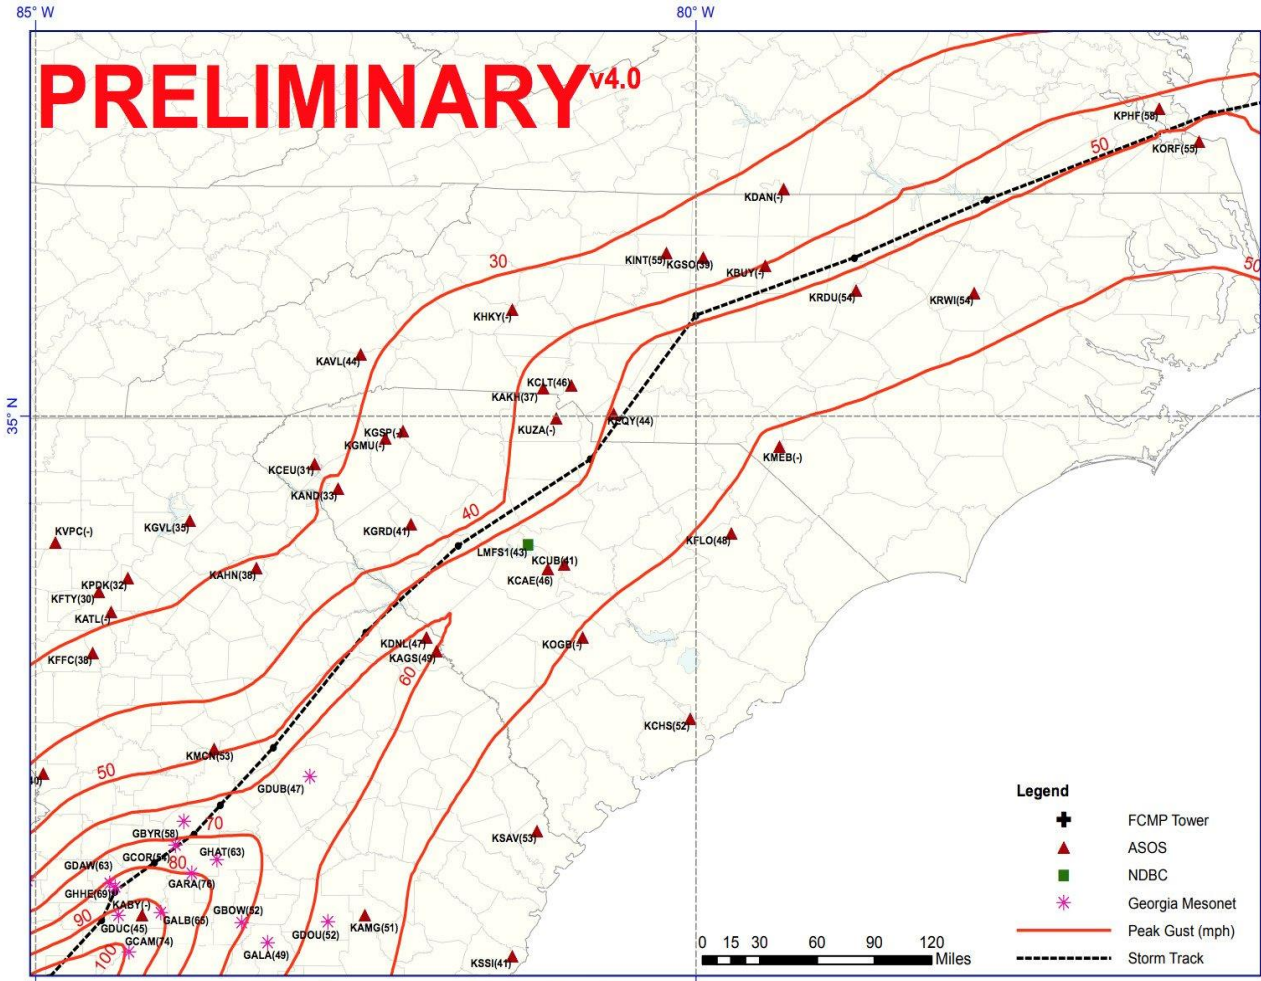
Hurricane Michael (2018): Preliminary Peak Wind Gust (mph)

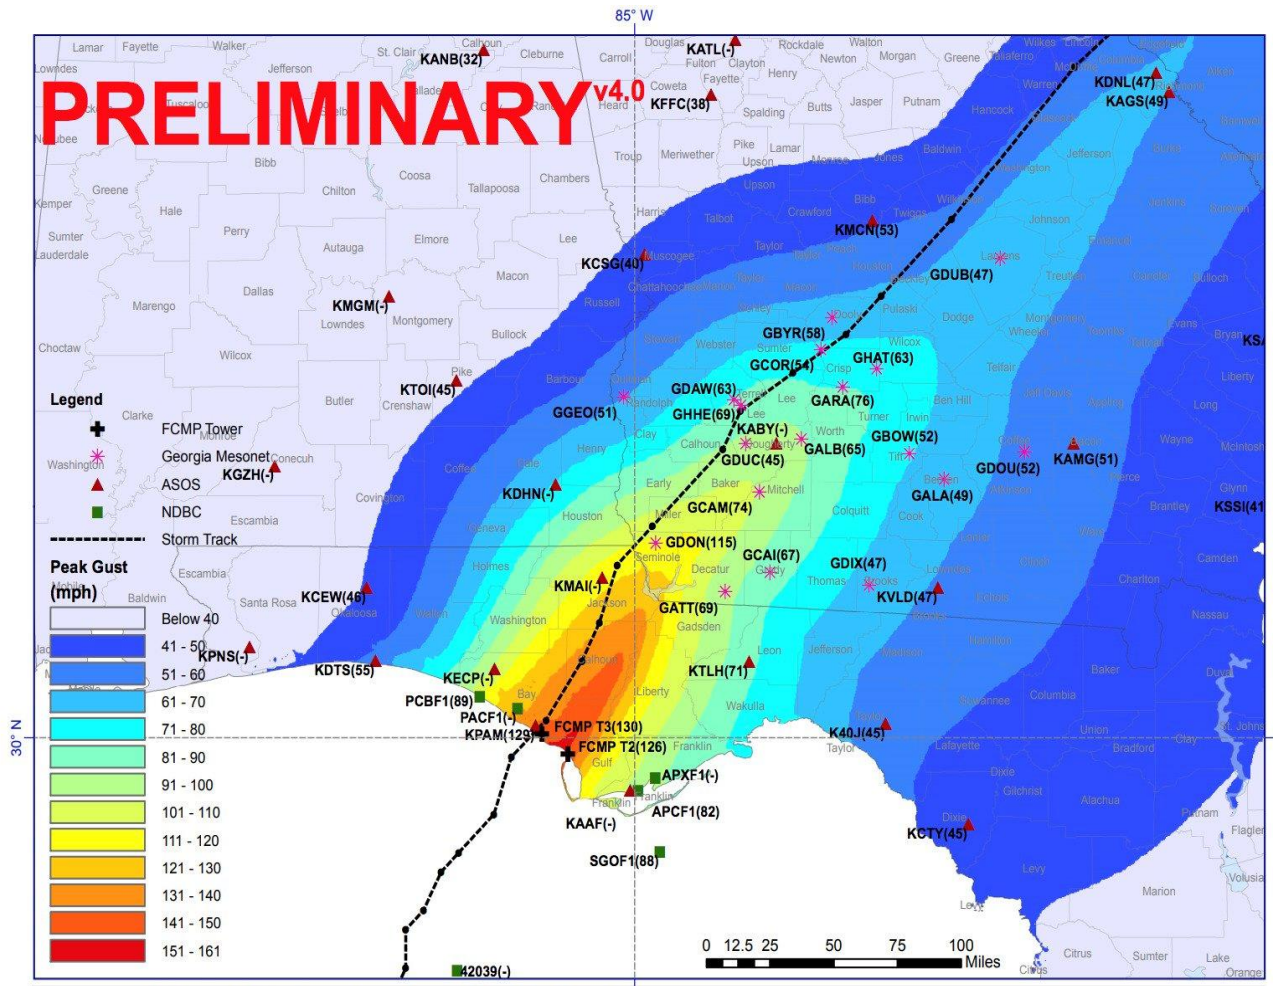
Hurricane Michael (2018): Preliminary Peak Wind Gust (mph)

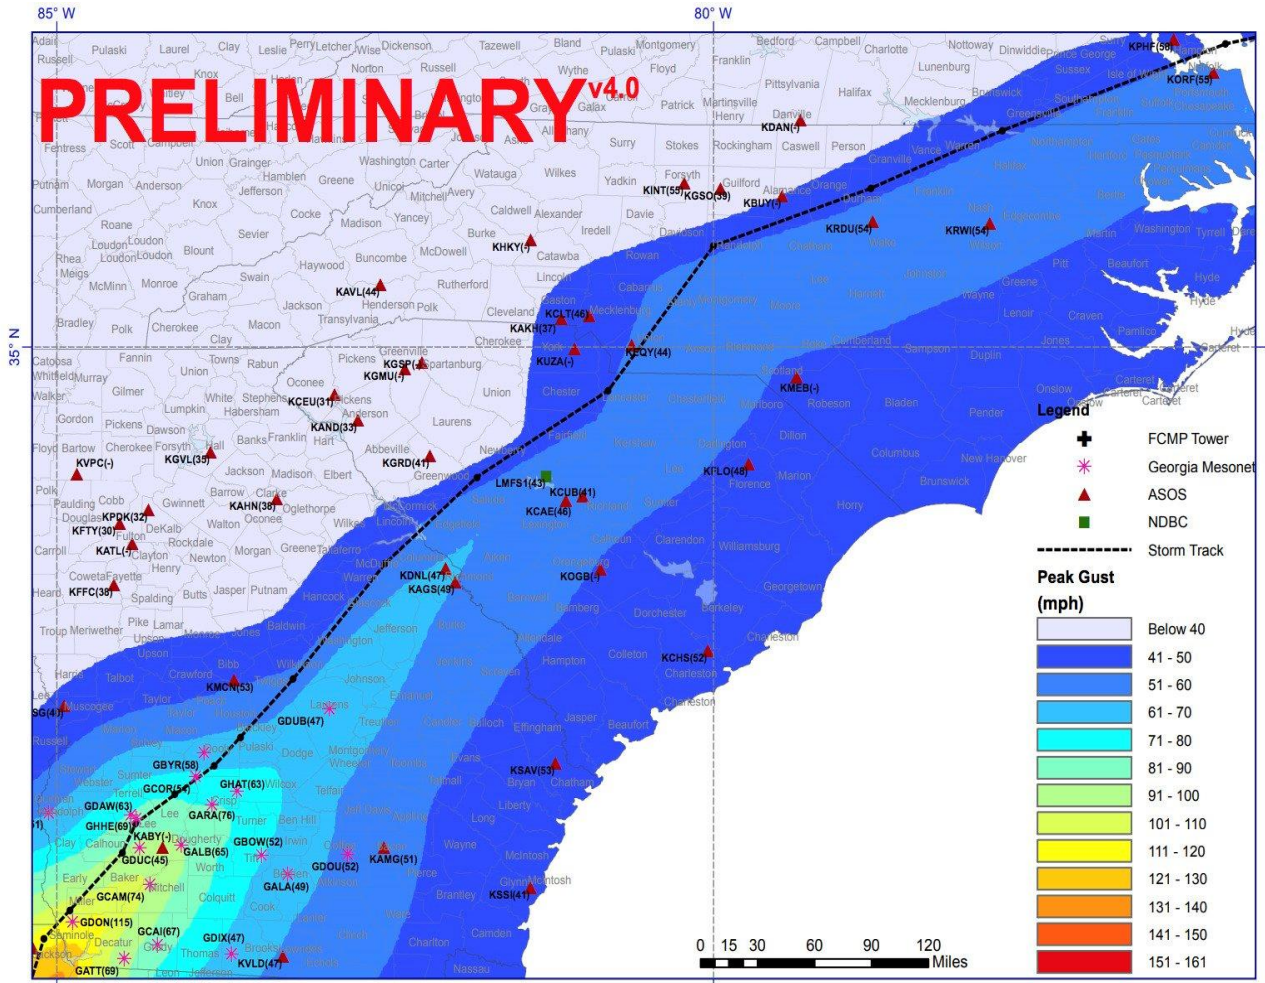
Hurricane Michael (2018): Preliminary Peak Wind Gust (mph)
