## HAILSTORM INVESTIGATION

DALLAS / FORT WORTH, TX

MAY 24, 2011

## **HAILSTORM INVESTIGATION REPORT**

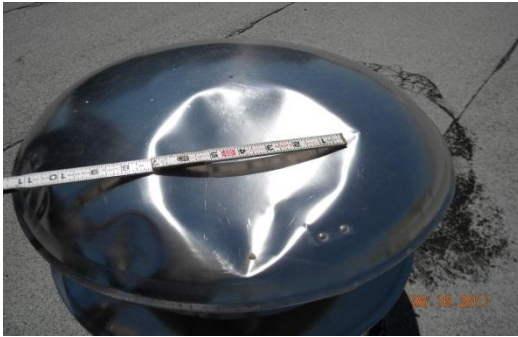
Figure 1. Vent cap buckled by large hail in Irving.

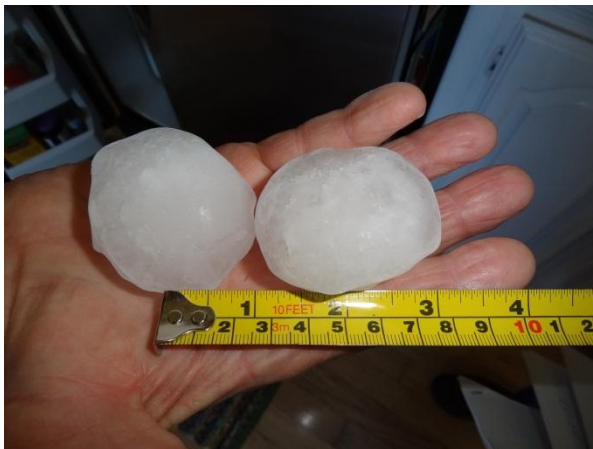
Figure 2. Hailstones saved by homeowner in Irving.

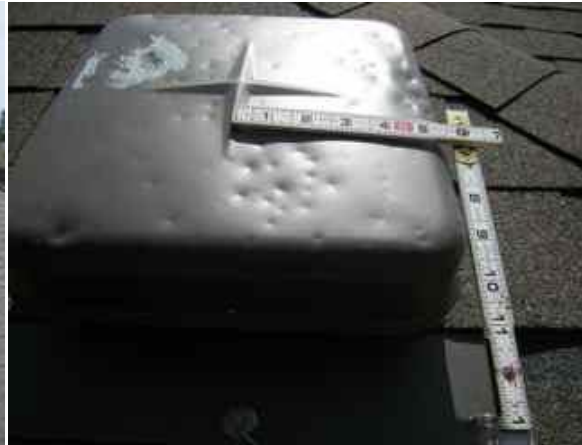
1.03-2. Dents in top of metal vent cover.

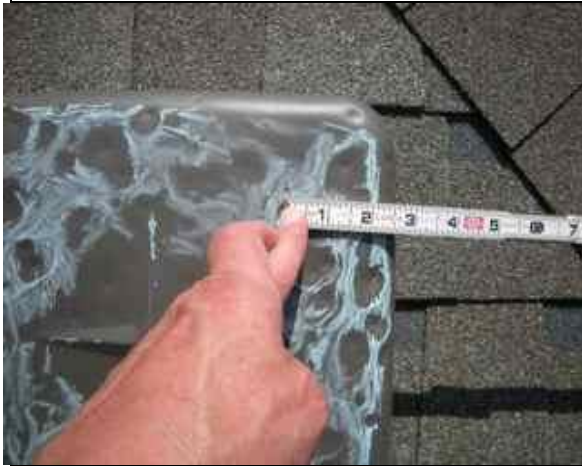
1.03-3. Dents in top of metal vent cover after chalk-rub.

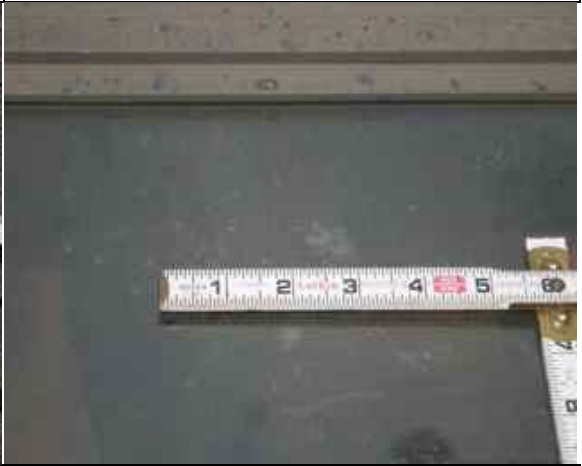
1.03-4. Hail spatter mark on horizontal glass pane of skylight.

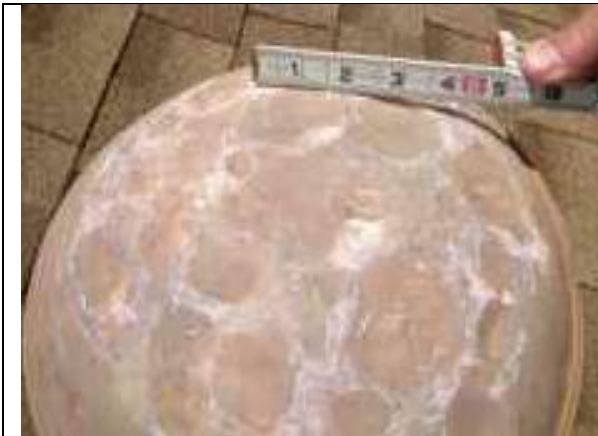
1.05-1. Multiple hail marks shown.

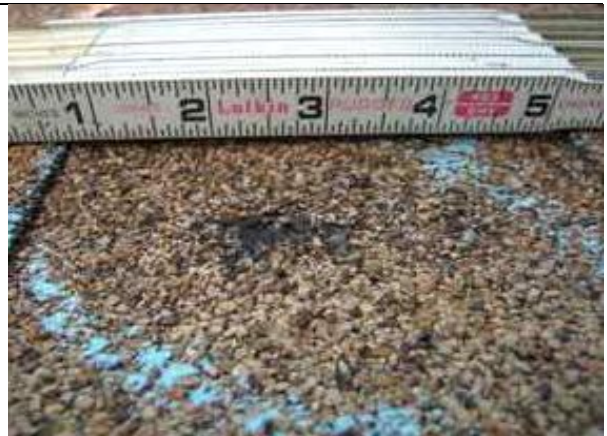
1.05-2. Large hail mark on shingle

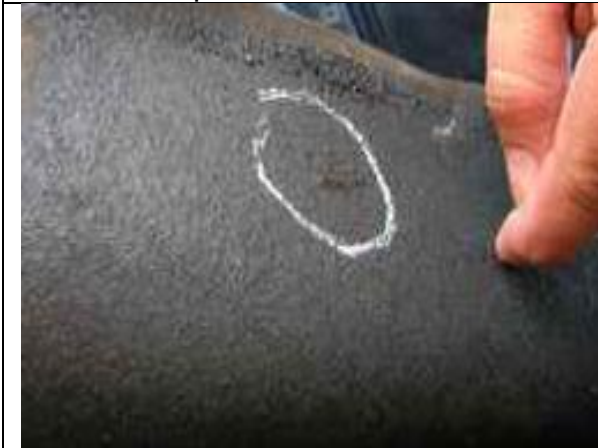
1.05-3. Large hail mark.

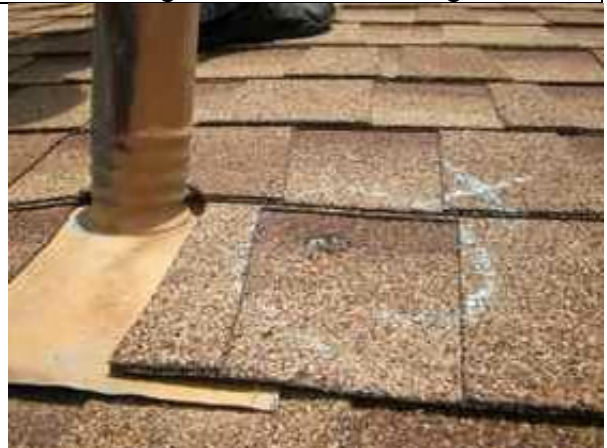
1.05-4. Large hail mark on shingle.

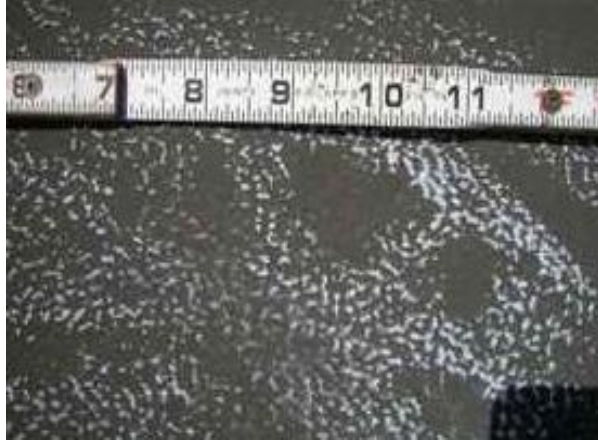
1.06-1. Multiple hail marks shows.

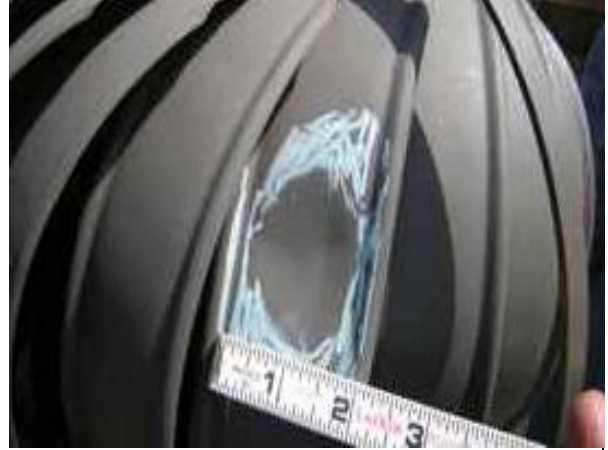
1.06-2. Dent left from hail.

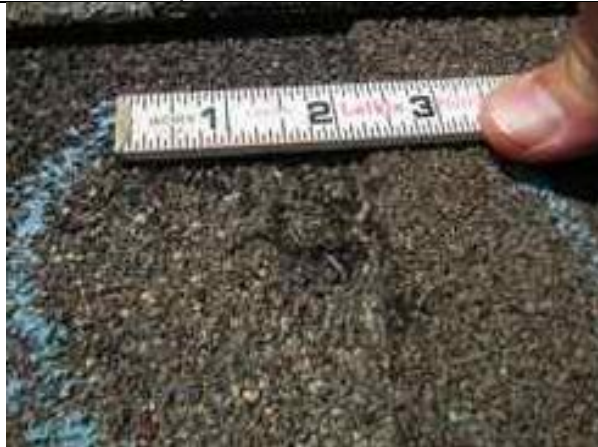
1.06-3. Hail damage on shingle.

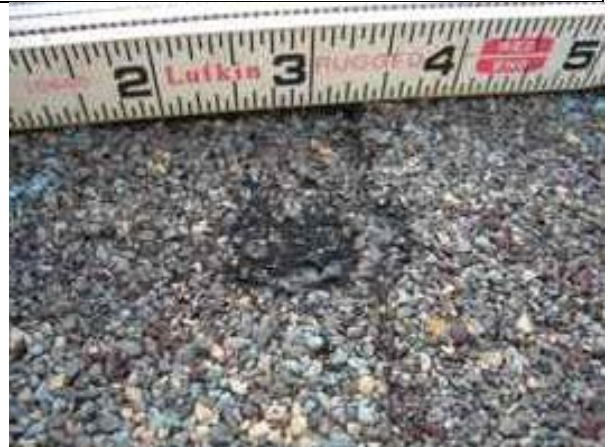
1.06-4. Hail damage on shingle.

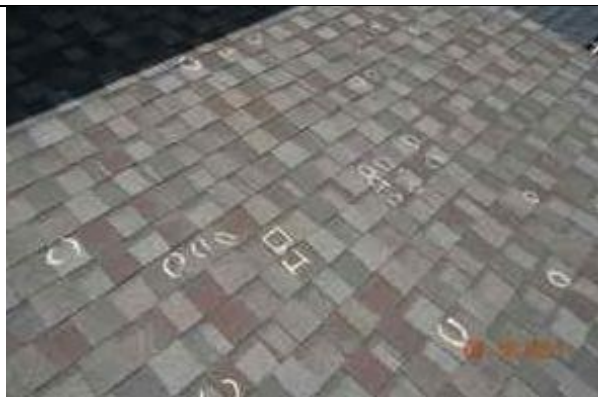
1.11-1. West facing slope area with many impacted shingles.

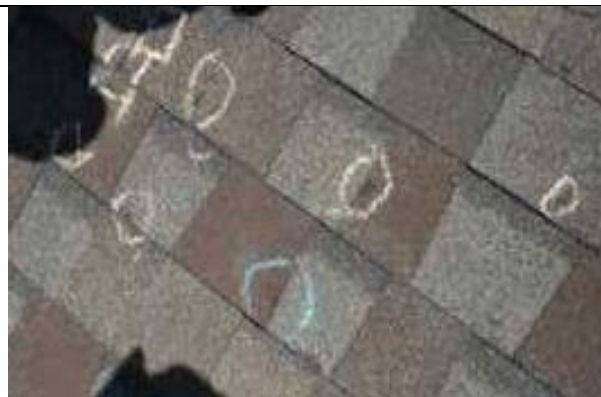
1.11-2. Overview of some "bruised" shingles.

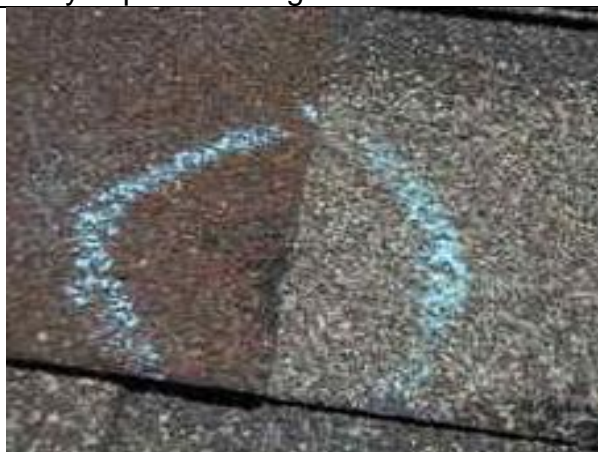
1.11-3. Close-up of "bruised" shingle laminate.

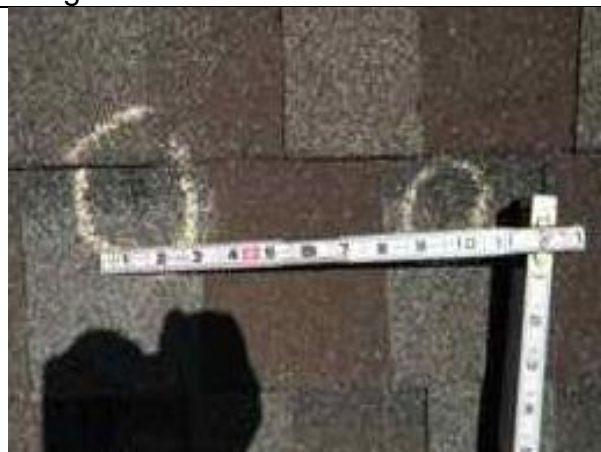
1.11-4. Overview of some "bruised" shingles.

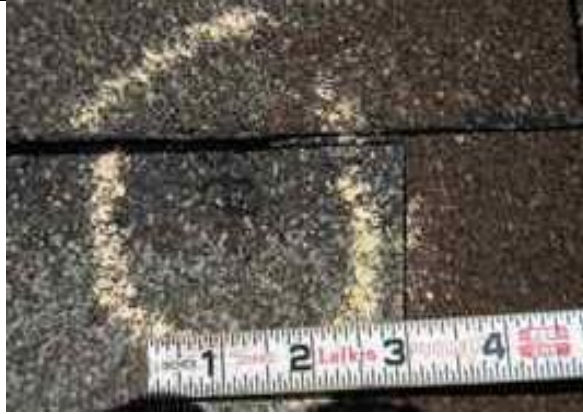
1.11-5. 1/2 –inch to 5/8-inch impact mark.

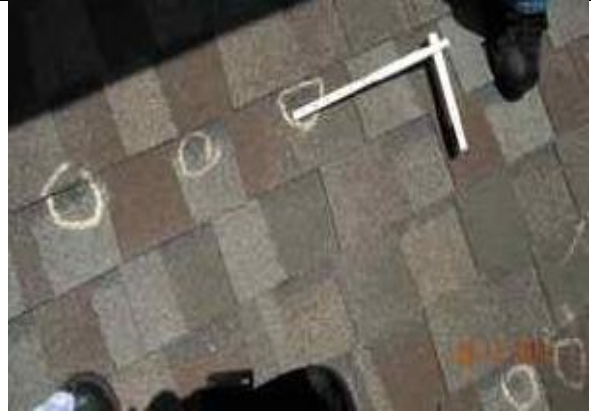
1.11-6. Overview of some “bruised” shingles.

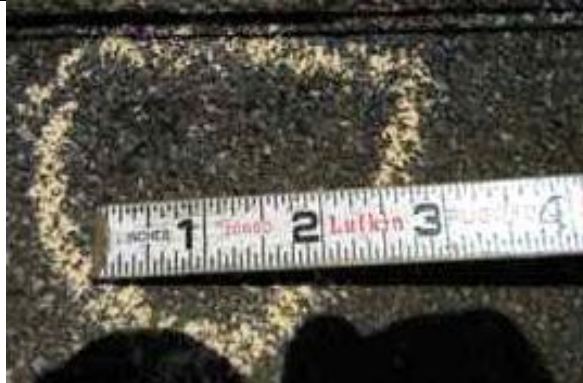
1.11-7. 1-3/4-inch impact mark.

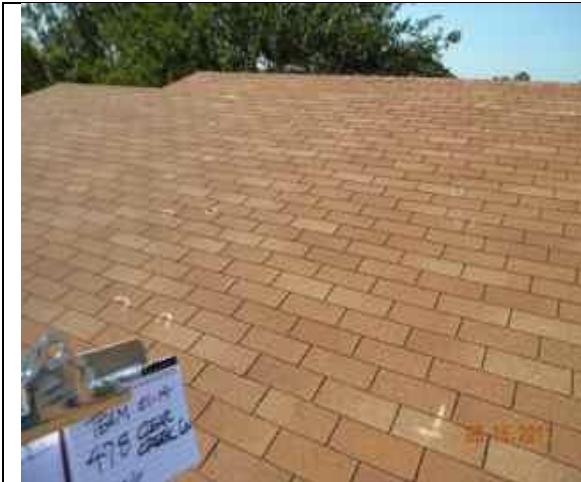
1.14-1. South facing slope area with many impacted shingles.

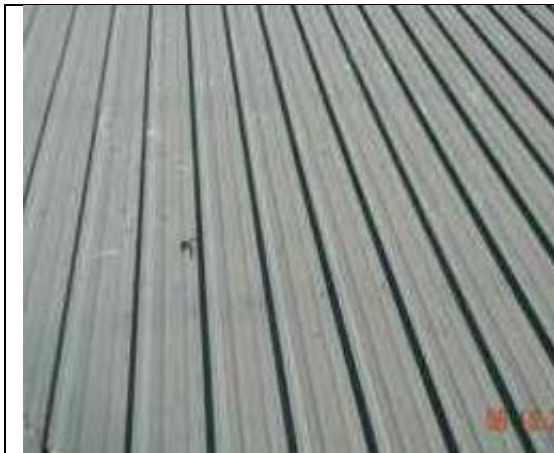
<b>Comments Regarding Inspection</b>	<b>Many panels had seam openings</b>

1.16-1. WSW facing slope area with many impact depressions in metal roof ribs.

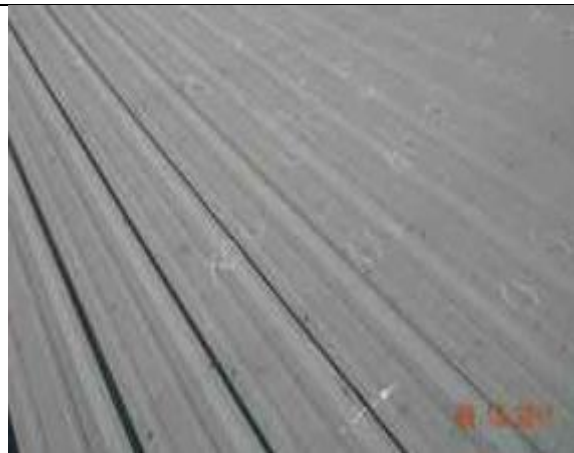
1.16-2. WSW facing slope area with many impact depressions in metal roof ribs. Overview of impact marks (circled on metal panels).

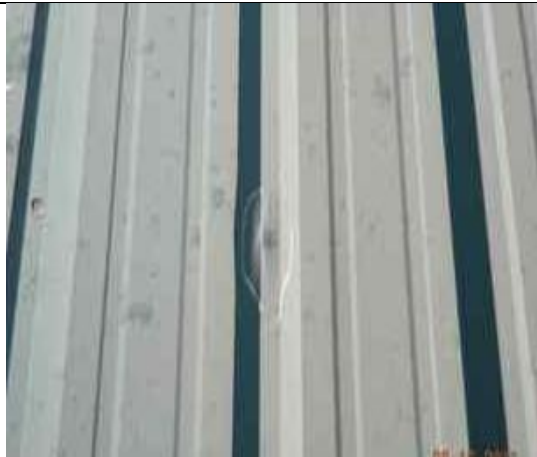
1.16-3. Overview close-up of impact depressions in metal roof rib.

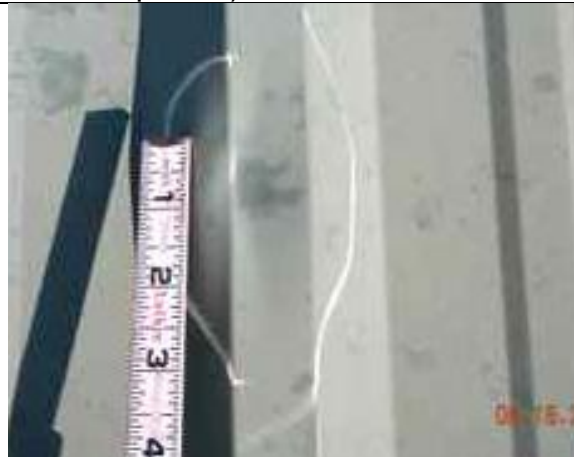
1.16-4. Close-up of impact depressions in metal roof rib in Photo 3.

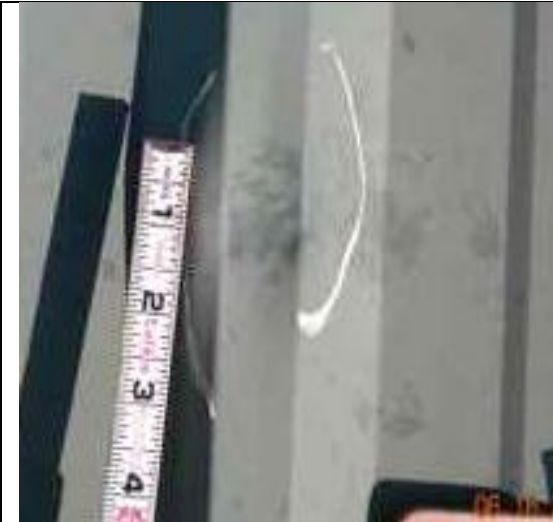
1.16-5. Overview close-up of impact depressions in metal roof rib.

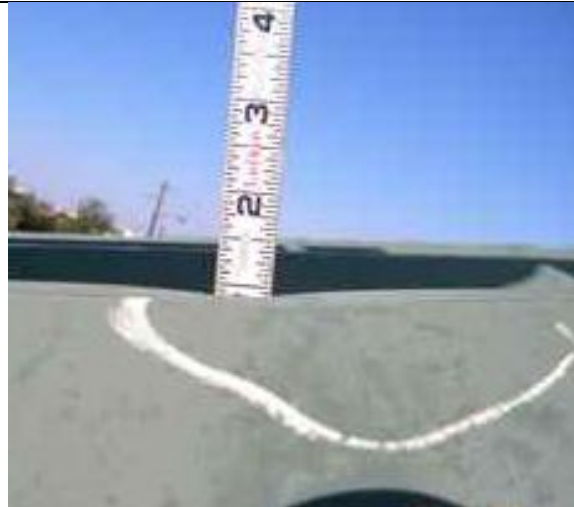
1.16-6. Cross view close-up of impact depressions in metal roof rib.

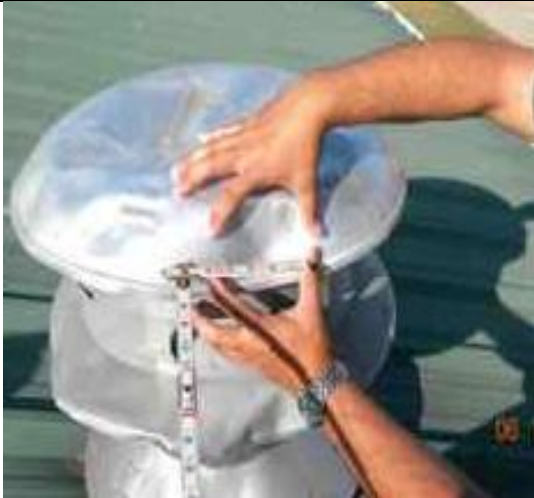
1.16-7. 4 to 5-inch impact depression with smaller impacts marks also.

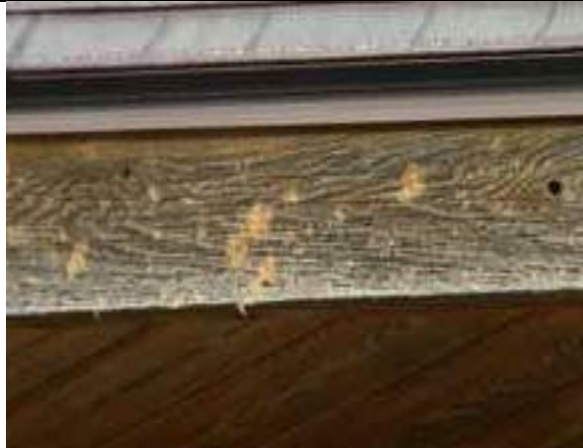
<b>Comments Regarding Inspection</b>	<b>Damage for side laps and for dents. Damage on EIFS wall cladding also.</b>

1.23-1. Wood damage from hail.

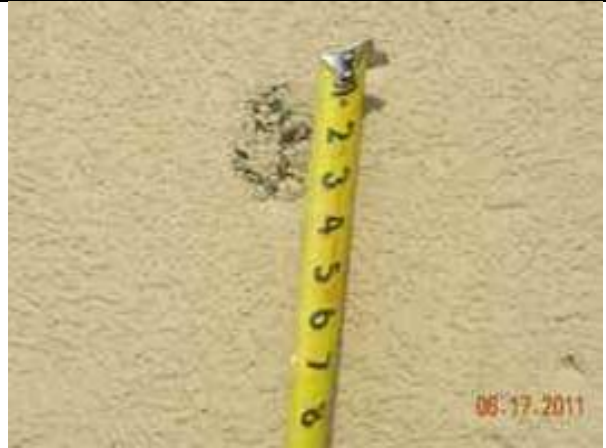
1.23-2. Hail mark shown.

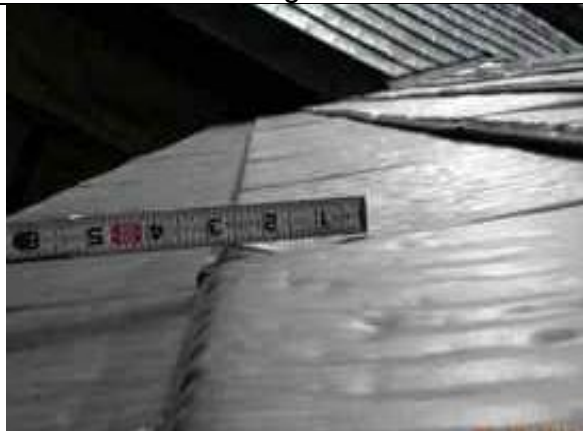
1.23-3. Metal damage from hail.

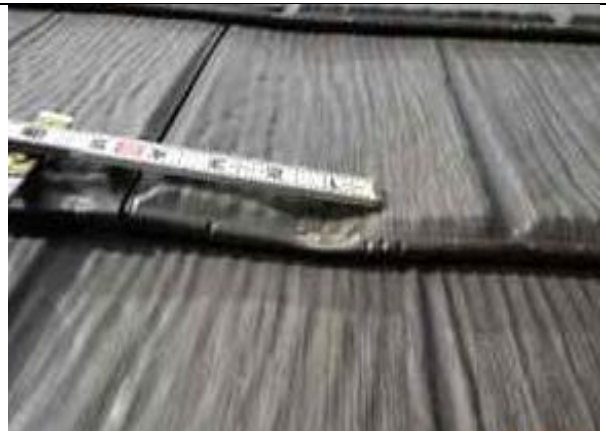
1.23-4. Shingle damage from hail.

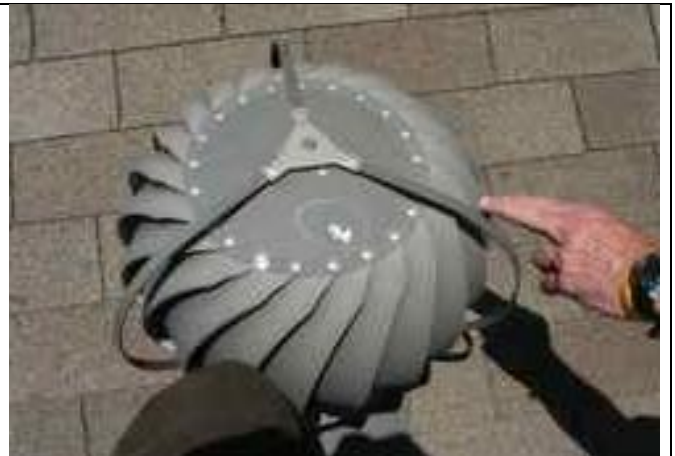
2.07-2. Dent in aluminum turbine vent.

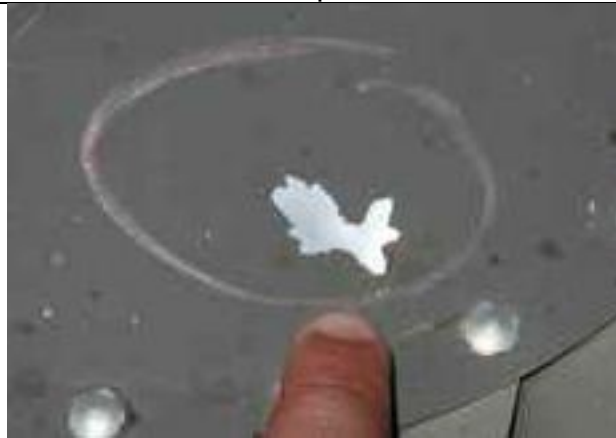
2.07-3. Close up.

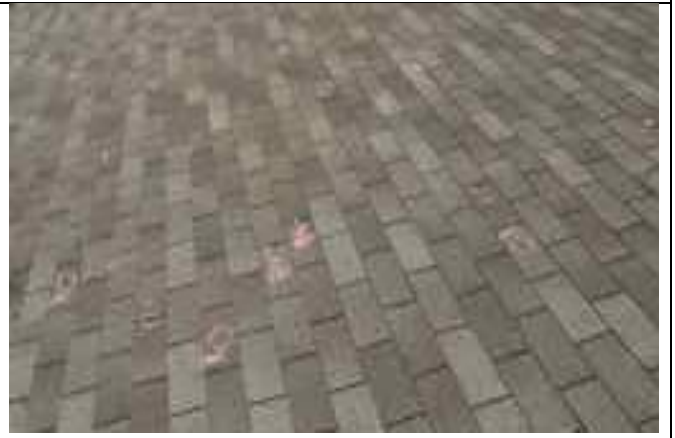
2.07-4. West test square overview.

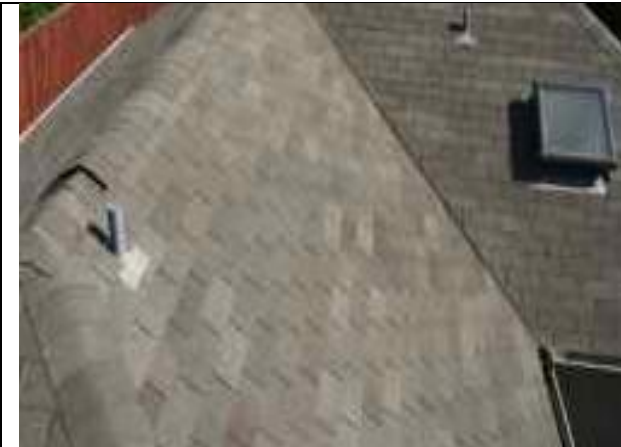
2.09-1. West slope overview.

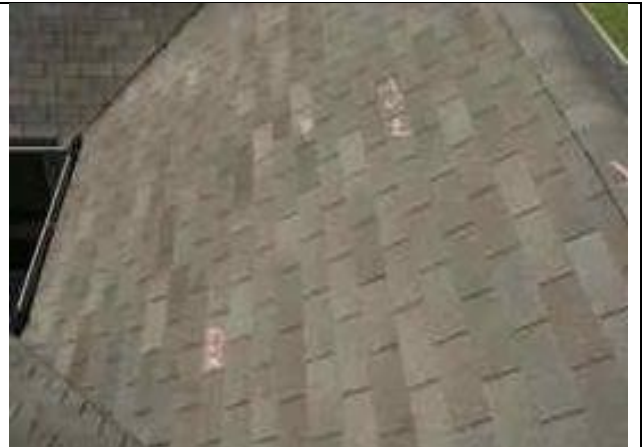
2.09-2. West test square overview.

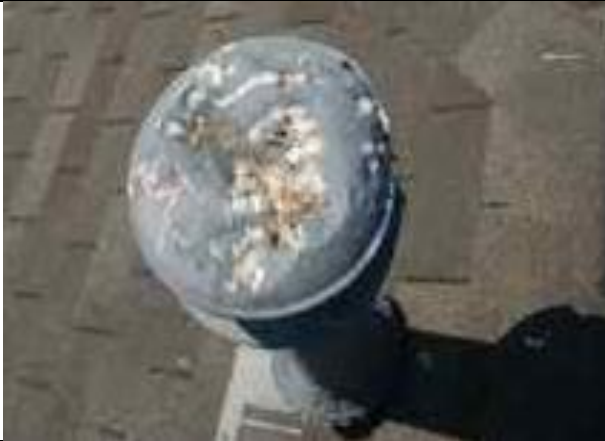
2.09-3. Dented flue cap.

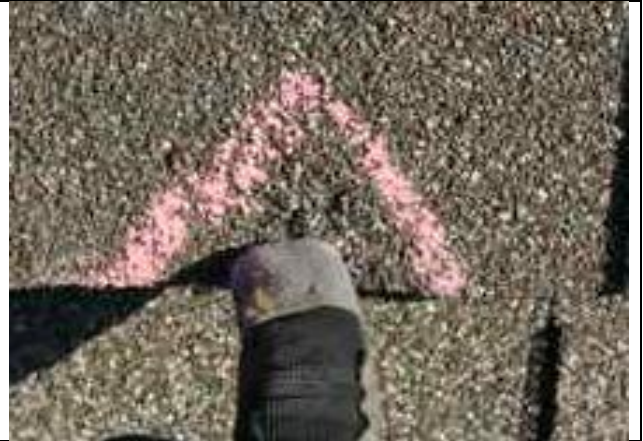
2.09-4. Bruised shingle.

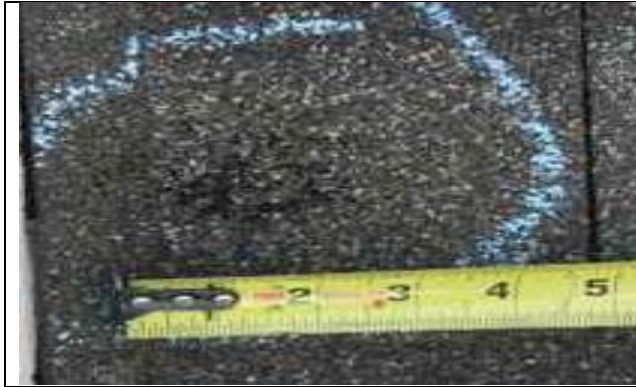
2.19-7. Two-and-one-half inch wide bruise.

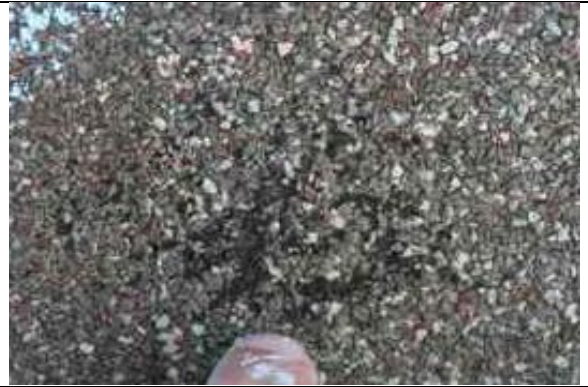
2.19-8. Close up.

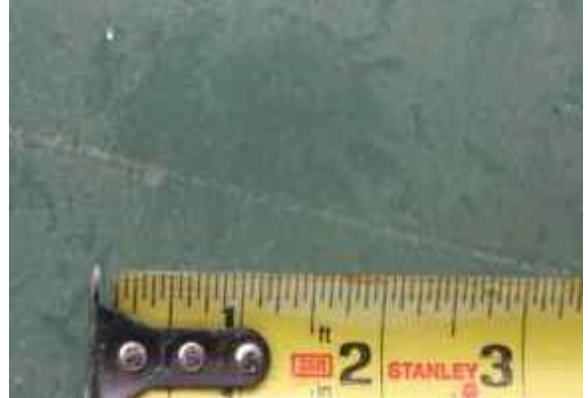
2.19-10. Two-inch wide spatter mark on transformer box.

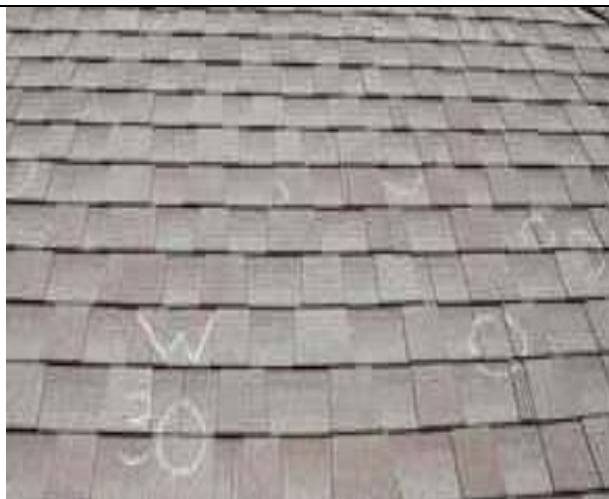
3.03-1. Number of impacts in 100 sq ft test area.

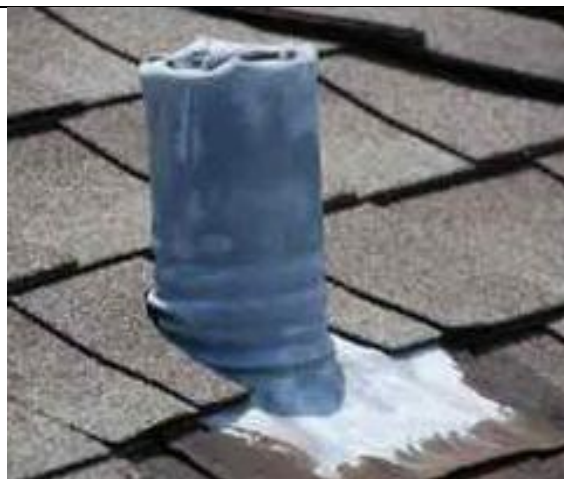
3.03-4. Same vent stack at 3.03-3 indicating damage on opposite side.

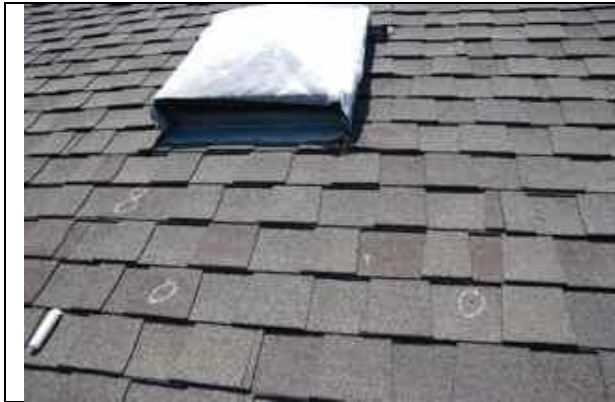
<b>Comments Regarding Inspection</b>	<b>Impact resistant shingle roof with minimal damage. Test areas measured and evaluated from ladder (5'x20').</b>

3.07-1 Overview

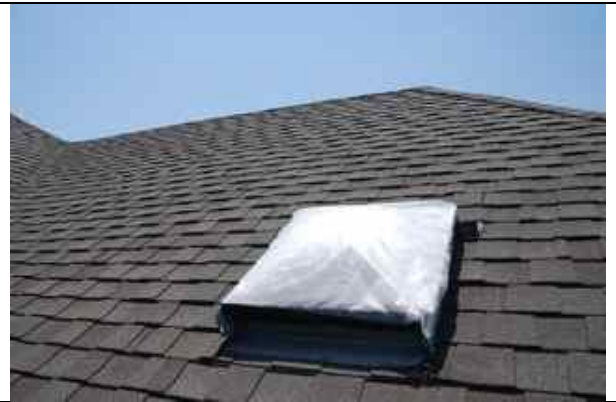
3.07-2 Skylight damage

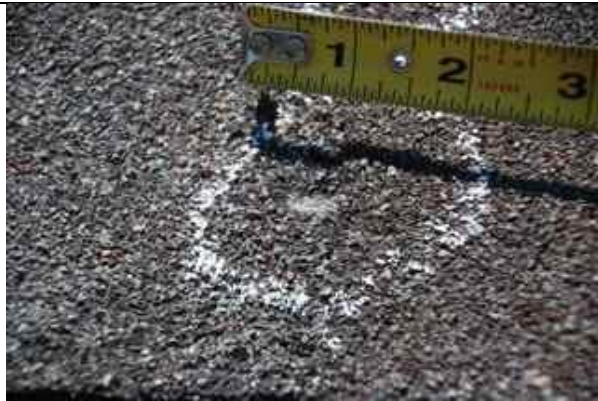
3.07-3 Damaged shingle

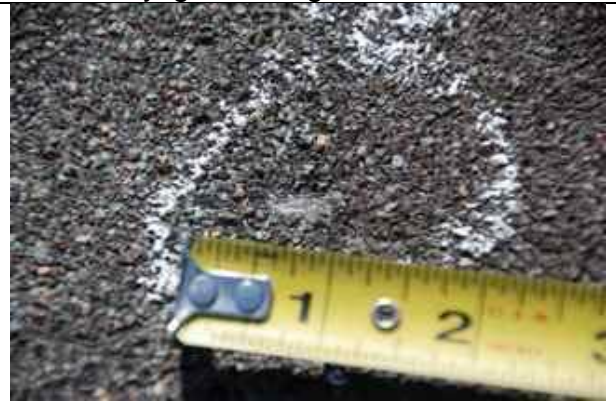
3.07-4 Damage showing reinforcement

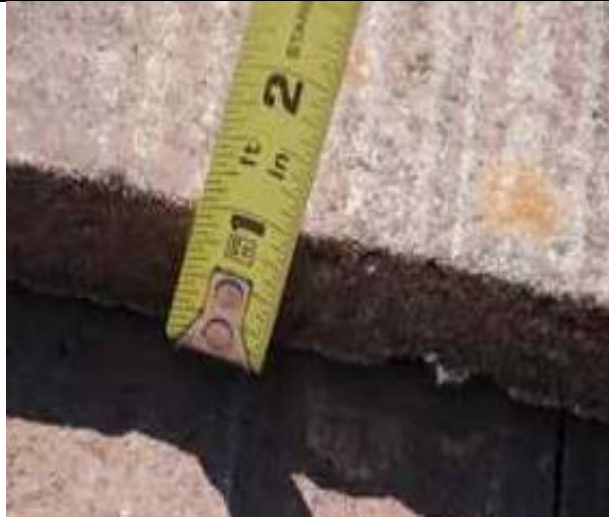
3.11-1. Thickness of concrete tile.

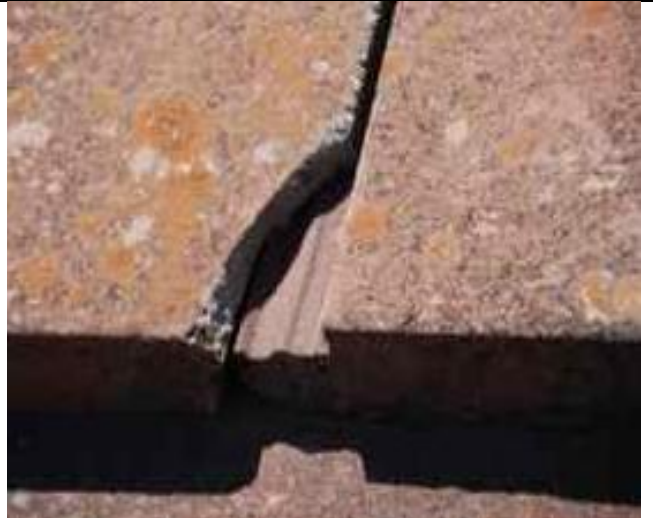
<b>Comments Regarding Inspection</b>	<b>Damage was mainly cracked off right corners, not clear that damage was caused by hail storm.</b>

3.11-2. Recent right corner break in tile.

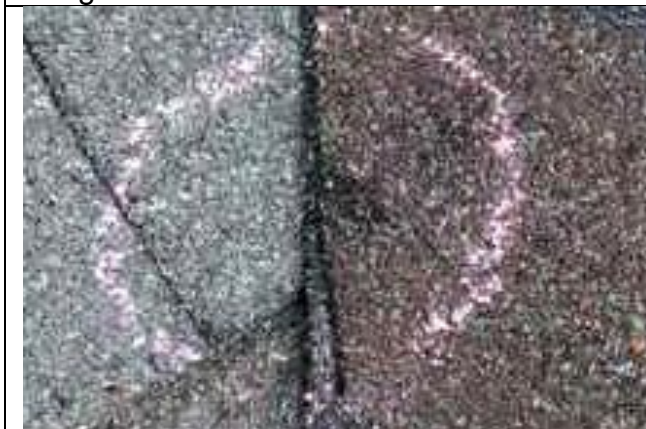
4.04-3. Exposed bitumen in the damaged shingle.

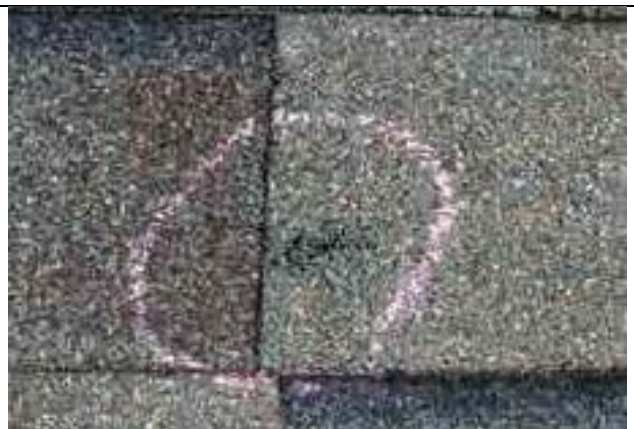
4.04-4. Exposed bitumen in the damaged shingle.

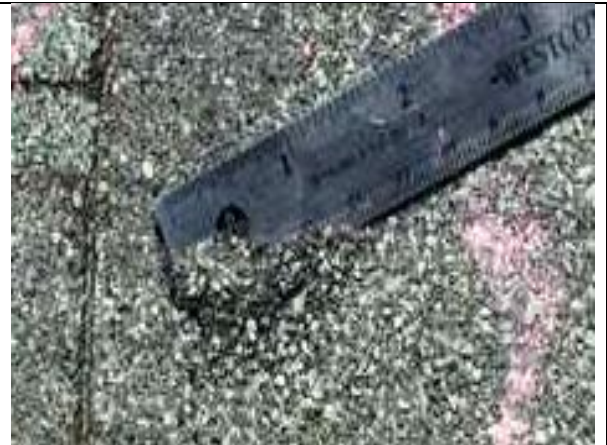
4.05-2. Fractured laminated shingle.

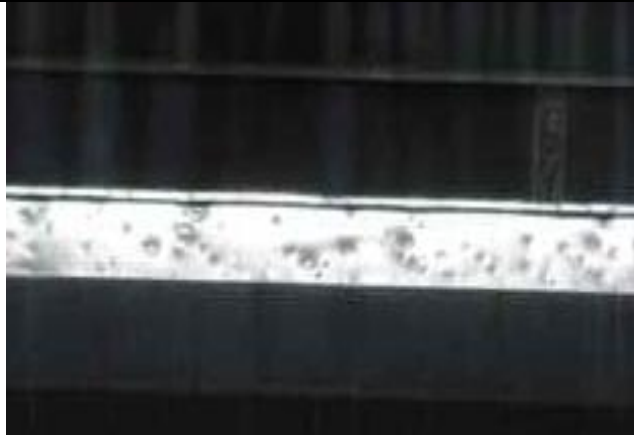
4.11-1. Multiple indentations on the copper gutter.

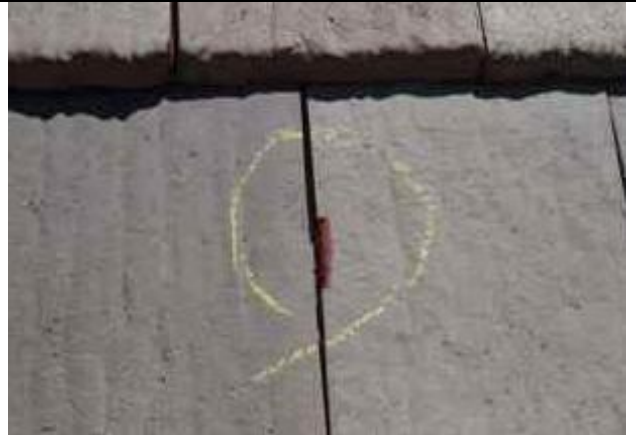
4.11-2. Chipped edge of tile on steep slope roof.

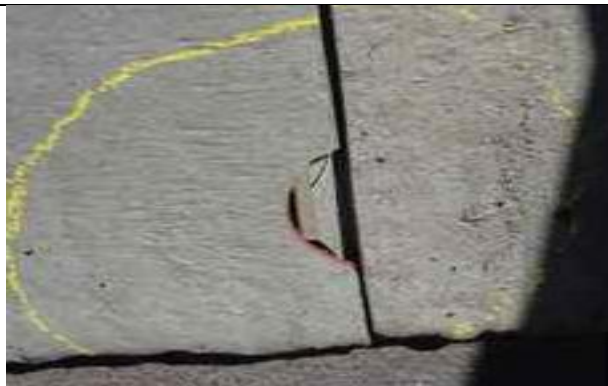
4.11-3. Chipped edge of tile on steep slope roof.

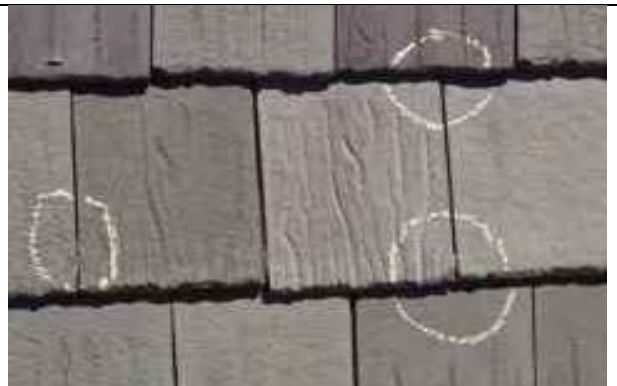
4.11-4. Multiple chipped tiles on steep slope roof.

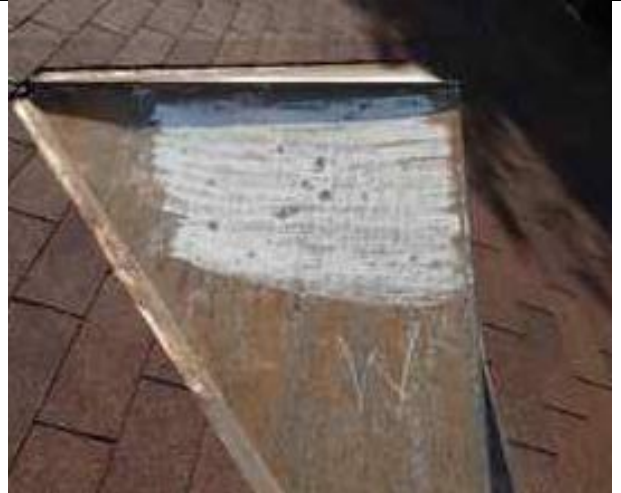
5.01-2. Impact on metal dormer.

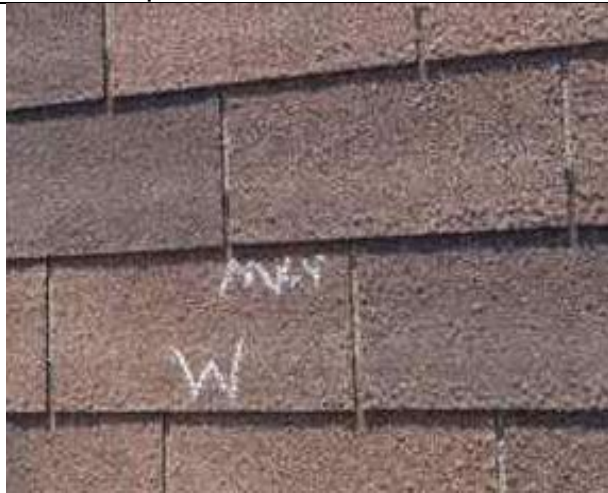
5.01-3. West facing slope, IR blisters.

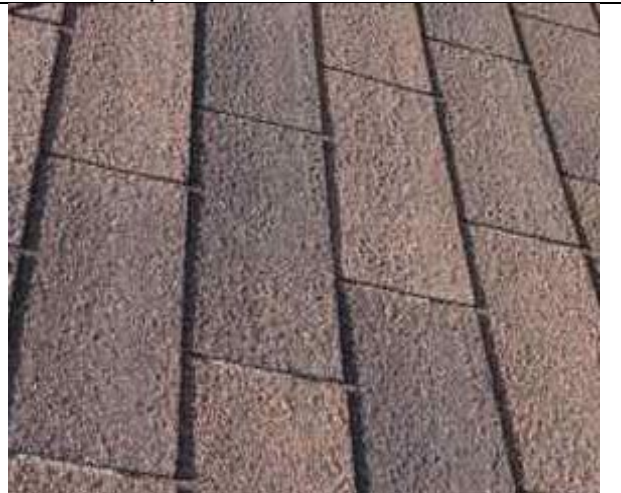
5.01-4. Unbroken rash blisters.

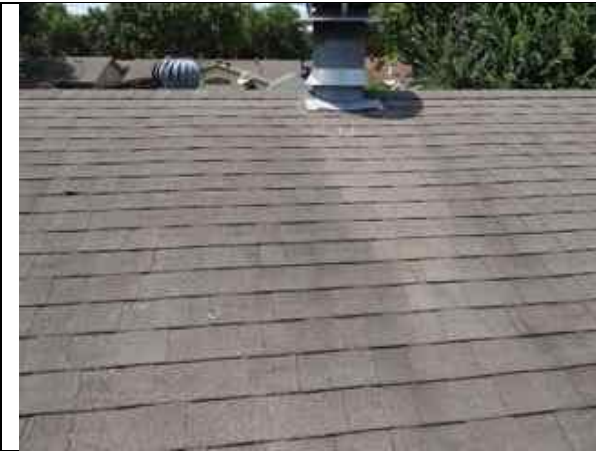
**5.05-1. Overview**

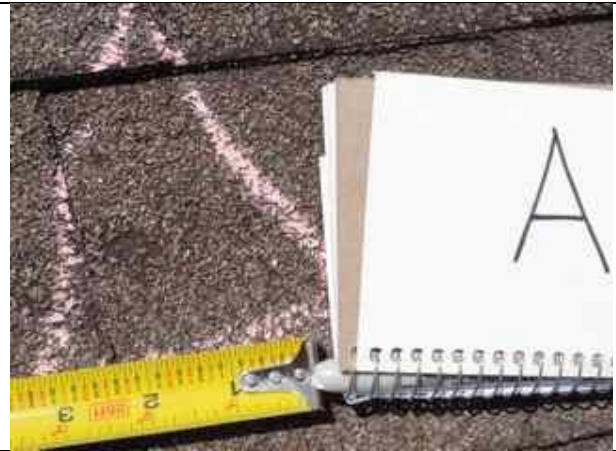
**5.05-2. Hail scuffed shingle**

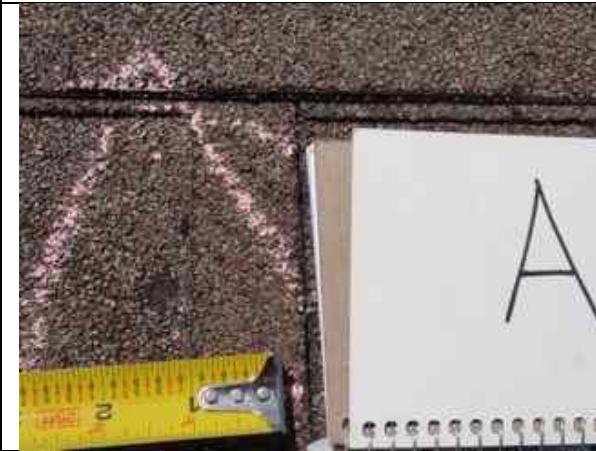
**5.05-3. Hail scuffed shingle**

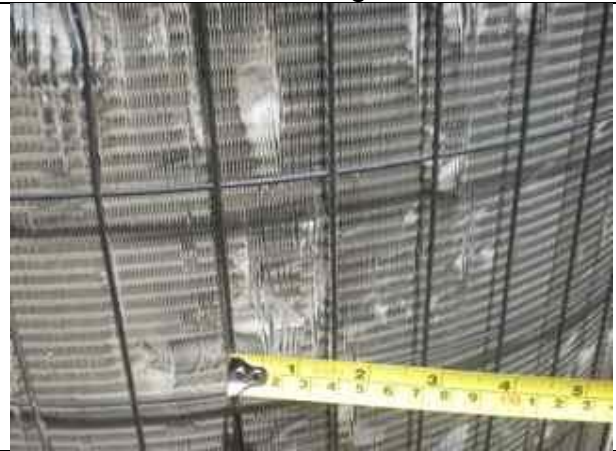
**5.05-4. Hail dents on air handler**

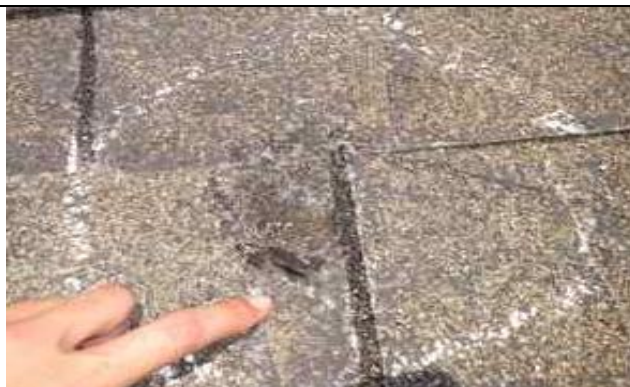
5.06-1. Impact fracture on shingle tab.

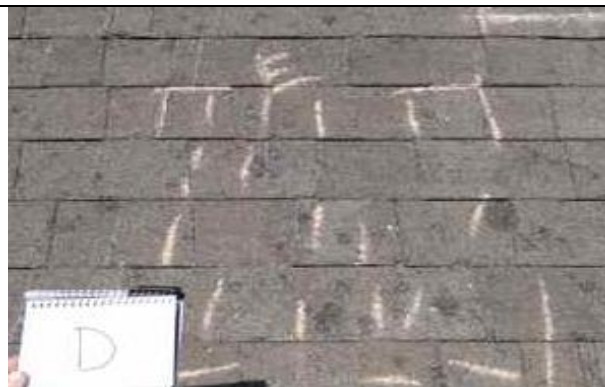
5.06-2. Measured areas with impact locations marked on East facing slope.

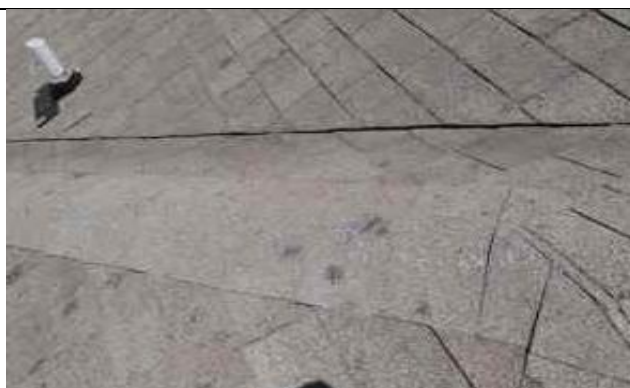
5.06-3. Impact marks on hip shingles.

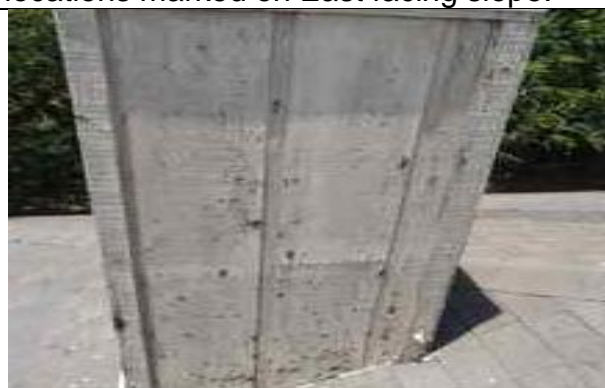
5.06-4. Impact marks on wood siding.

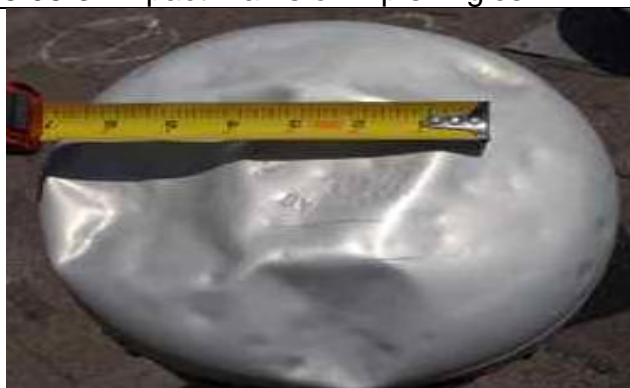
5.06-5. Impact marks on metal vent cover.

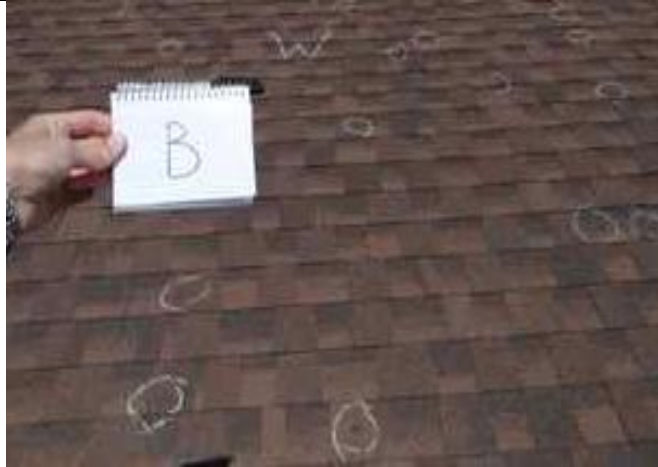
5.07-7. Impact locations marked on West facing slope of roof.

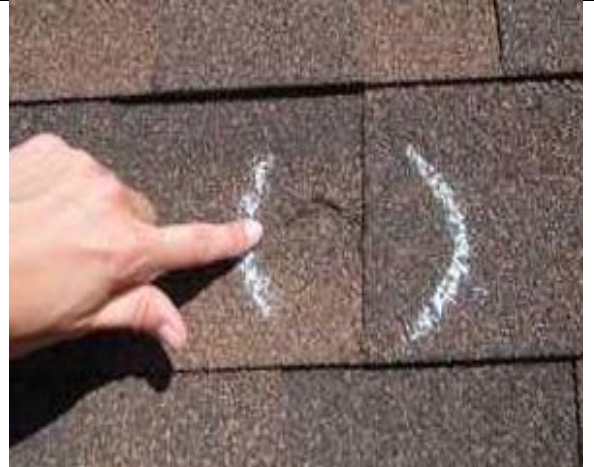
5.07-8. Impact fracture on face of shingle.

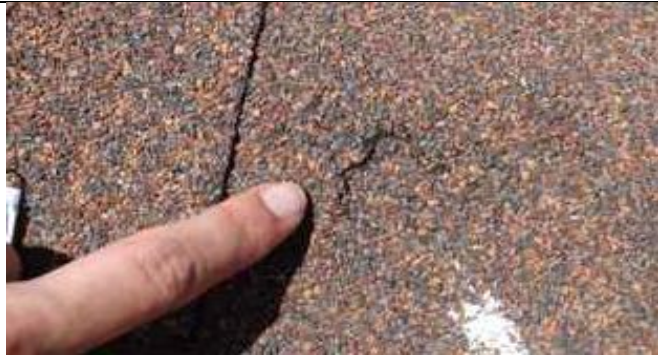
5.07-9. Close-up of impact fracture on shingle.

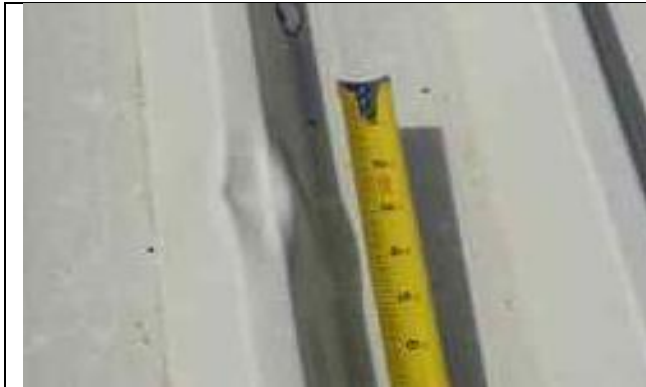
5.08-1. 4-inch dent.

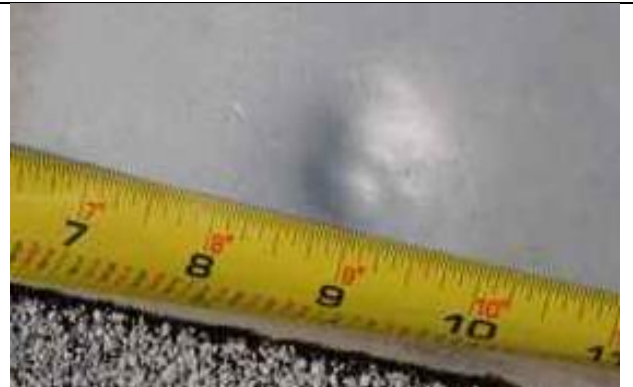
5.08-2. 2-inch dent.

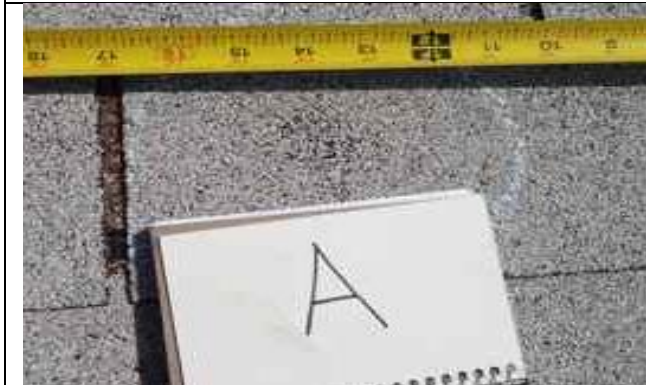
5.08-3. Granule loss.

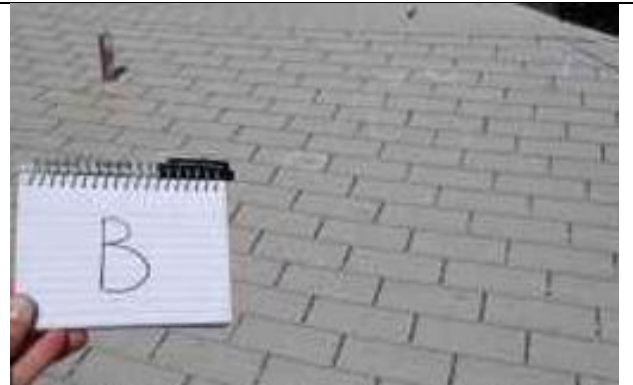
5.08-4. Multiple hail marks.

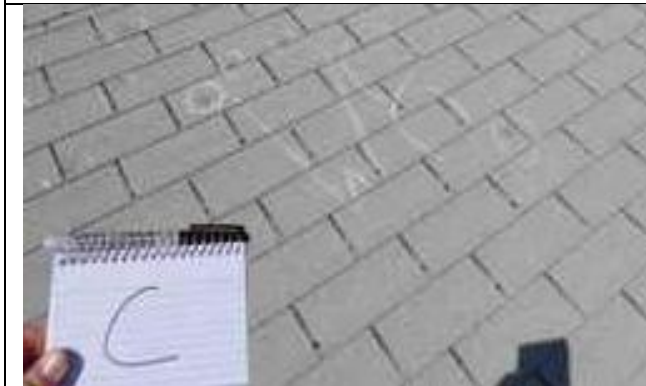
5.08-5. Multiple hail marks.

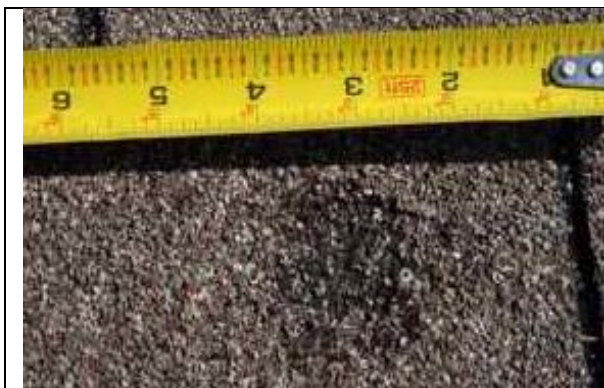
5.09-1. 2-1/4-inch hail mark.

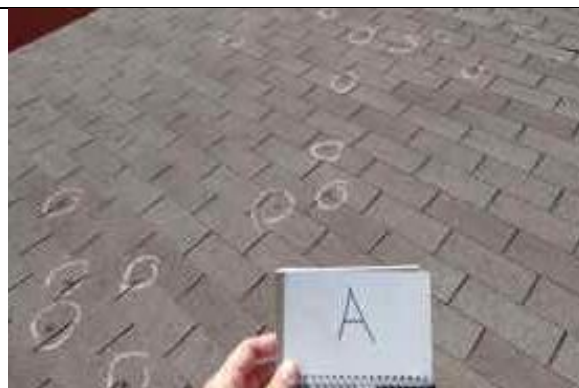
5.09-2. Multiple hail marks.

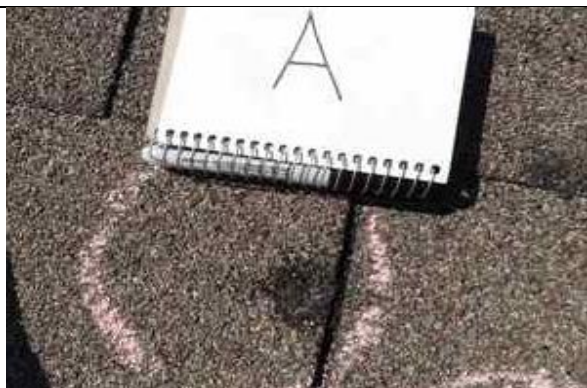
5.09-3. Granule loss.

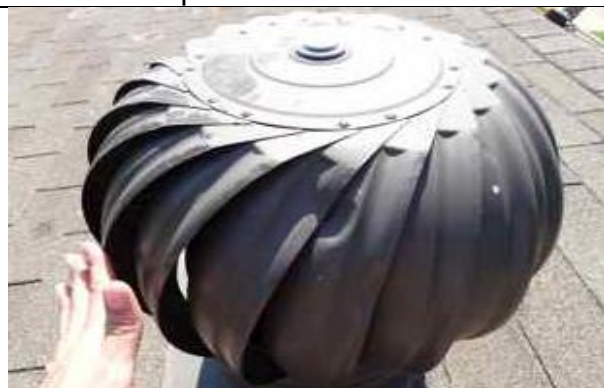
5.09-4. Dented vent cap.

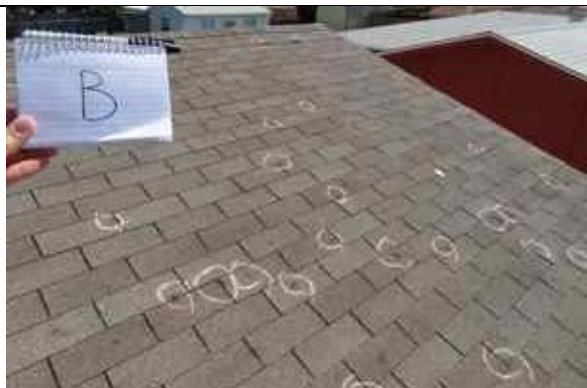
5.09-5. Multiple hail marks.

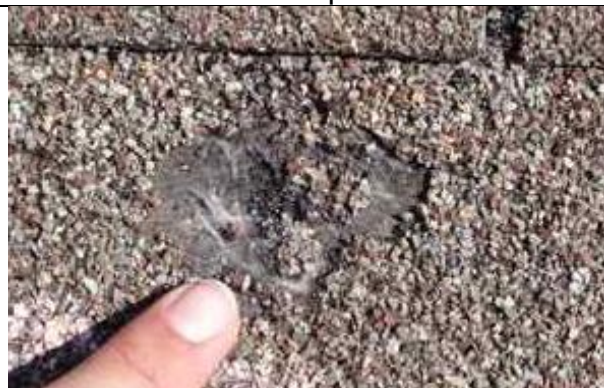
5.09-6. Damaged shingle.

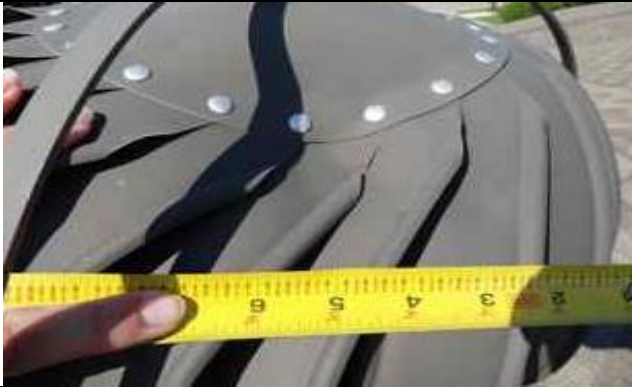
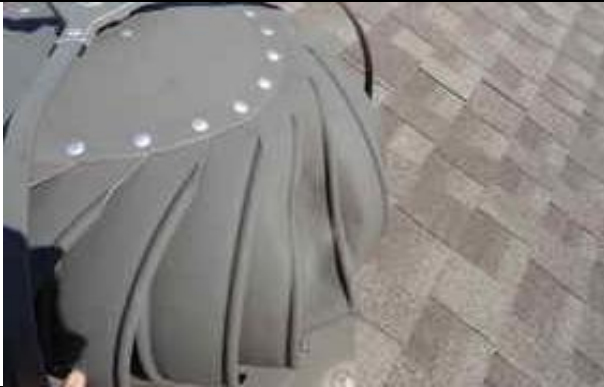
5.10-1. Dent in turbine vent	5.10-2. Dent in turbine vent
