## HAILSTORM INVESTIGATION

DALLAS / FORT WORTH, TX

MAY 24, 2011

## **HAILSTORM INVESTIGATION REPORT**

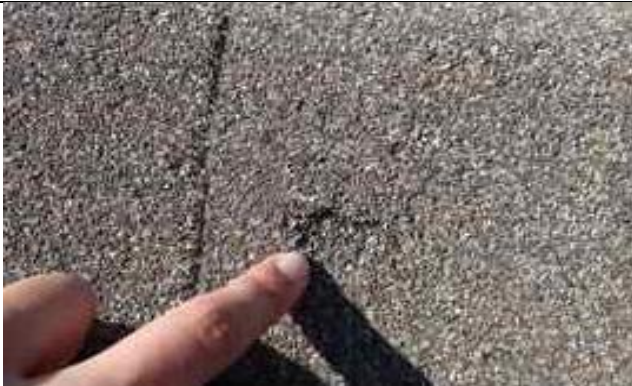
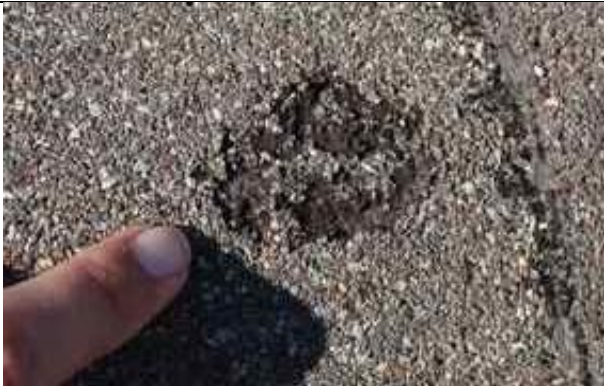
5.10-3. Shingle fracture along ridge	5.10-4. Close up of impact mark on shingle

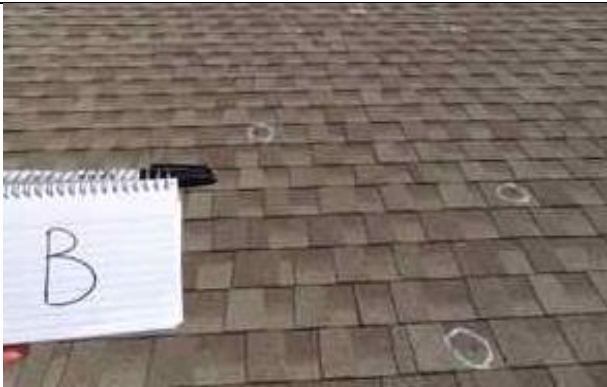
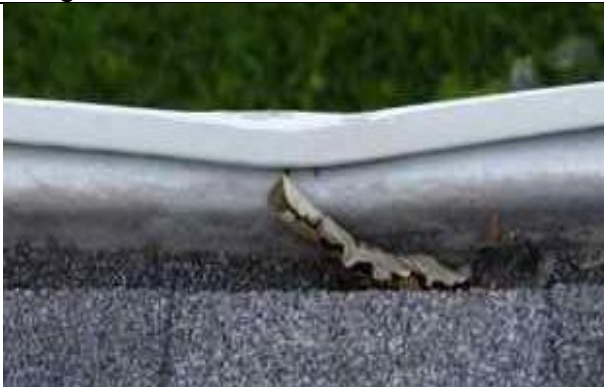
5.10-5. 10' x 10' area on North facing slope with impact locations marked	5.10-6. Dent in gutter

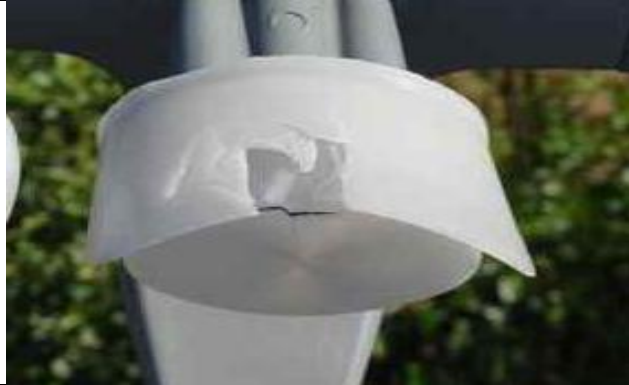
5.10-7. Broken plastic receiver on satellite dish

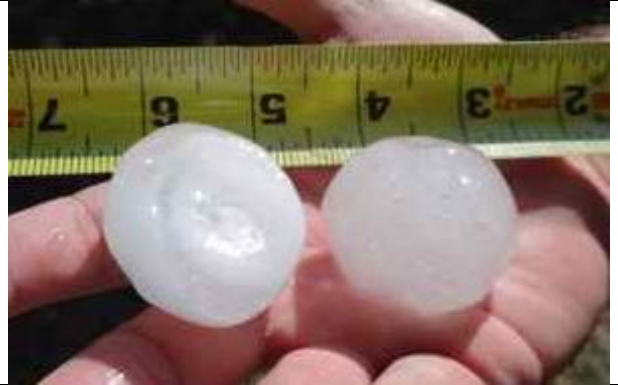
5.10-8. Hailstones saved by homeowner

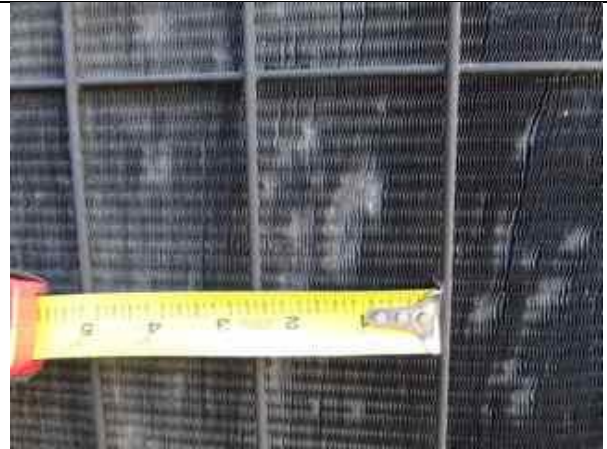
5.11-2. Hail hits on air handler

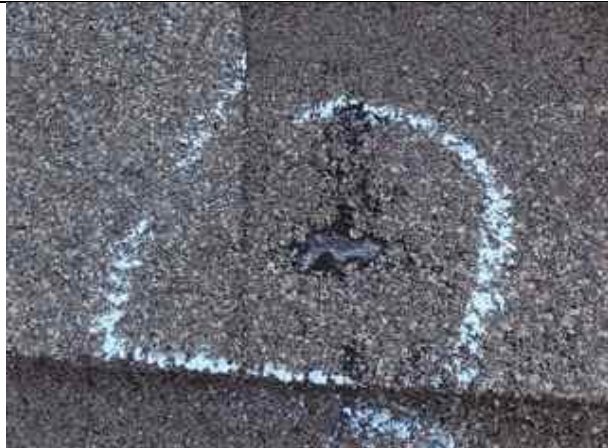
5.11-3. Hail damage showing felts

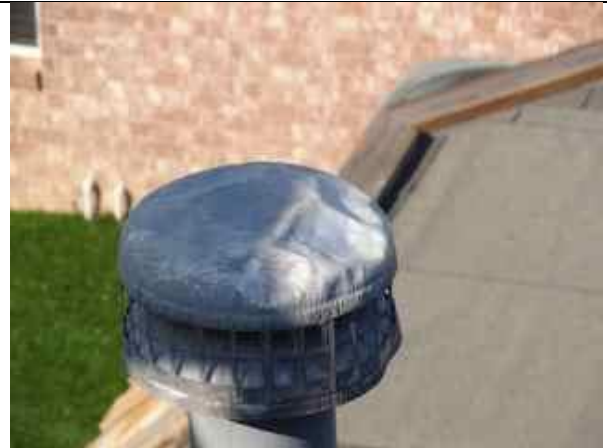
5.11-4. Hail damage on vent stack

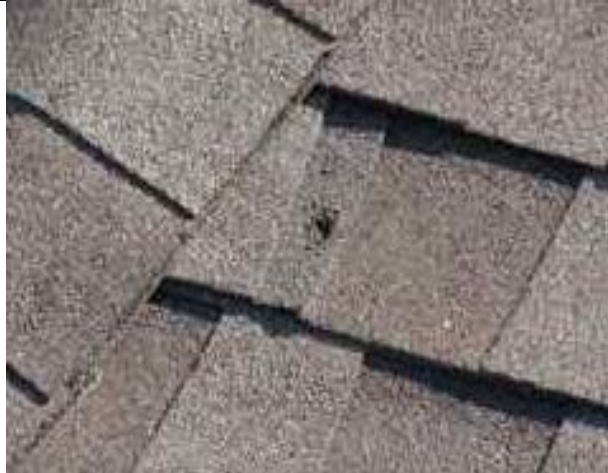
5.12-5. Puncture on IR shingle.

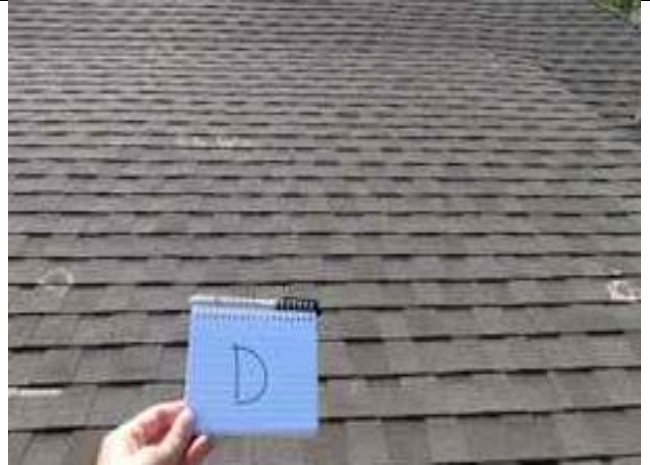
5.12-6. 10' x 10' area on West facing slope with impact locations marked (IR roof).

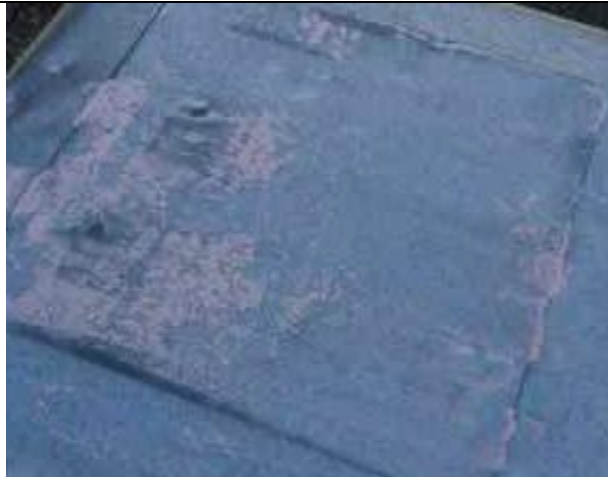
5.12-7. Dents in metal roof vent highlighted by chalk.

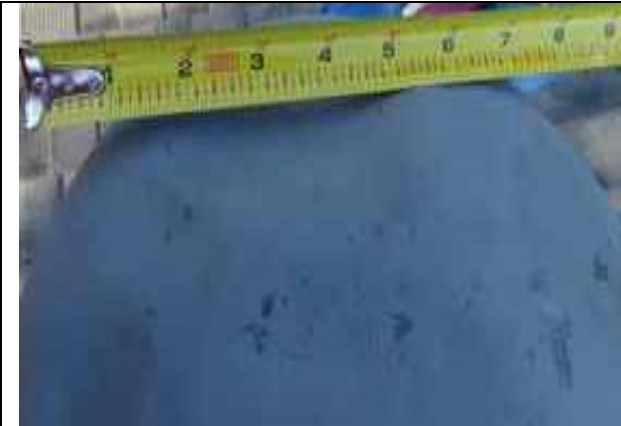
5.13-1. Dents and splatter marks in metal vent.

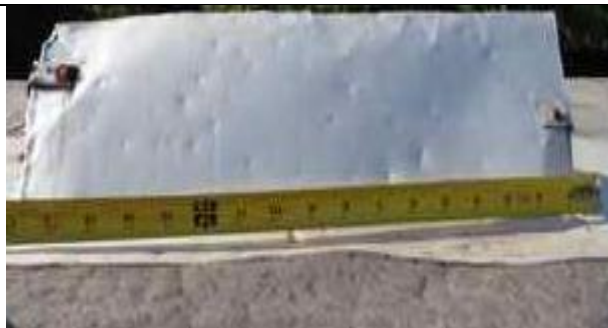
5.13-3. Numerous impacts in metal chimney cover.

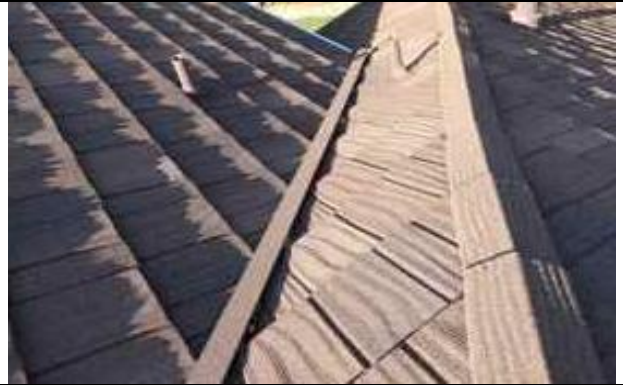
5.14-2. Valley of granule covered metal roof.

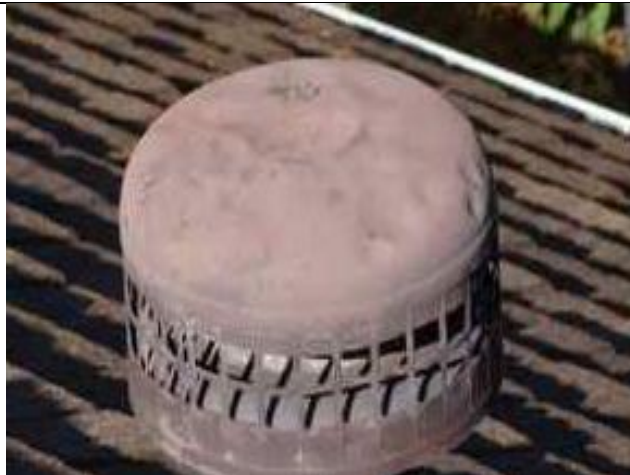
5.14-3. Dents and splatter marks in metal vent.

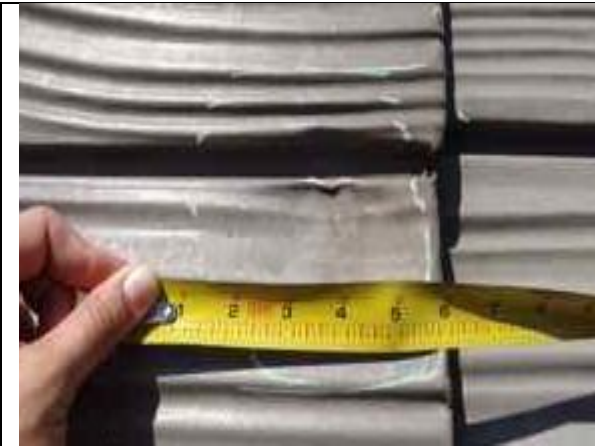
5.15-1. Large dent in metal shingle.

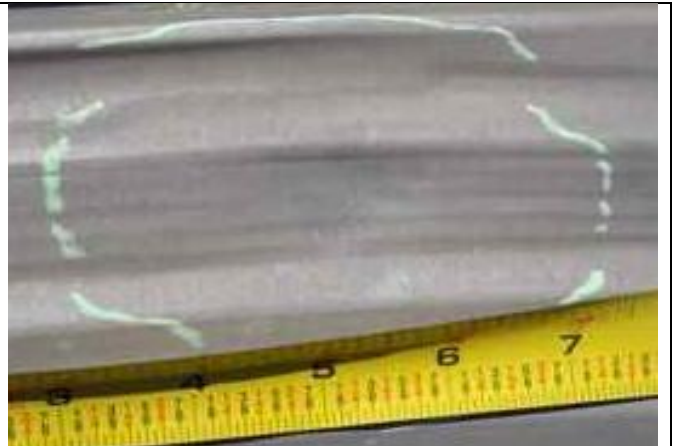
5.15-2. Large dent in metal shingle.

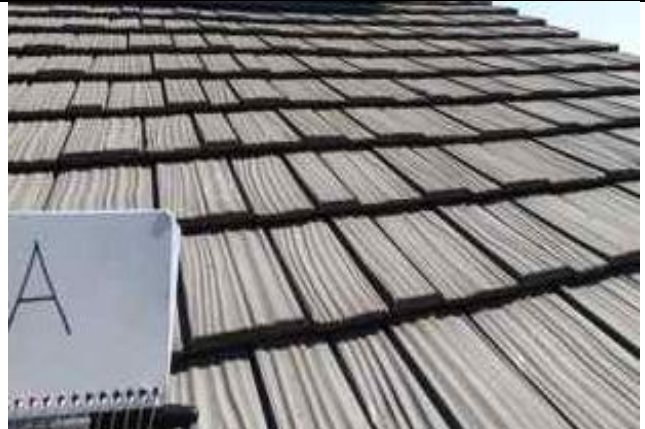
5.15-4. 10' x 10' area on South facing slope with impact locations marked.

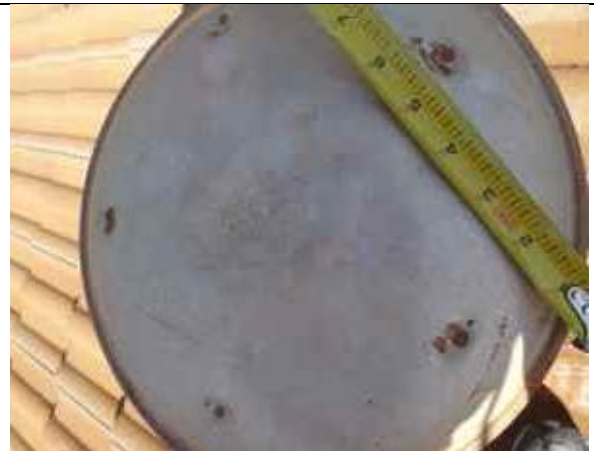
5.16-2. Large dents in metal vent.

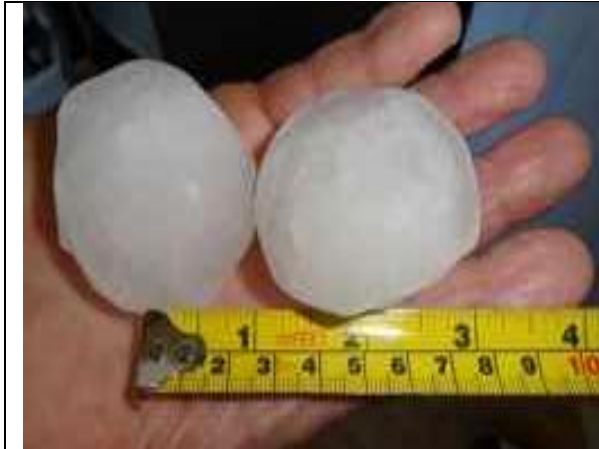
5.17-1. Homeowner saved hailstones.

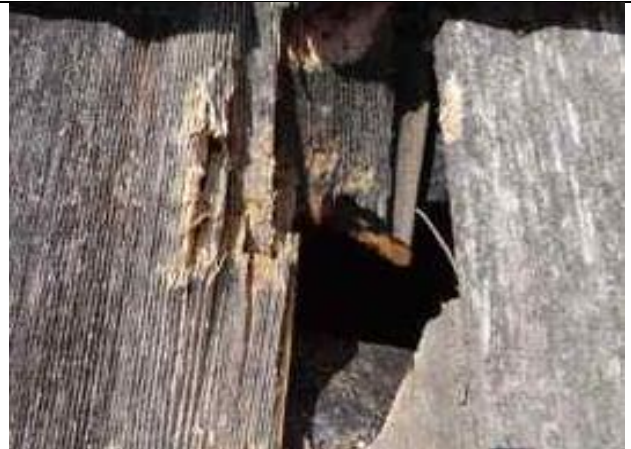
5.17-2. Large puncture from hail in cedar shake.

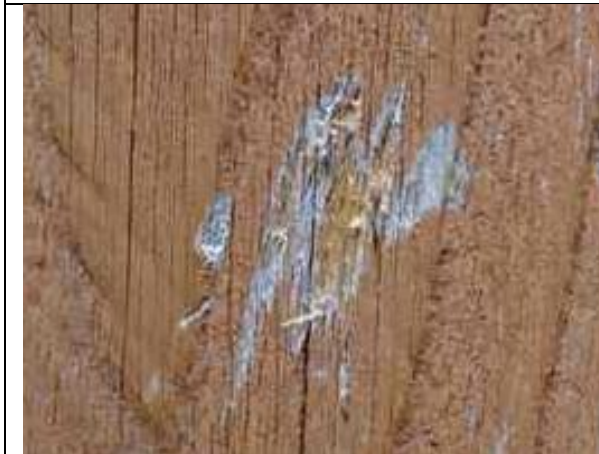
5.17-3. Splatter mark on stained wooden fence.

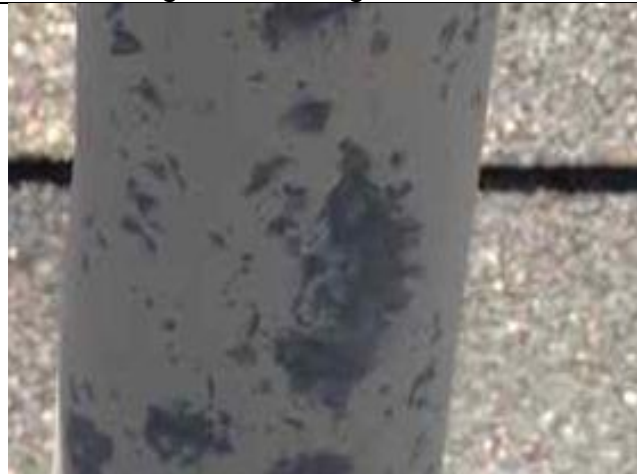
5.18-4. Spatter marks on metal vent stack.

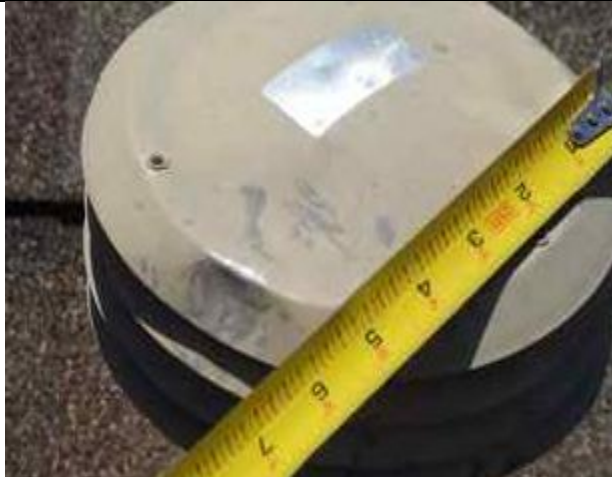
5.18-5. Dent and spatter mark on metal vents

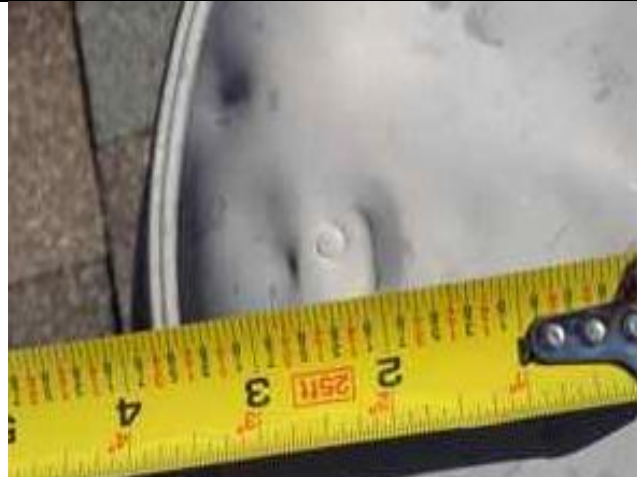
5.18-6. Dents in metal vent.

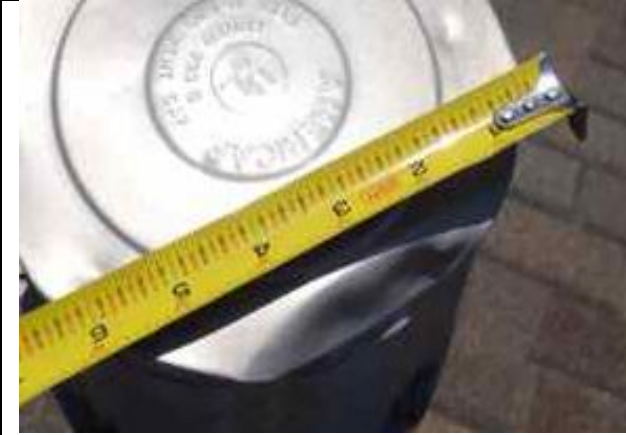
5.18-7. Large dent on edge of metal vent.

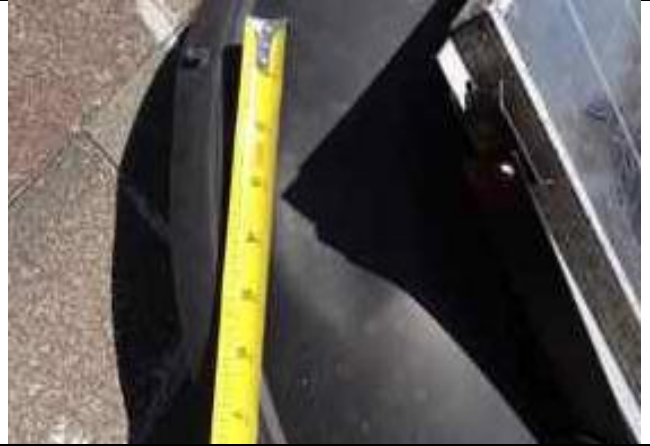
5.18-8. Dent in edge of solar panel vent.

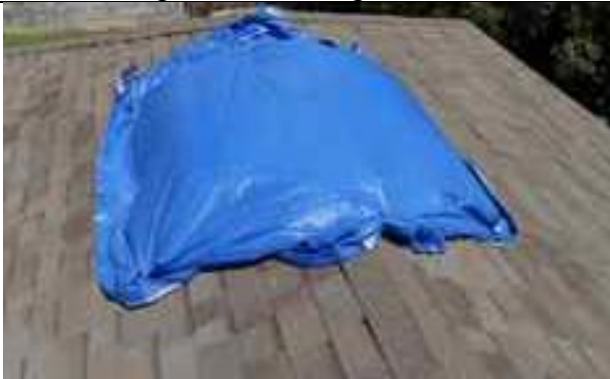
5.18-9. Broken skylight.

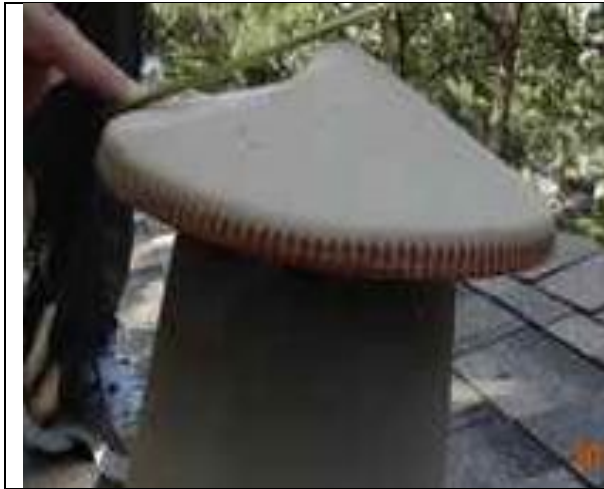
6.01-1. Dent profile.

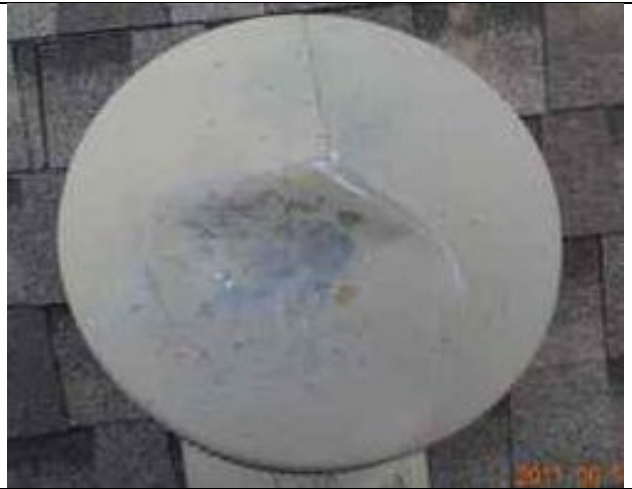
6.01-2. Dent boundary and coinciding splash mark.

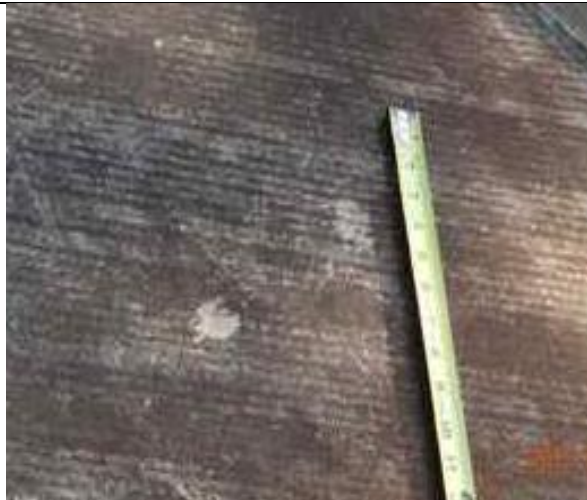
6.01-3. Splash marks on steel chimney cap.

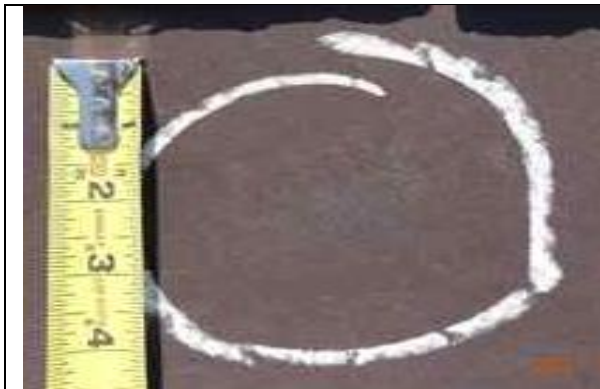
6.07-1. Splash mark on synthetic simulated slate.

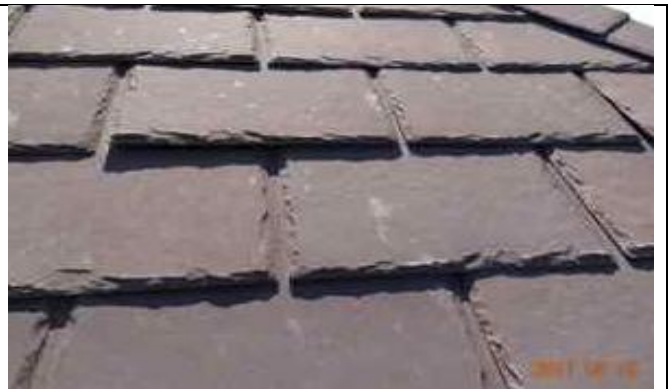
6.07-2. Splash marks on synthetic simulated slate.

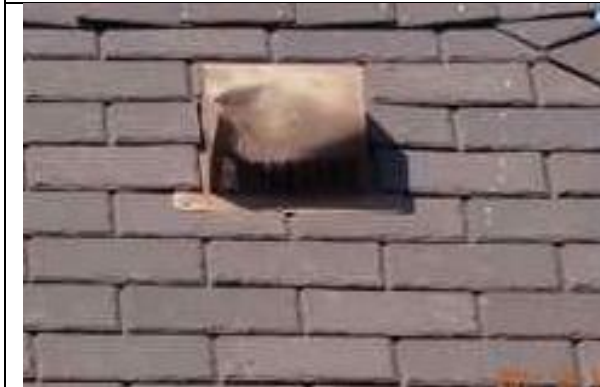
6.07-3. Dent on attic vent.

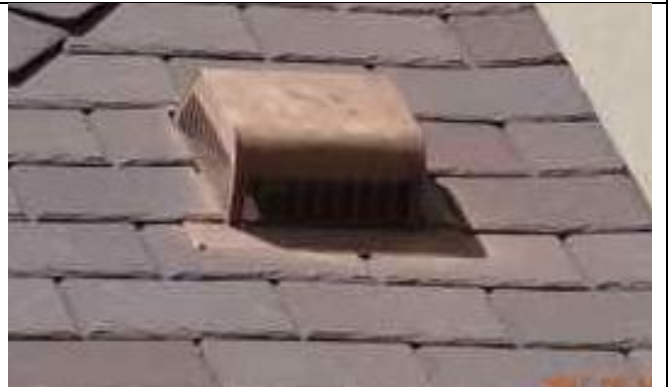
6.07-4. Splash marks on attic vent.

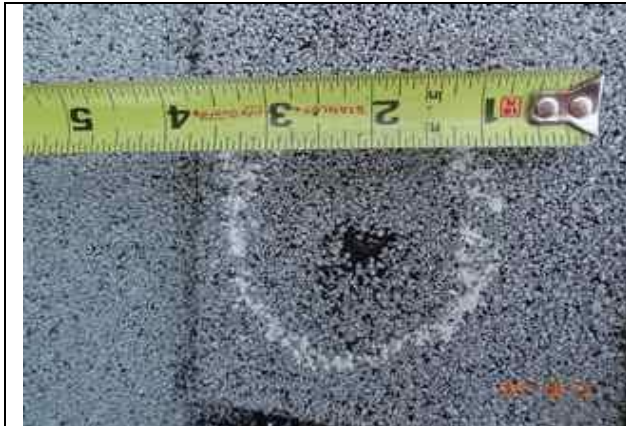
<b>Comments Regarding Inspection</b>	<b>Partially treed property. -Assessment-for class 4, we would have expected no damage.</b>

6.08-1. Hail scuff on impact resistant shingle

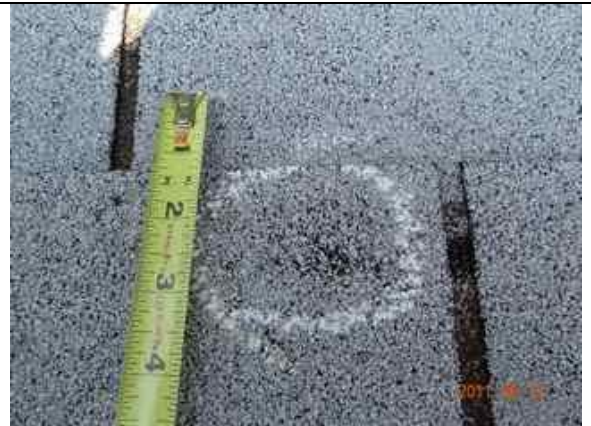
6.08-2. Hail scuff on shingle

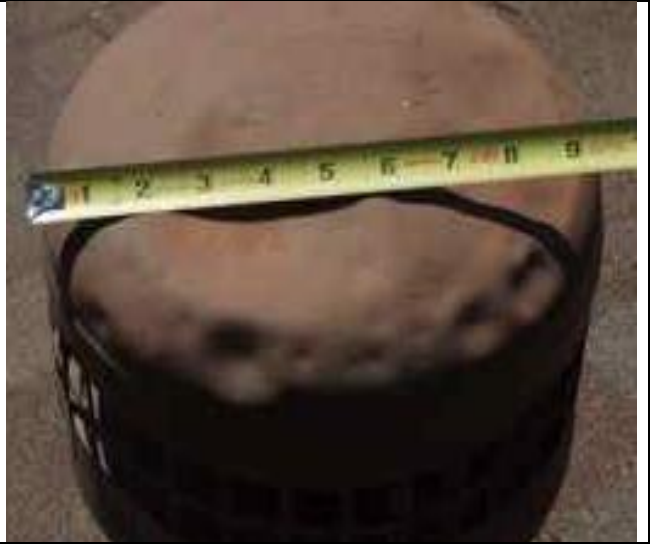
6.11-2. Dents in aluminum vent cap.

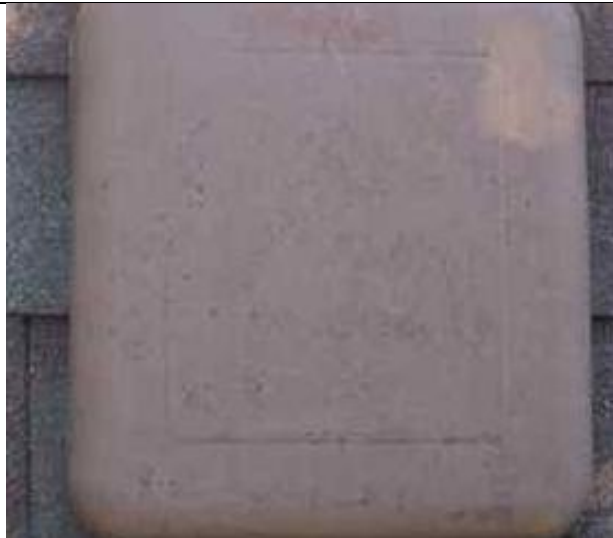
6.11-3. Splash marks on steel attic vent.

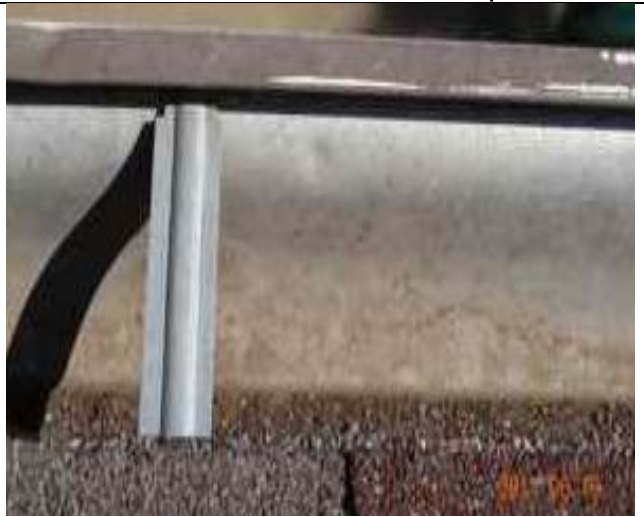
6.11-4. Dent in aluminum gutter.

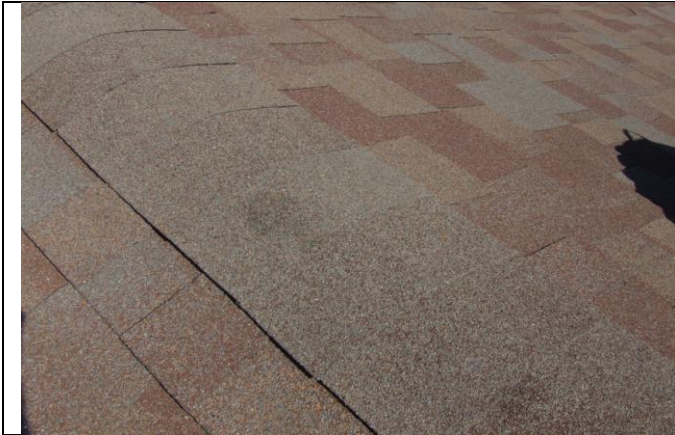
6.11-5. Bruises on shingles

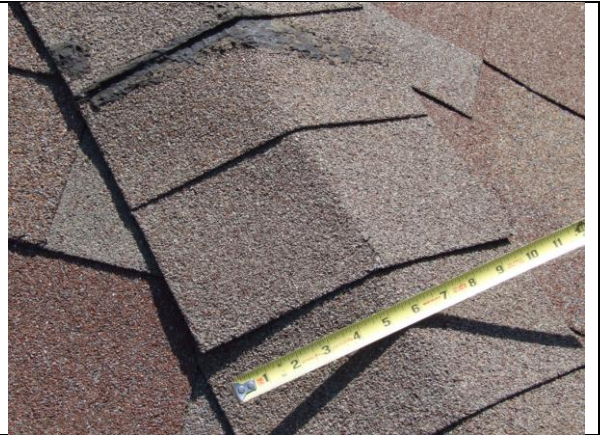
6.11-6. Crack in unsupported area

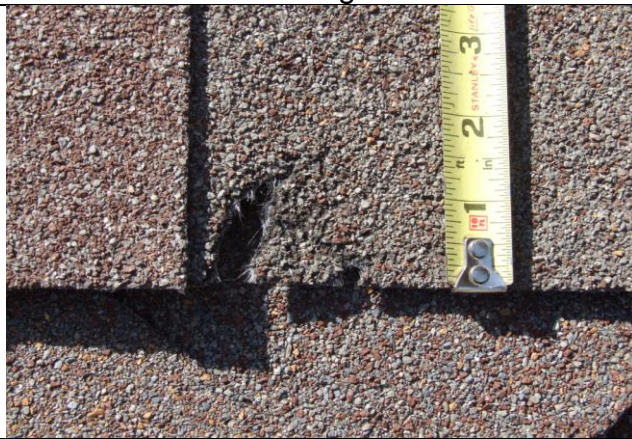
6.11-7. Penetrating damage with erosion

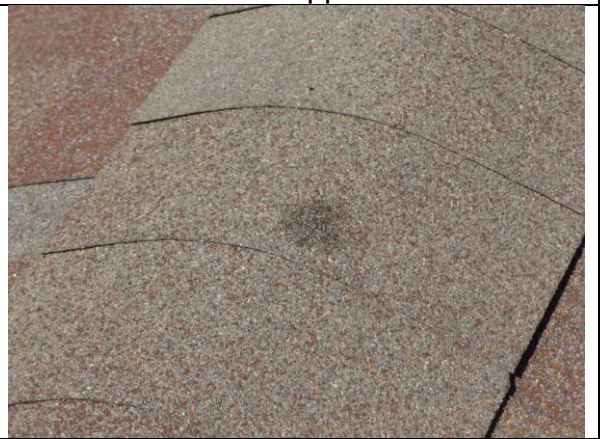
6.11-8. Hail mark

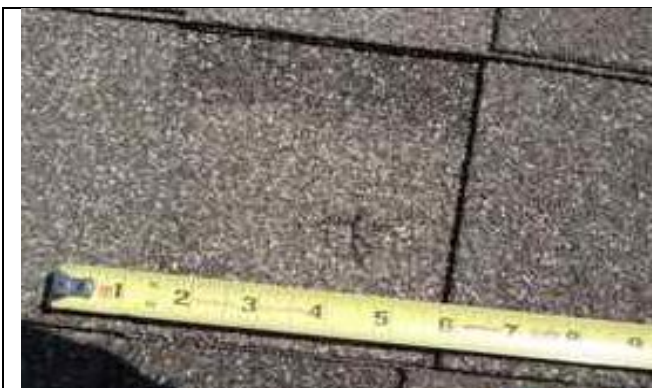
6.13-1. View of granule damage and mat fracture.

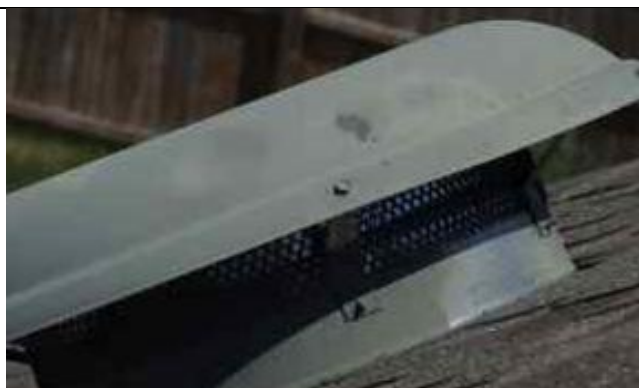
6.13-2. View splash mark on an attic vent.

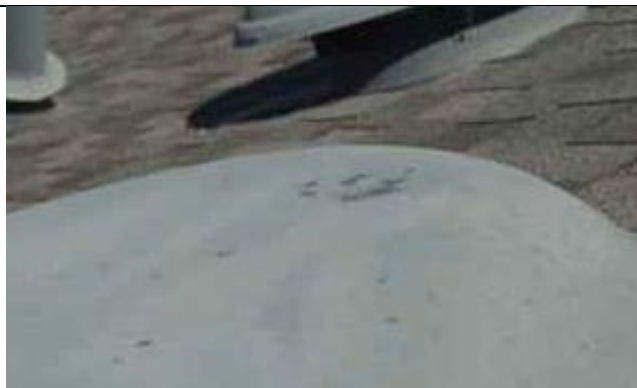
6.13-3. View splash mark on an attic vent.

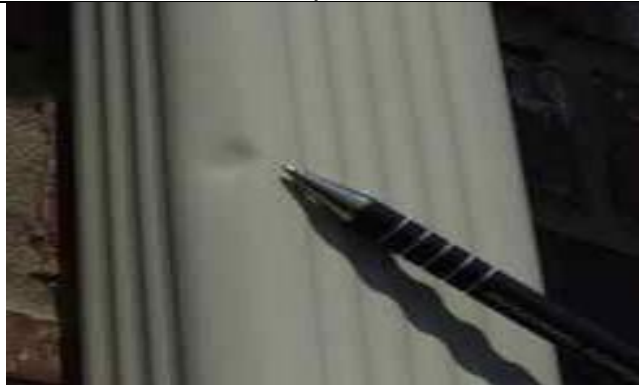
6.13-6. View of a dent in a downspout.

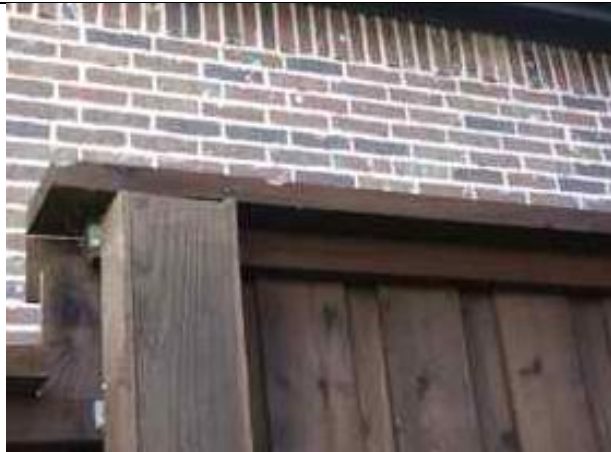
6.14-3. View of chipped wood on the top rail of a wood fence.

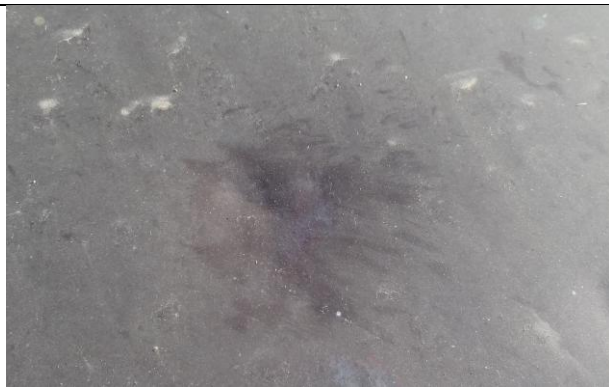
6.15-1. Splash mark and dent on copper roof panel.

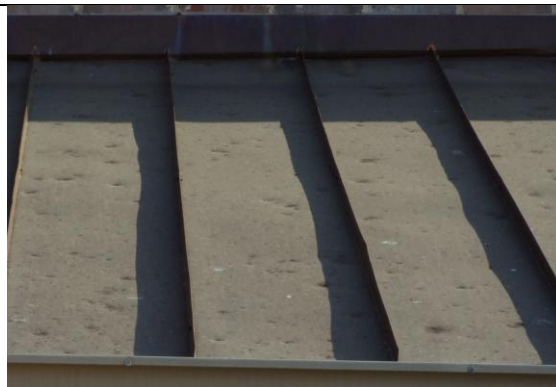
6.15-2. Dents in copper roof panels.

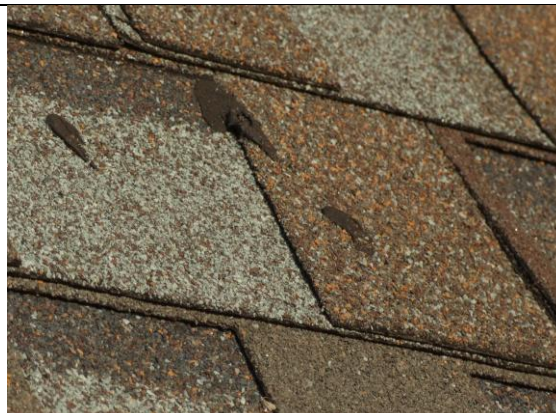
6.15-4. Shingle repairs unrelated to hail.

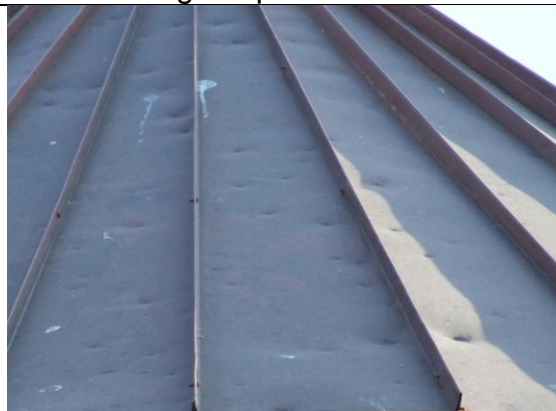
6.15-6. Dents in copper roof panels.

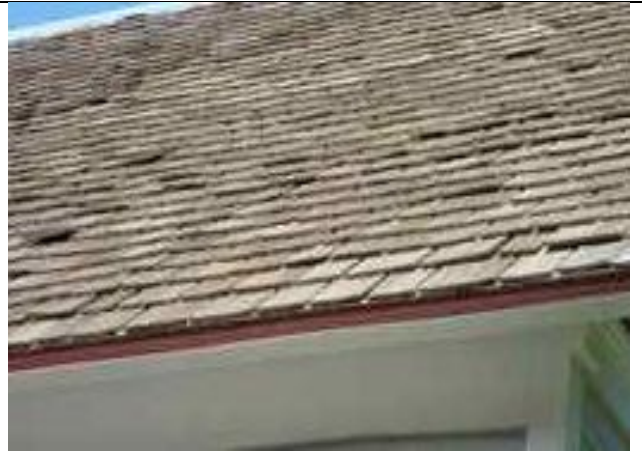
7.02-2. Cedar shingles with some lifting.

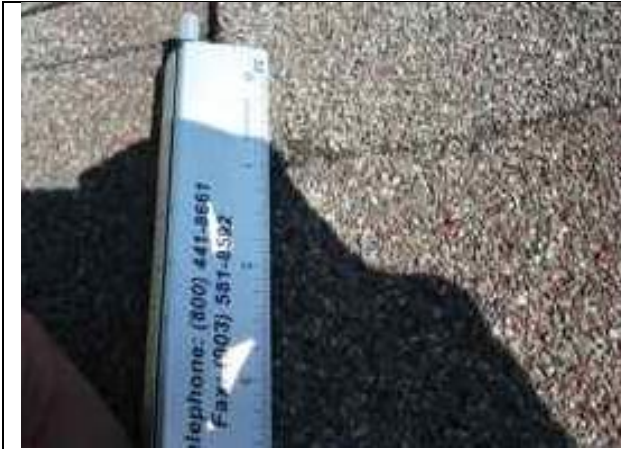
7.05-1. Asphalt shingle close up.

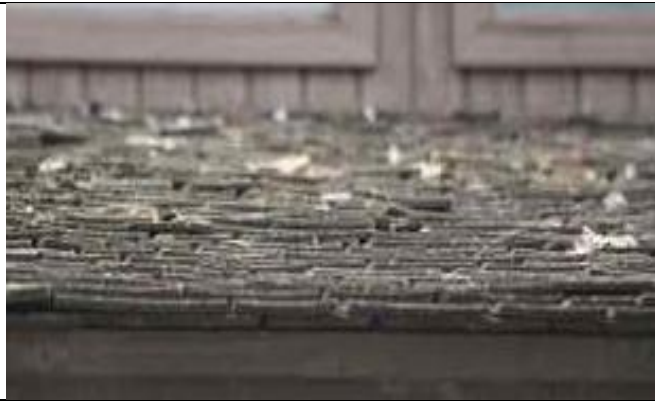
7.06-1. Broken shakes scattered as debris.

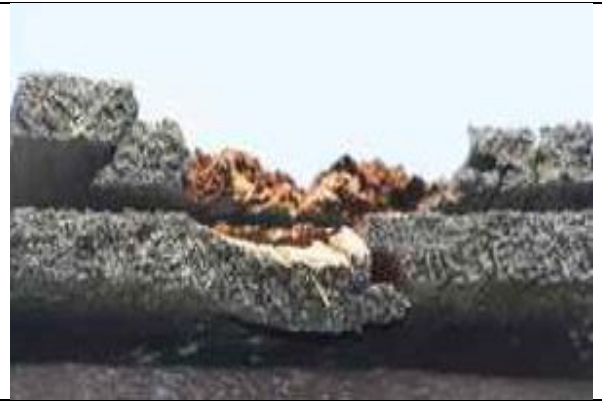
7.06-2. Damage to starter course wood shake.

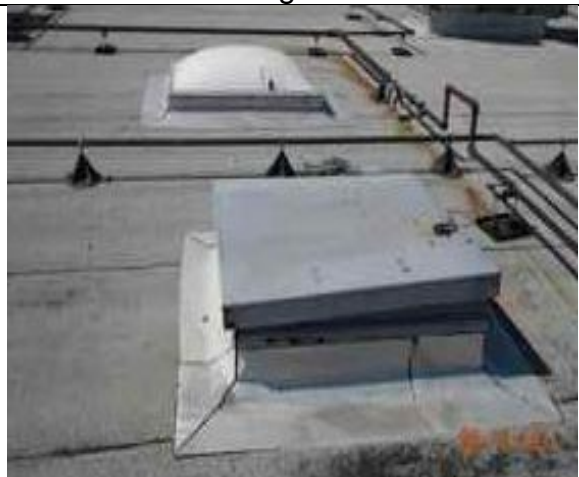
1.17-3. Overview of roof.

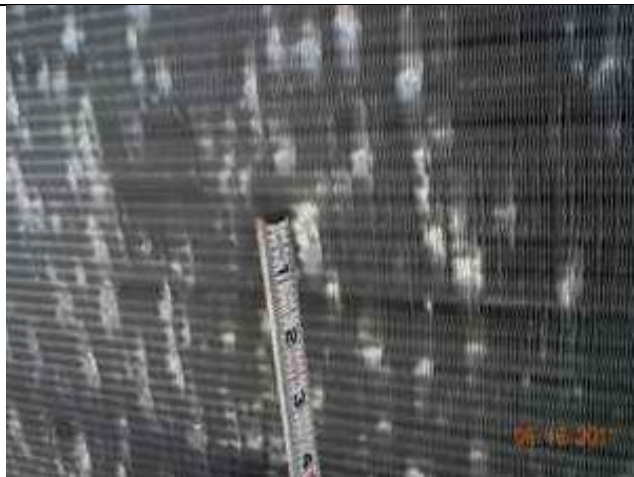
1.17-4. Hail marks shown.

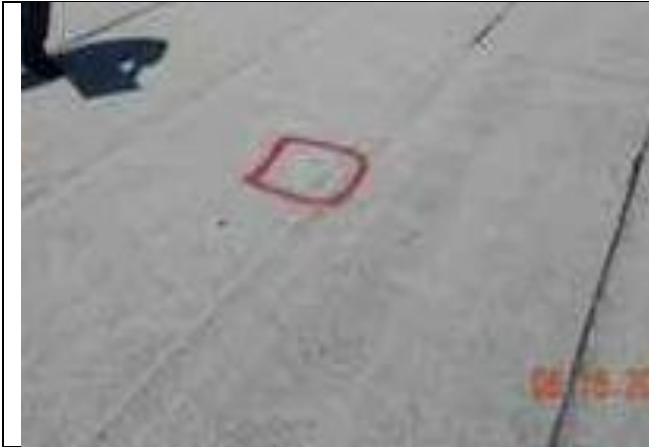
1.18-1. Large hail mark.

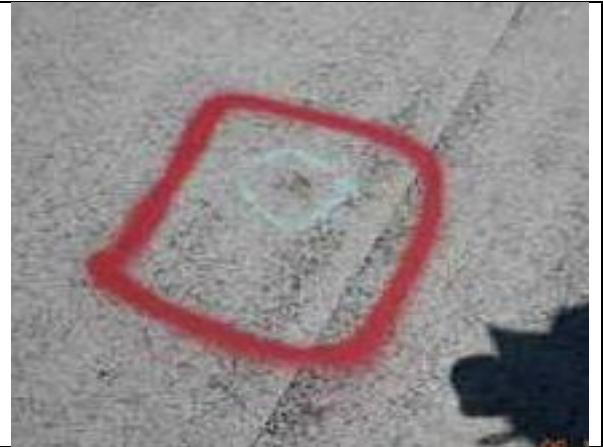
1.18-2. Large hail mark.

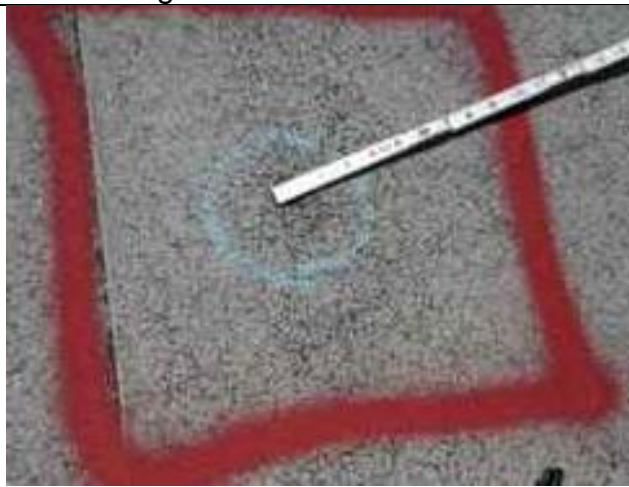
1.18-3. Large hail mark.

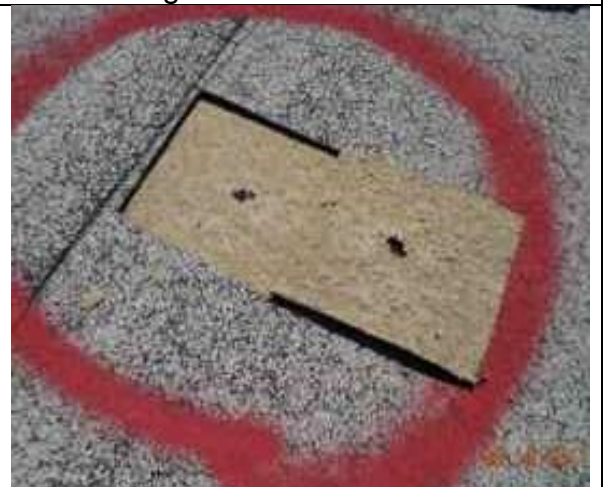
1.18-4. Hail penetrated roof.

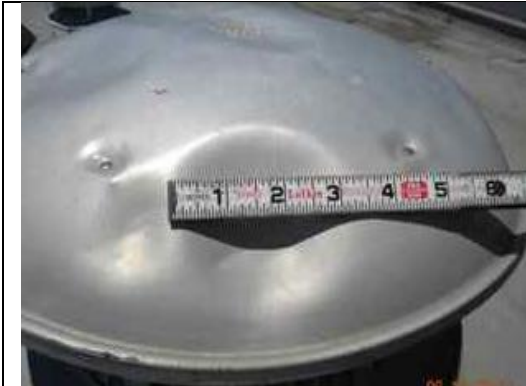
1.19-1. Close-up of impact ~ 3-inches.

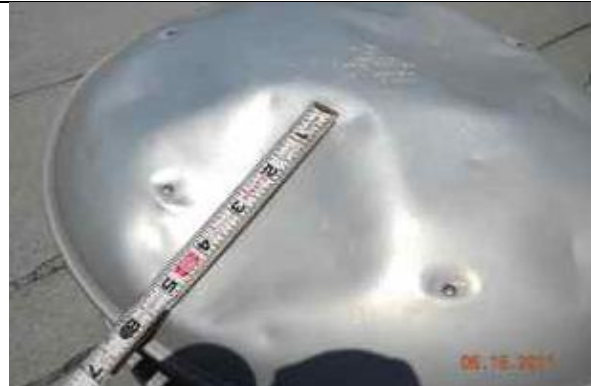
1.19-2. Close-up of impact ~ 4 to 5-inches.

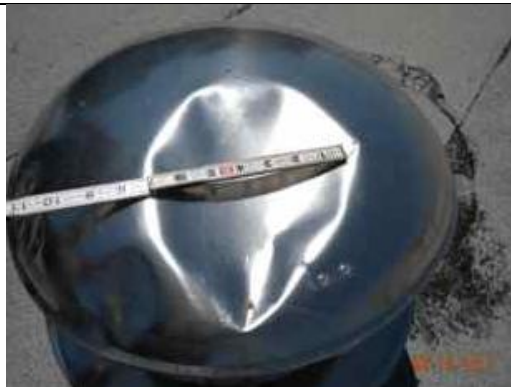
1.19-3. Close-up of impact ~ 4 to 5-inches.

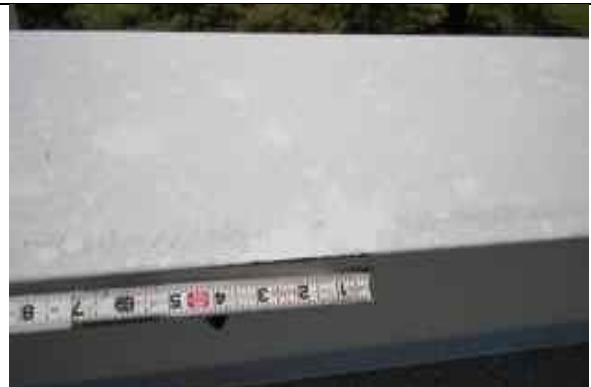
1.19-4. Close-up of impact on coping edge ~ 3-inches.

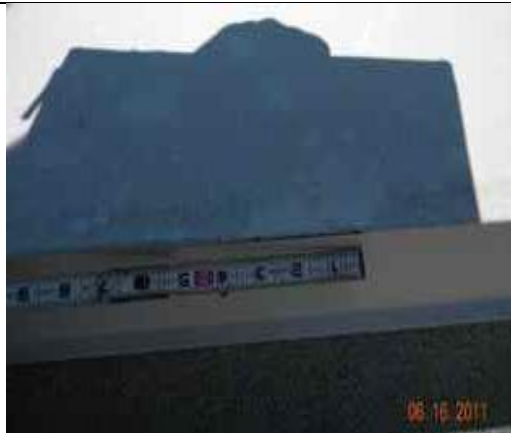
1.19-5. Close-up of impact on coping edge ~ 3-inches.

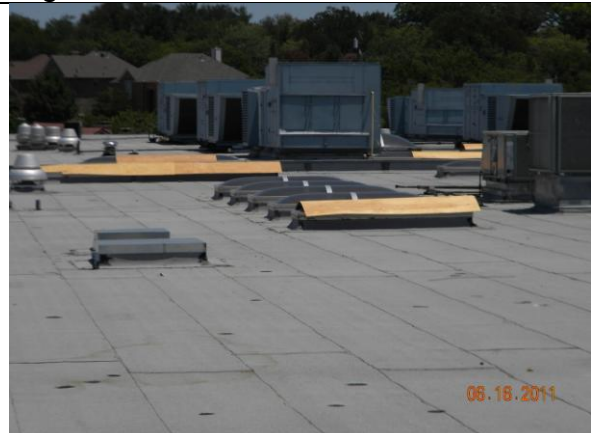
1.19-6. Overview of impact area

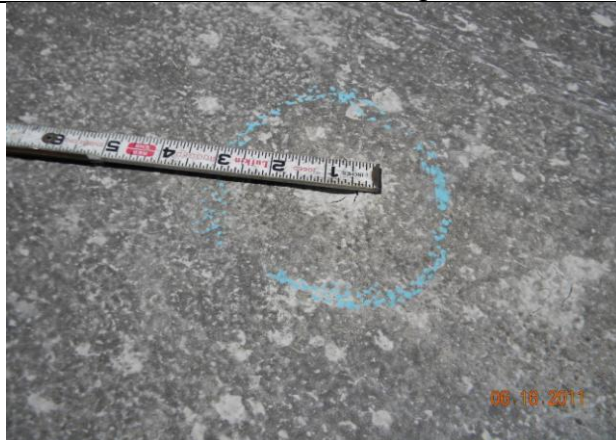
01.20-3. Close view of impact damage ~ 1.5-inch.

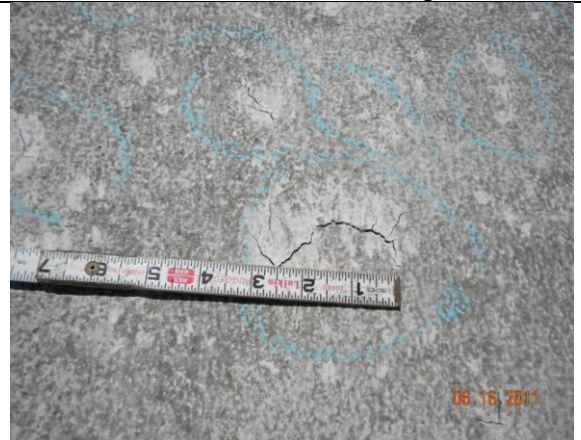
01.20-4. Close view of impact damage ~ 3 to 3.5-inch.

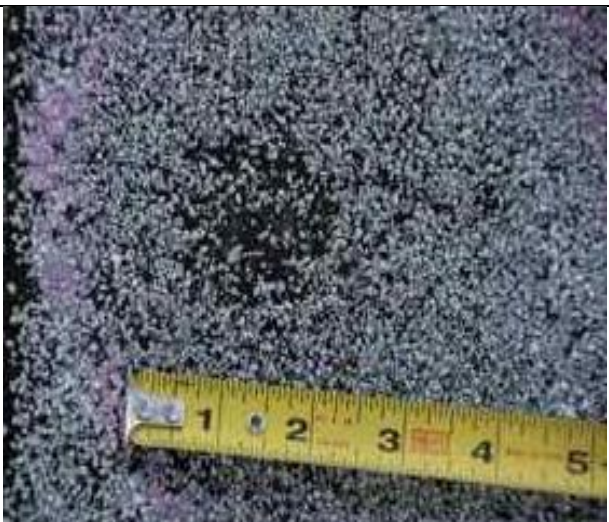
A close-up photograph showing a yellow measuring tape placed horizontally on a dark, textured surface. The tape is marked from 1 to 5 inches. The surface is covered with numerous small, dark, clustered impacts, likely from hail.	
3.08-3. Typical impact to modified bit.

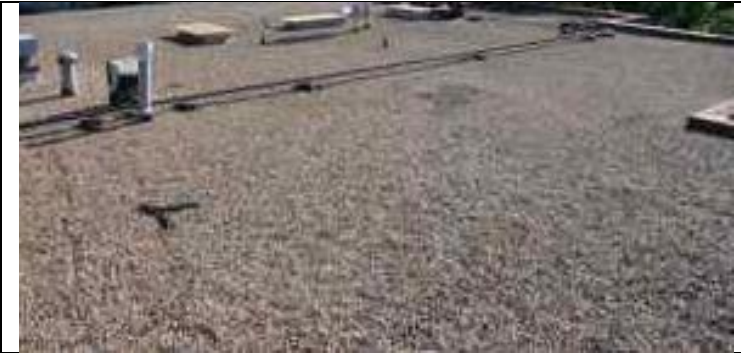
3.08B-1. Hail impact divots in BUR roof.

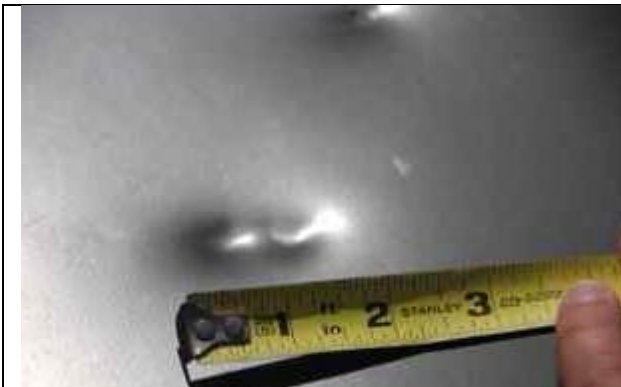
3.09-1. Hail impact dents in metal flashing on top of parapet wall.

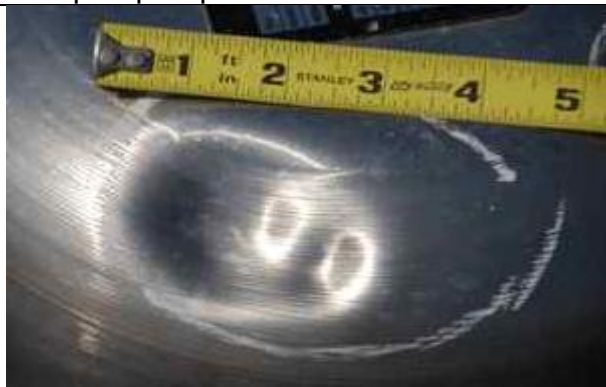
3.09-3. Large dent in exhaust fan from hail impact.

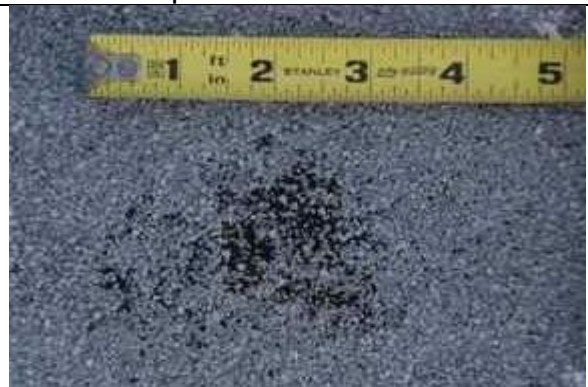
3.09-4. Typical hail impact damage to roof.

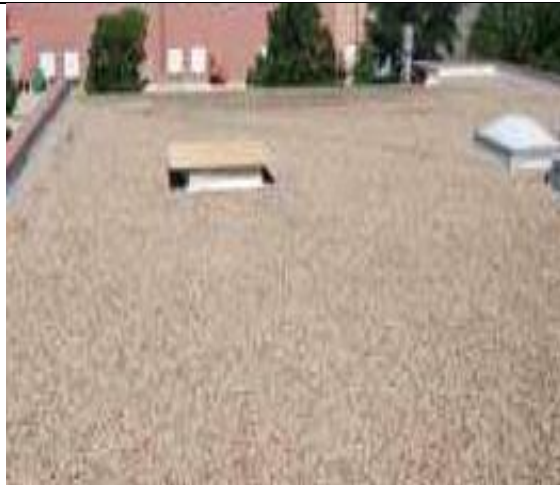
3.10-3. Damaged skylight and no visible damage to BUR.

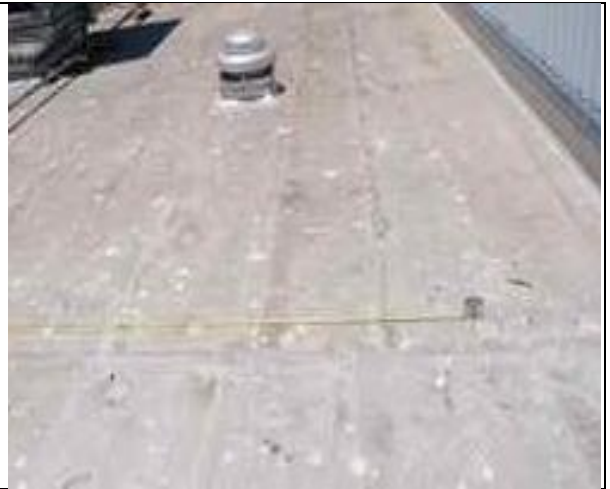
3.12-2. Large number of big hail strikes to single ply roof covering at this location.

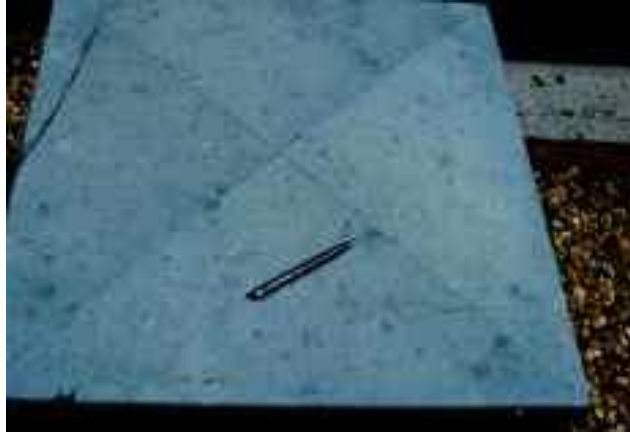
4.02-1. The dark spots on top of this sheet metal cap are spatter marks from hail strikes. The larger ones appear to be from hailstones of 1"–1.25" diameter.

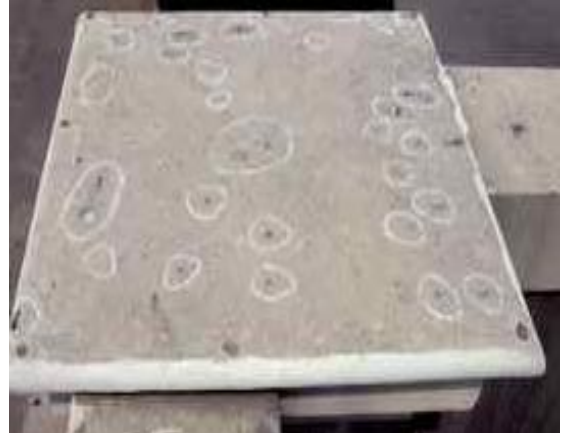
4.02-2. At the SW and NW corners of this roof are square enclosures lined with walls, and the walls are topped with exterior insulation and finish system (EIFS).

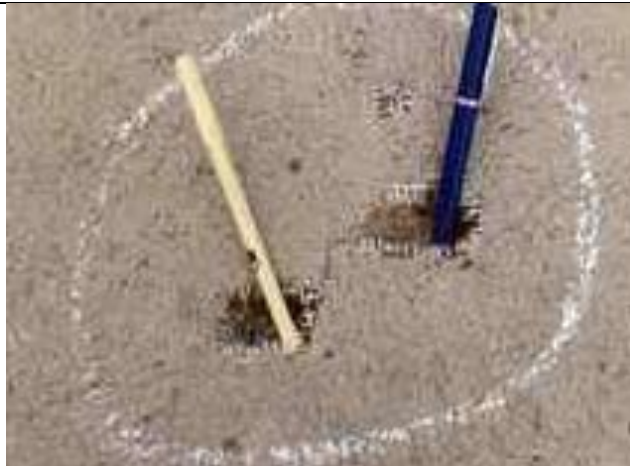
4.02-3. This is a close-up of two holes in the EIFS consistent with hail strikes.

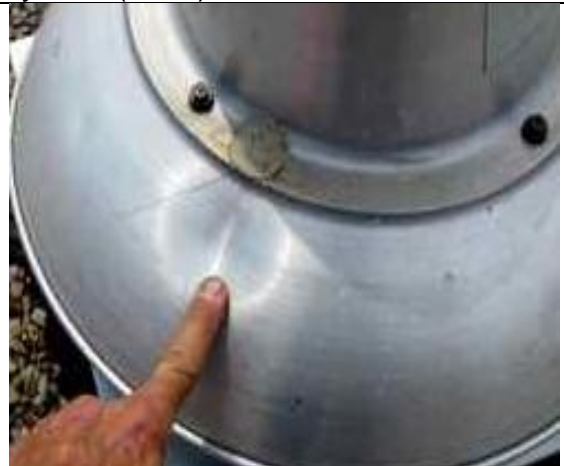
4.02-4. This indentation in an exhaust cover is approximately the size of an egg.
