## HAILSTORM INVESTIGATION

DALLAS / FORT WORTH, TX

MAY 24, 2011

## **HAILSTORM INVESTIGATION REPORT**

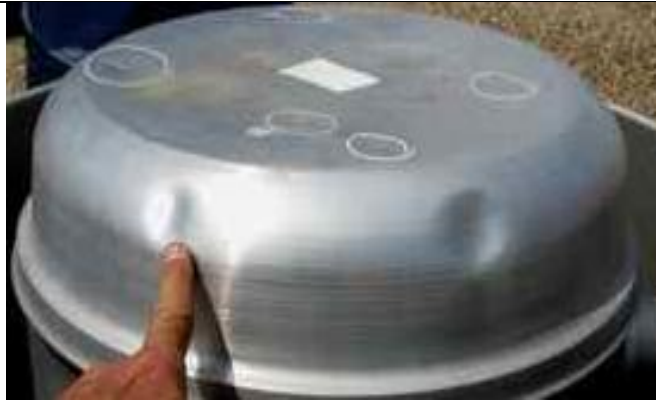
4.02-5. Several indentations (encircled in white) were noted on this exhaust cover.

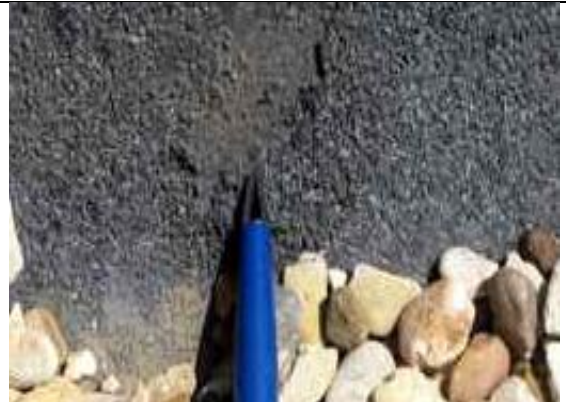
4.02-6. Close examination of this base flashing showed bare spots where mineral granules were knocked loose.

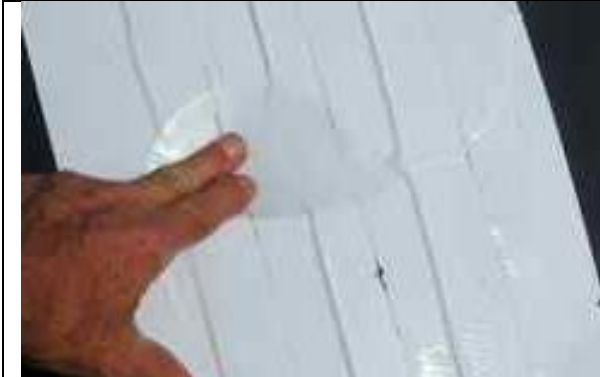
4.03-1. White tape was used as a temporary fix for several skylights that were broken by hail strikes.

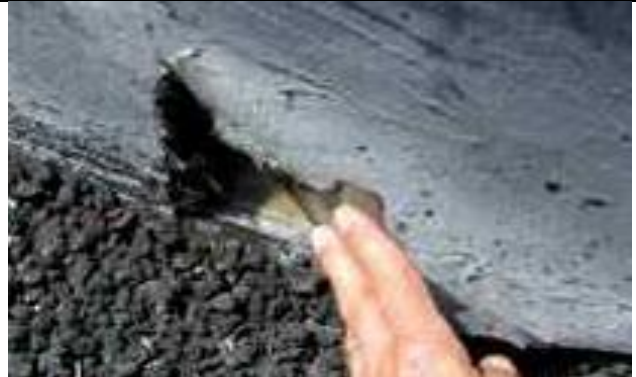
4.03-2. The old, weathered felts on this wall were especially vulnerable to damage from hail strikes

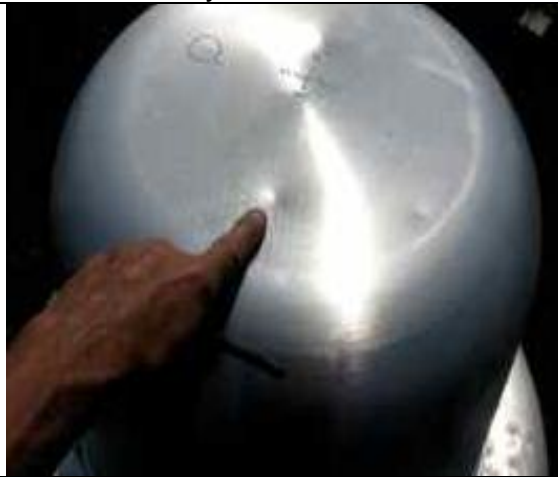
4.03-3. Sheet metal exhaust units provide conspicuous evidence of hail strikes.

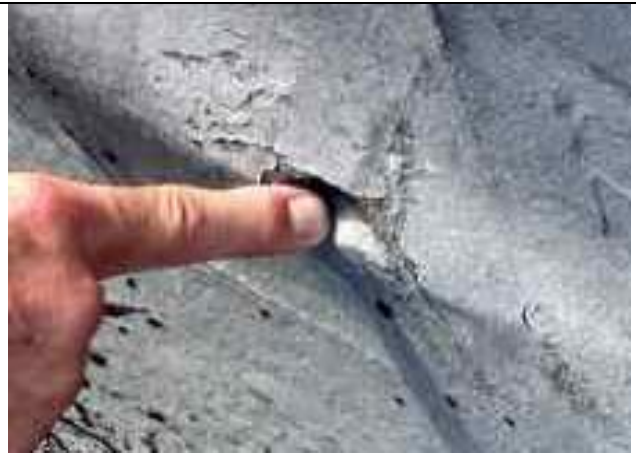
4.03-4. This is a close-up view of racked felts on a parapet with evidence of hail strikes.

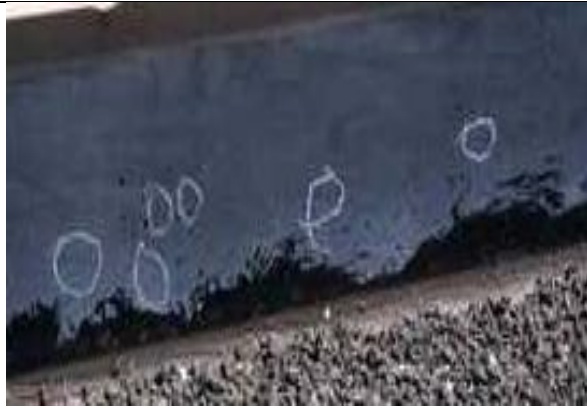
4.03-5. Encircled on the wall/base flashings of this parapet are numerous hail strike locations.

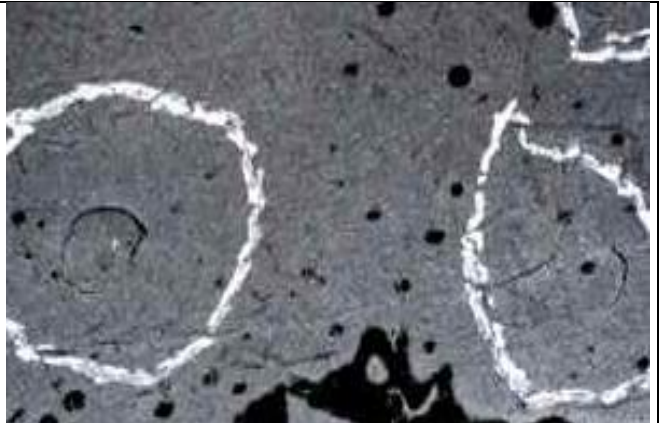
4.03-6. This is a close-up of some hail strikes on wall/base flashings on a parapet.

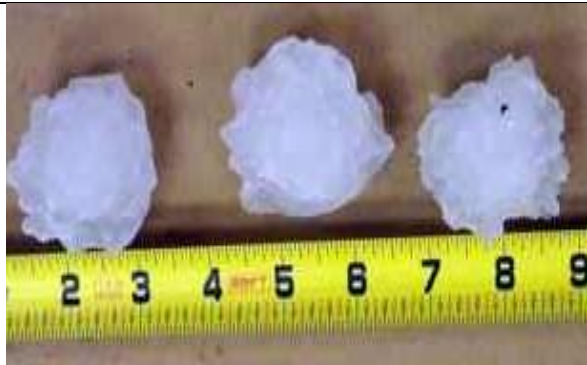
4.03-7. These are actual hailstones preserved following the hailstorm.

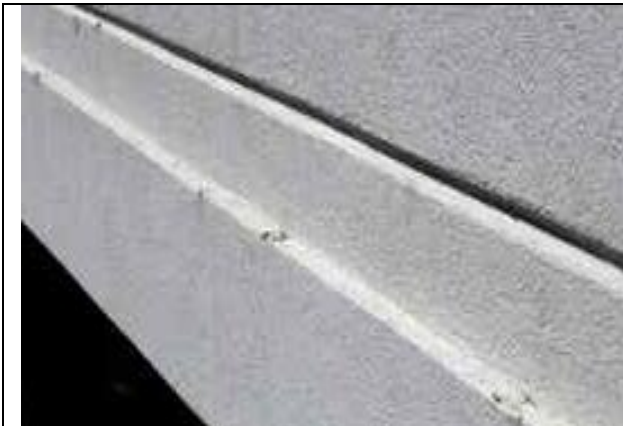
<b>Comments Regarding Inspection</b>	<b>Widespread damage throught the entire roof. Splatter marks on metal coping.</b>

4.06-1. Puncture marks on the EIFS wall.

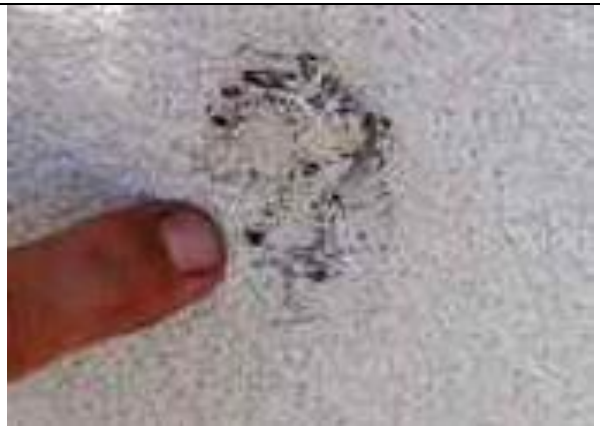
4.06-2. Close-up picture of the punctured EIFS wall surface.

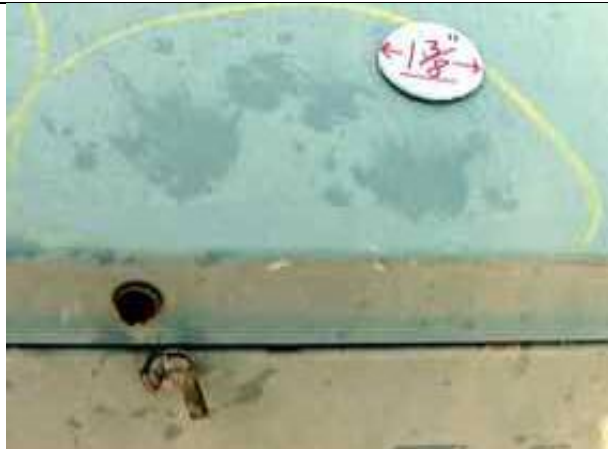
4.06-3. Spatter marks on the top surface of the AC unit.

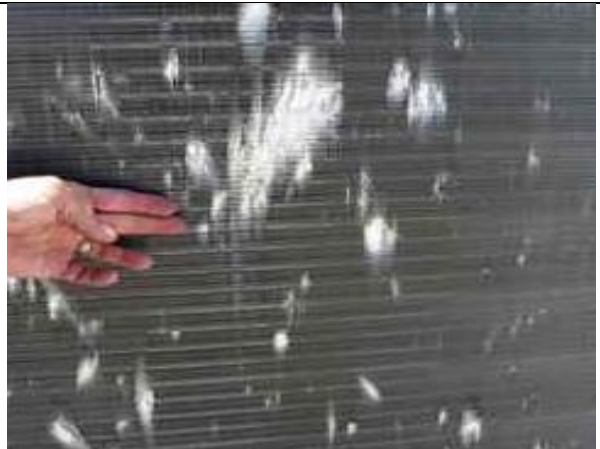
4.06-4. Indentation on the heat exchanger fins on roof mounted AC unit.

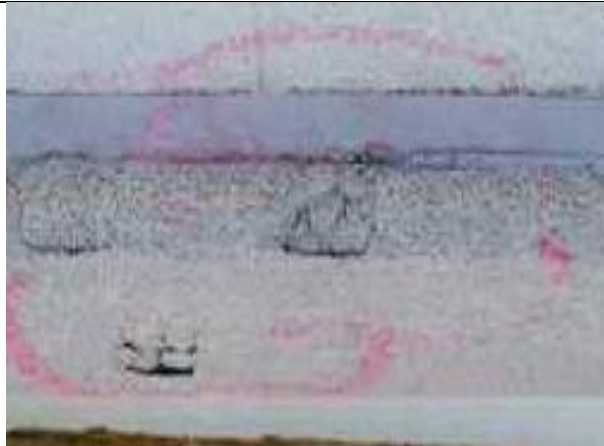
4.06-5. Punctured/Fractured base flashing on the roof.

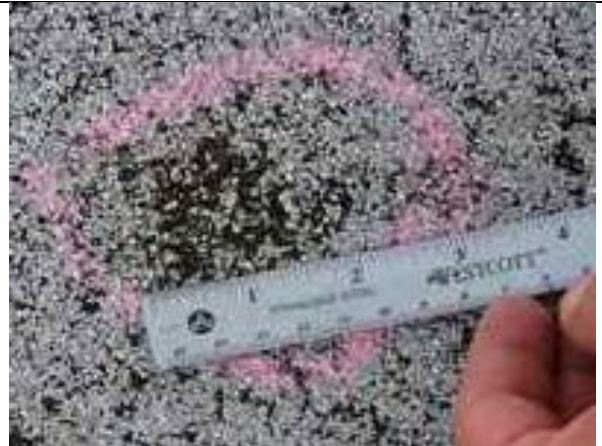
4.06-6. Displaced granules on the surface of the mod. bit roof.

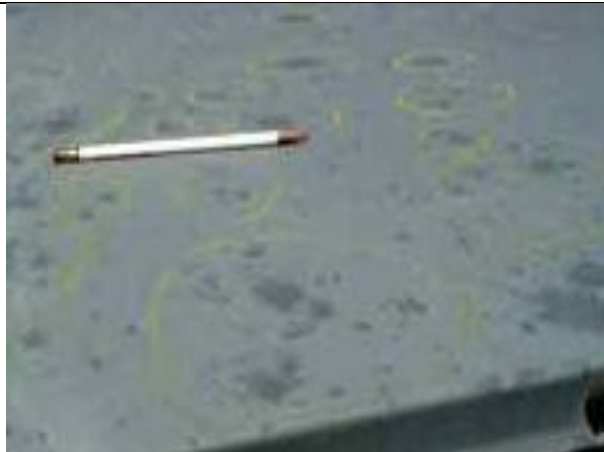
4.06-7. Several spatter marks on the top surface of the AC unit.

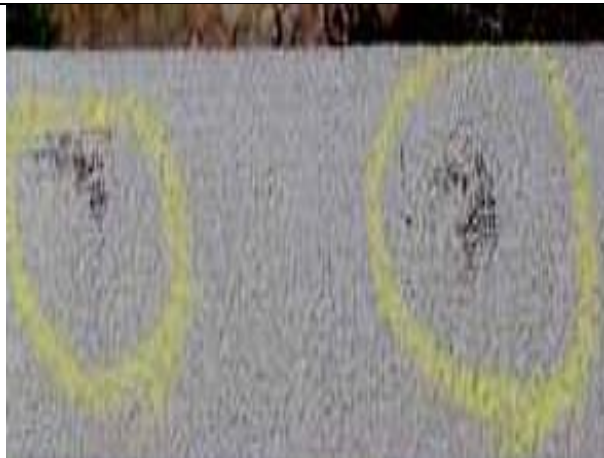
4.06-9. Puncture marks on the EIFS surface.

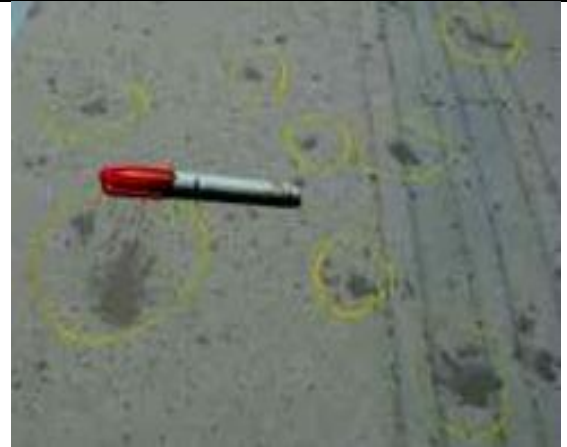
4.08-2. Spatter marks on the AC Unit.

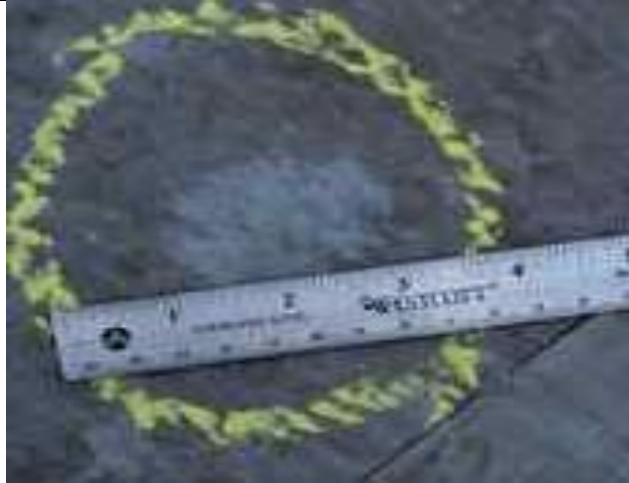
4.08-3. Spatter mark on the wall flashing.

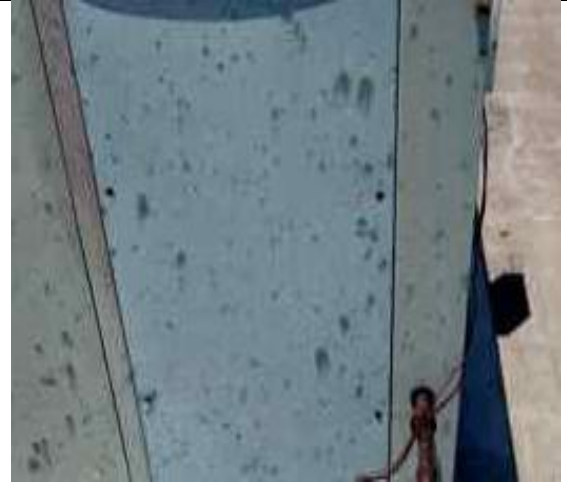
4.08-4. Spatter marks on the side panel of AC unit.

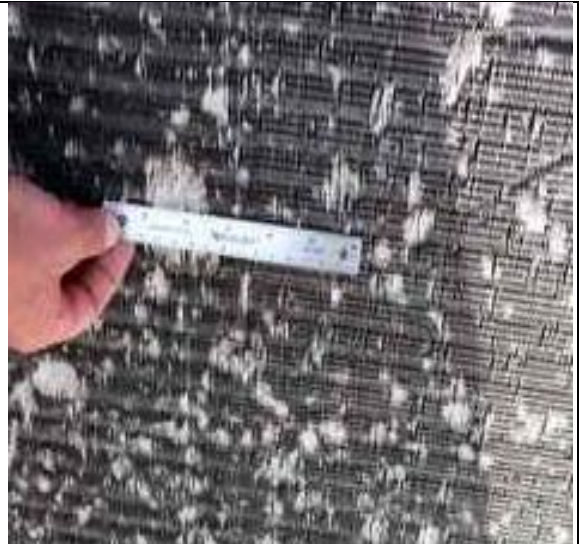
4.08-6. Indentations on the heat exchanger fins on roof mounted AC unit.

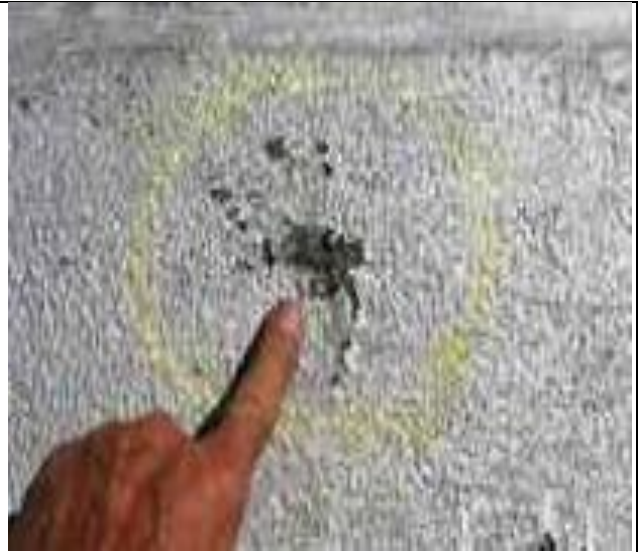
4.09-2. Chipped aluminized coating on the base/wall flashing.

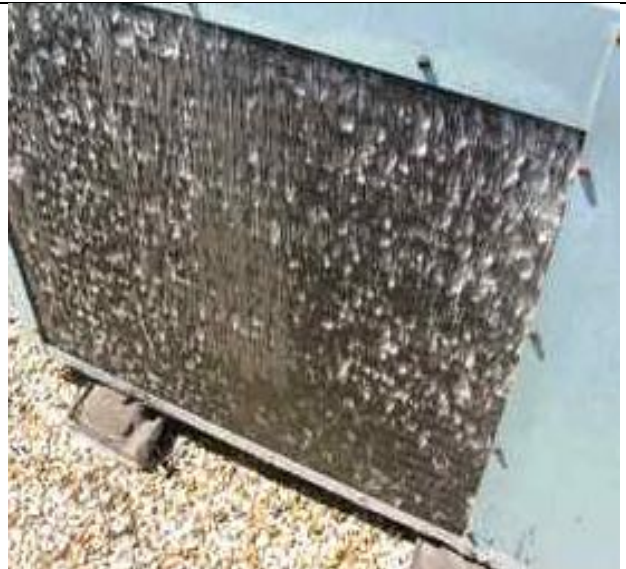
4.09-4. Multiple indentations on the heat exchanger fins on roof mounted AC unit.

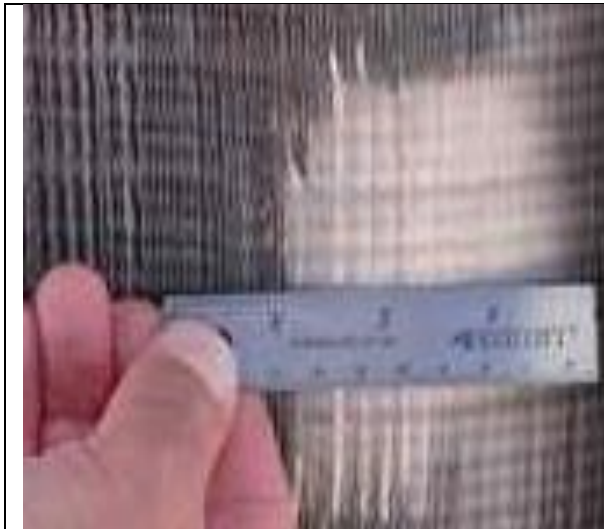
4.09-5. Multiple indentations on the heat exchanger fins on roof mounted AC unit.

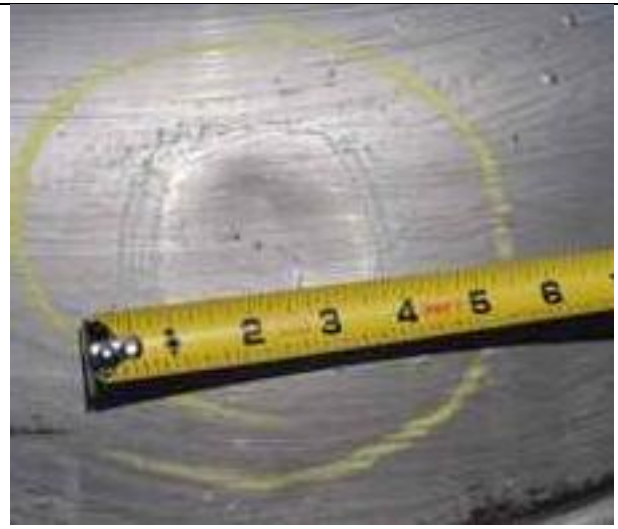
4.09-6. Large size indentation on the metal exhaust unit.

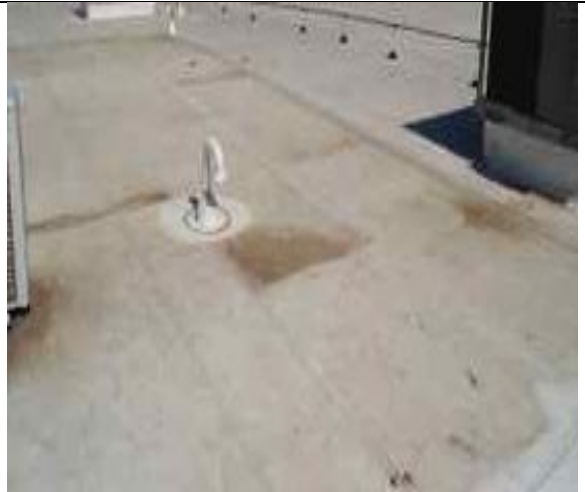
7.03-4. TPO and PVC on same roof.

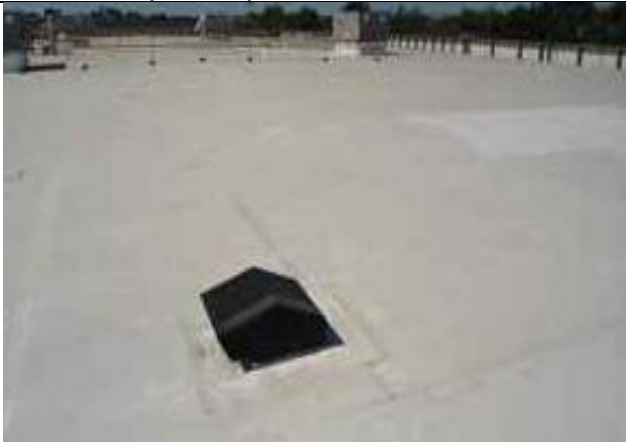
7.03-5. Two types of flat roof sections.
